Railway EMI impact on train operation and environment

A. Morant, Å. Wisten, D. Galar, U. Kumar
Division of operation, maintenance and acoustics
Luleå Tekniska Universitet, LTU
Luleå, Sweden
amparo.morant@ltu.se, ake.wisten@ltu.se,
diego.galar@ltu.se, uday.kumar@ltu.se

Abstract: Several studies in Sweden have looked into railway electromagnetic interference (EMI) either to discover the source of the interference or to determine if the equipment in the system is performing properly. The movement of rolling stock along an electrified track produces certain EMI events. Transient electromagnetic fields are produced in the signalling system when the train leaves the neutral section of the overhead power line and enters the powered section. These transient EM fields are mainly produced by the engine. The track's infrastructure system has been tested for EMI events, but this phenomenon affects the surrounding environment as well, up to at least 10 meters from the track. The infrastructure is designed so that the return current from locomotives should go through the running rails, but occasionally the ground acts as a conductor, transmitting current to areas that are distant from the rail

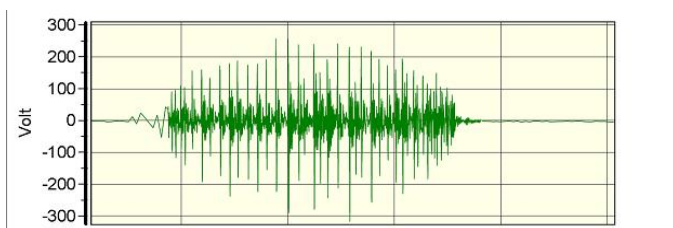
Figure 2. Measurements on a Dranetz analyser in the signal system when the driver turns up the power of the locomotive.

The starting of a locomotive from a specific train was identified as the main source of the EM waves that affected the signalling system. Transient EM fields produced at this time caused the interference.

To prevent the repetition of such occurrences, the insulated section of track and OHL was connected to the power system and energised to avoid the locomotive's random stops and starts and to prevent the undesired transient EM fields.

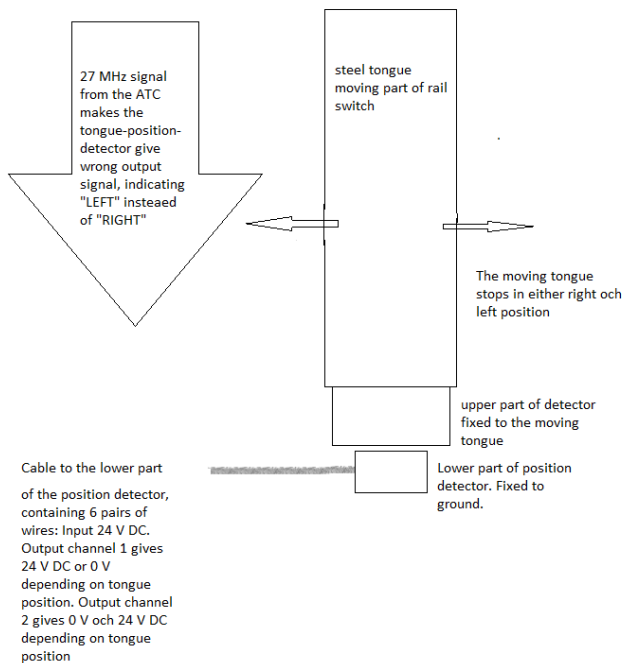
In a 2005 case analysis by LTU and Trafikverket (former Bankverket) [19], the rail switch position detector indicated position "left" instead of "right" due to interference from the ATC transmitter (Fig. 2). The switches had one detector to check the position of the track and the direction of the train crossing it. This detector was giving wrong information and causing a misunderstanding between the train command and train direction.

Figure 2. Rail switch position detector indicates “LEFT” instead of “RIGHT” due to ATC signal from passing train.

To prevent this undesired behaviour, all detectors were removed and replaced with safer ones that were EMC tested. The new detectors work properly, indicating that a lack of testing of the previous ones was the reason for the problem. In future, the failure immunity tests should be performed at all low frequencies from DC to 80 MHz, (not in standards) and according to standards for 80MHz – 1000 MHz (and upwards).

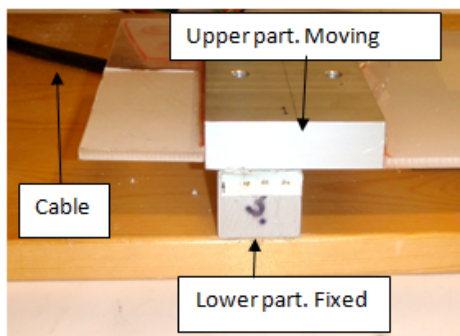
Figure 3. Photo of the switch’s blade position detector in the laboratory

Since these detectors are essential to the safety of the train, they were sent to LTU EMC lab for testing. The tests found that the detector was sensitive to many radio frequencies from DC to 300 MHz. The main EM source was the ATC radio transmitter located under the front of the active head of the locomotive.

These detectors had previously been tested and carried the CE marking. However, they were not properly tested for the interferences produced by the ATC and were being interfered with. Consequently, the detector state was altered and showed wrong information, thereby compromising safety.

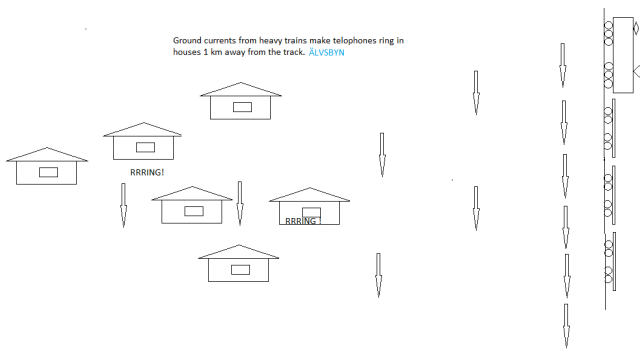
In a study case performed in 2002 by LTU and Trafikverket (former Bankverket), telephones were ringing due to the ground currents created when a heavy train was passing (Fig. 5). When the train was going uphill in Älvsbyn, the locomotive configuration used was three locomotives working at the same time. That configuration caused telephones to ring in the surrounding area up to one kilometre from the railway. This happened every night when a train was going up the hill and three locomotives were working.

Figure 5. Ringing of telephones due to ground currents from passing heavy trains.

Ground currents were produced due to several locomotives working together; the return current system was inadequate in these circumstances. Return currents from locomotives should go through the running rails; but when there is a bad earth return path, the ground acts as a conductor, transmitting these currents to distant areas.

Although the problem was identified, nothing was done about it, given the low criticality of the issue (the only constructions in the area are summer houses, not inhabited full time). Therefore, the issue remains open.

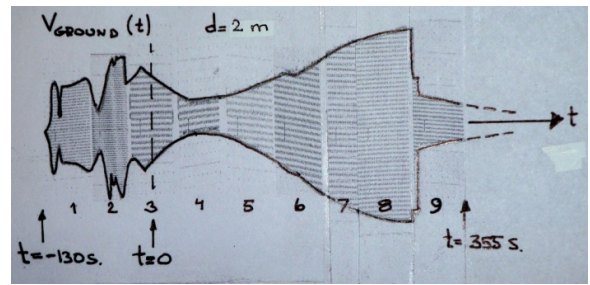
Note that the sudden voltage drop 310 sec after the engine's passing, shown in Fig. 7, occurs because the engine is passing the next transformer.

Figure 7. Ground voltage 2 m from the closest rail, to the right of the track, going towards NARVIK, 1529.785 km north of Stockholm. Scale 10 V/div.

Fig. 7 shows the voltage from 130 sec before the engine's passage to 355 sec after its passage (maximum voltage approx. 115 V_{pp}). Fig. 8 shows an expanded graph of the ground voltage, printed on a paper roll.

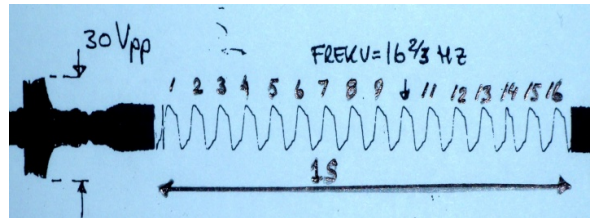
Figure 8. The ground voltage at a distance of 10 m from the rail. Maximum voltage 30 V_{pp}. Expanded time plot during one second, shows the voltage shape and the 16.7 Hz frequency.

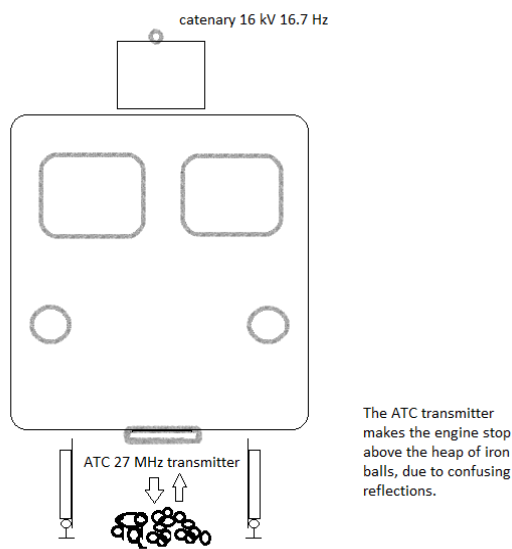
The locomotive stopped where it crossed a heap of iron (composed of pellets that fell in the loading process). The heap of ore was acting as an EM mirror and reflected EM waves were disturbing the system’s transceiver. Since the ATC transceiver was less than one meter away from this EM mirror, the disturbances were very high.

Figure 9. The ATC transmitter disturbed by a ‘heap of iron balls’ underneath the locomotive.

To prevent repeat occurrences, the ATC radio is now routinely switched in these mining areas. However, the issue is not solved. This phenomenon is easily applicable to any other spot signalling systems which have to transmit a signal to awaken the balise or the emitting cable.
