Measurements and Analysis of Electromagnetic Interferences in the Swedish Railway Systems

Luleå University of Technology
Division of Operation and Maintenance
Luleå Railway Research Center

Doctoral Thesis

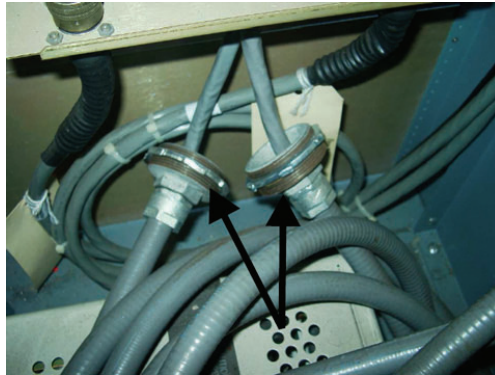
Figure 23 The shield of the cable from the hot box detectors is not in use.

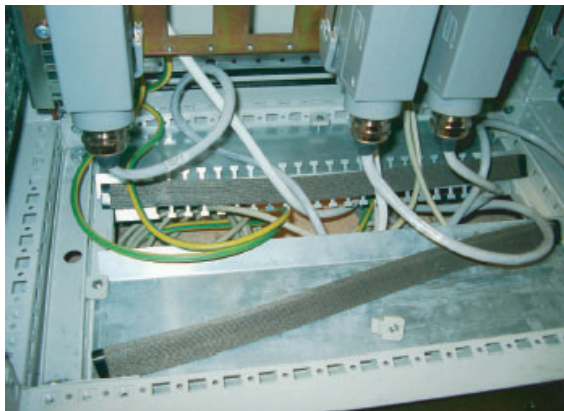
The same issue arose when investigating the technical building in Kiruna railway yard, where problems were found with wrongly mounted cables entering control cabinets. Figure 24 shows an example of incorrect mounting in an advanced EMC-protected cabinet. Here no attempt was made to connect the cables correctly to the cabinet when they entered the bottom of the box, and the cables' shield was not connected anywhere in the cabinet. Instead, the filter for the cables and wires was simply thrown on the floor inside the cabinet. This shows how the use of expensive and advanced EMC-protected cabinets is meaningless if the installation is not performed correctly.

Figure 24 An intake of cables into an EM cupboard, where the incoming cables are not connected to the ground.

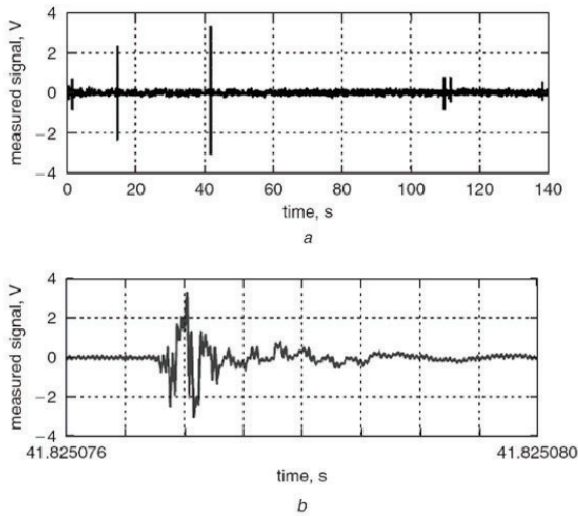
Figure 27 (a) Signal measured on the flat wheel detector at Notviken. (b) Close-up for the transients.

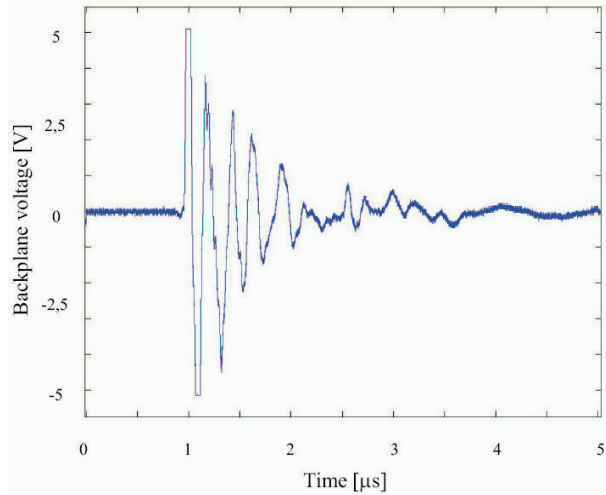
Figure 28 Transient measured on the backplane inside the shed of the analyzing unit at Sunderbyn. The extremely high amplitude could not be registered by the measurement equipment.

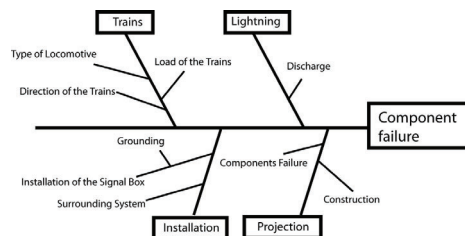
To obtain an overview of the problems at Oxmyran and structure possible sources of the fault, a cause-and-effect diagram was made, see Figure 29. Every component in the diagram could influence and be a possible source of EMC failure in the infrastructure and in the signal box.

Figure 29 Cause-and-effect diagram of possible error causes at Oxmyran.

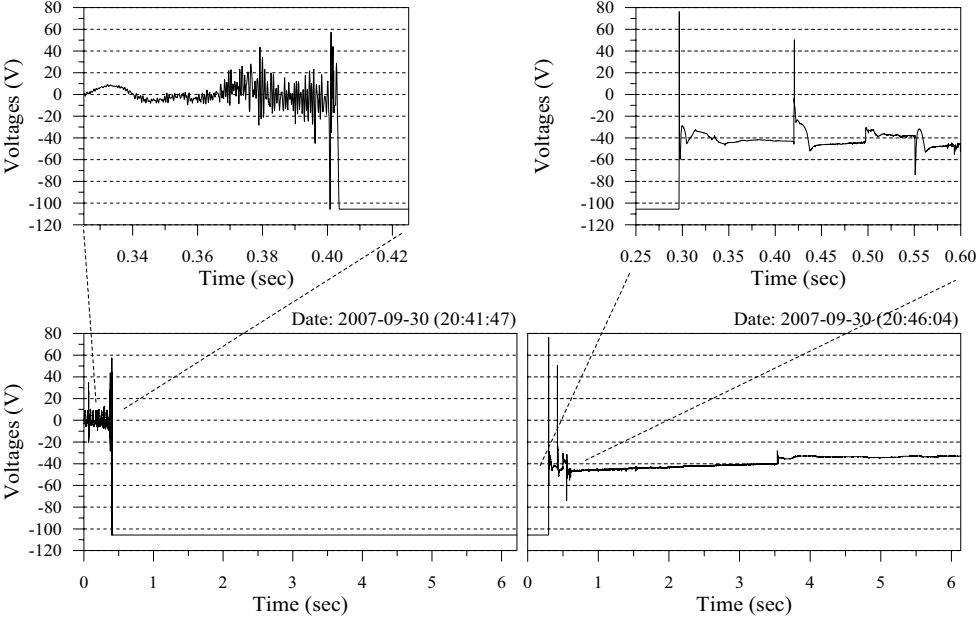
Figure 32 Measured voltages where the potential has dropped and the measurement system has been saturated. There are approximately 5 minutes between the two measurements.

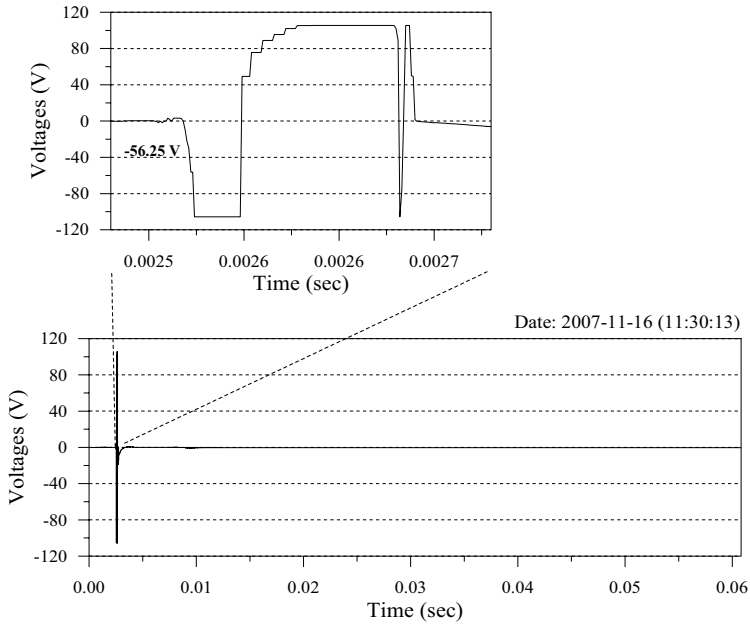
Figure 33 Voltage curve where the first transients are saturated. The sampling rate was 1 MHz.

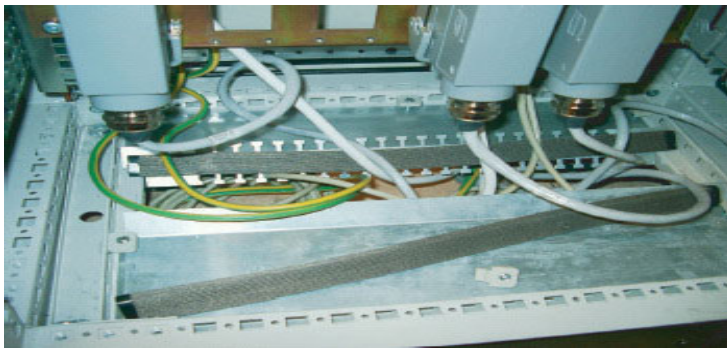
Figure 4: An intake of cables into an EM cabinet where the incoming cables are not connected to the ground.

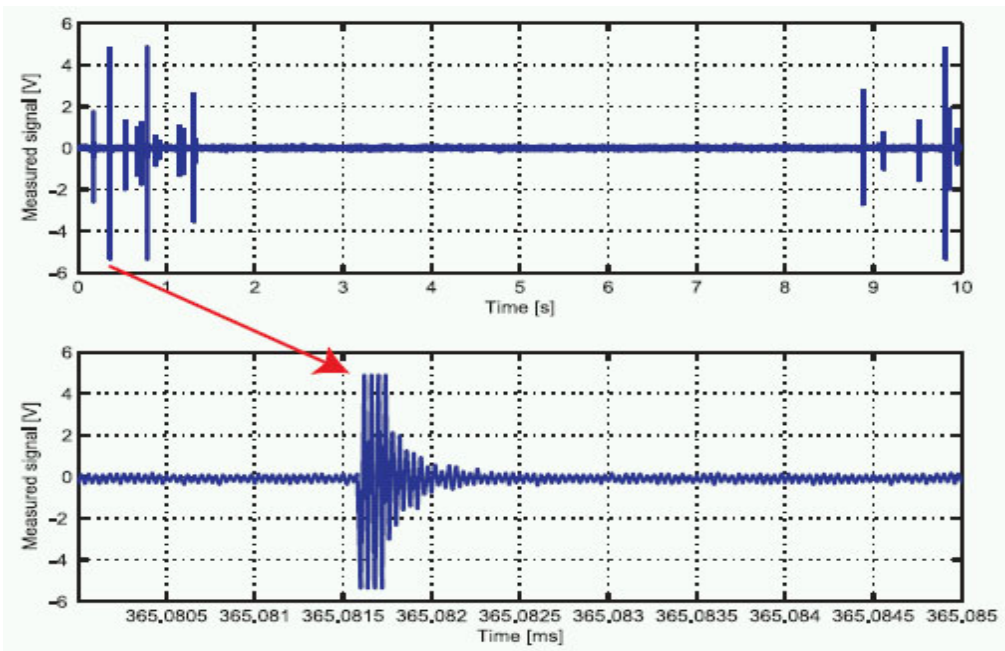
Figure 6: Measured transients on a flat-wheel detector during a train passage and the close-up picture for one transient. The signal shown in the lower close-up picture is saturated.

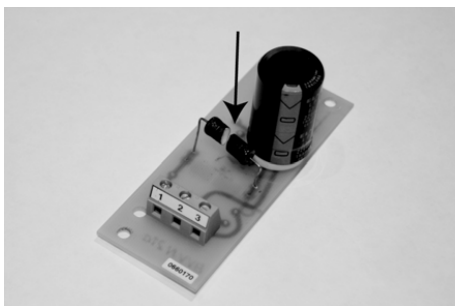
Figure 12. A faulty RC circuit.
