# Vehicle vibrations at the Hallandsås tunnel: collaborative investigation and results

**ABSTRACT:** Vehicle vibrations at the newly opened Hallandsås tunnel in southern Sweden caused a temporary speed restriction and a massive media attention. The problem was solved efficiently by Trafikverket, the infrastructure manager, and SJ, the rolling stock operator, working together. The cause of the vibrations was bogie hunting, caused by high equivalent conicity. An improved wheel reprofiling programme, together with corrective rail grinding has eliminated the vibration problem by the tunnel, and the temporary speed restriction was lifted shortly afterwards. The successful project has triggered a collaboration between Trafikverket and SJ to improve the detection and mitigation of poor ride comfort.

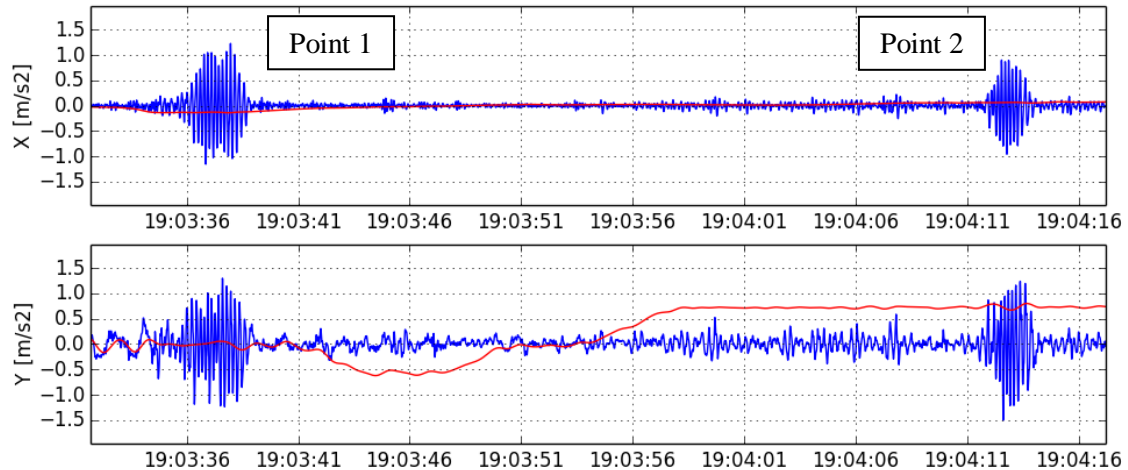
Two short vibrations events close to the tunnel were measured during this period, Figure 2, where the longitudinal (X) and lateral (Y) accelerations are shown. The frequency is about 5 Hz.

Figure 2. Two short vibration events by the Hallandsås tunnel measured on a SJ X55 train, i.e. Regina by Bombardier Transportation. Longitudinal (X) and lateral (Y) accelerations.

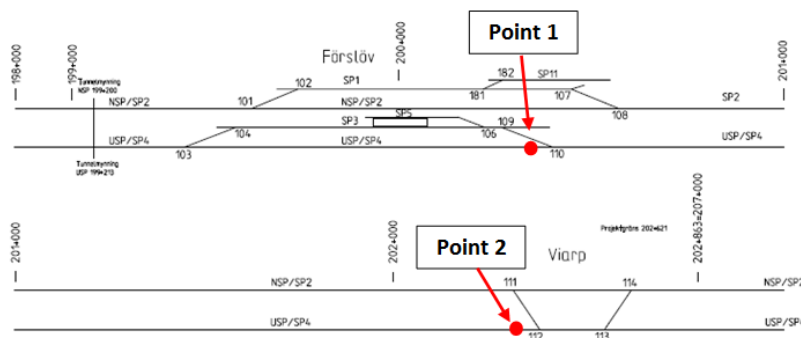
#### Locations of vibrations

The location of the events could be pinpointed by the GPS measurement. They were initiated close to track switches south of the tunnel, Figure 3, with the train going northward towards Gothenburg. The location was consistent with reports of other incidents, although vibrations were known to have continued into the tunnel.

Figure 3. A track map showing the locations of the vibrations in Figure 2, point 1 and 2, measured by GPS. Both events were initiated close to switches.

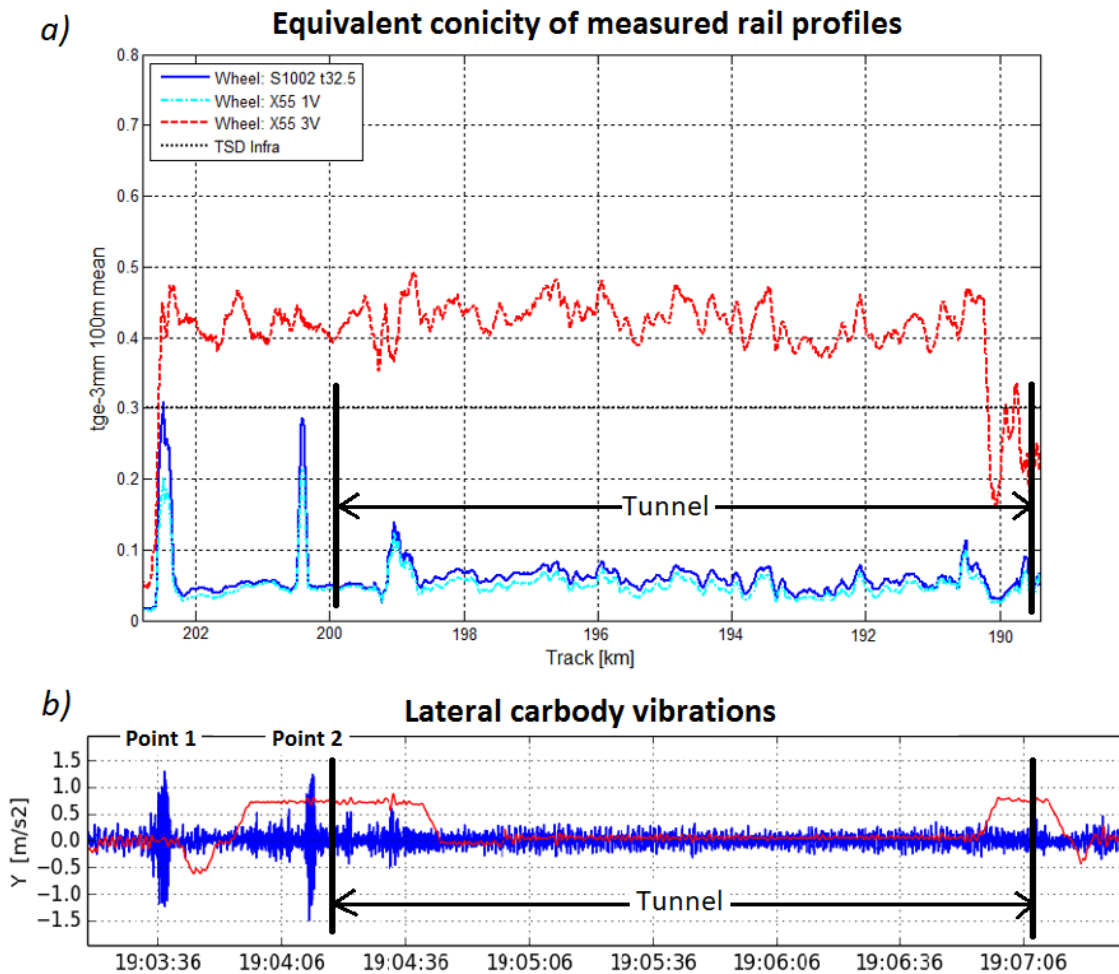
Figure 4. a) Equivalent conicity of measured rail profiles versus nominal and measured wheel profiles, although not from the vehicle with measured vibrations. b) Lateral acceleration in the carbody. The locations match the positions with high equivalent conicity of the mildly worn wheels and the nominal S1002 wheel profile.

The worn wheels show a consistent high equivalent conicity of 0.4 and above, whereas the mildly worn and the nominal S1002 wheel profile show a similar pattern, with low conicities except for a few hot spots. These coincide with the locations of the vehicle vibrations, shown in the bottom diagram.

The incident reports, equivalent conicity calculation and measured vehicle vibrations are all consistent with bogie hunting being the cause of the experienced vibrations by the tunnel. The investigation show that the rail profile was about 0.4 mm higher than the target profile, and a few short sections of less than 50 meters had track gauge below 1435 mm. Together with worn wheel profiles this caused high conicity, and the problems with vehicle vibrations.

An improved wheel reprofiling programme, together with corrective rail grinding has eliminated the vibration problem by the tunnel, and the temporary speed restriction was lifted shortly afterwards. The tunnel had no influence on the initiation of the vibrations, besides the possible
