Top-of-rail friction modifier – a vibro-acoustic measurement study

JVTC Projectnr XXX

**Division of Operation, Maintenance and Acoustic
JVTC - Luleå Railway Research Centre**

2013-12-19

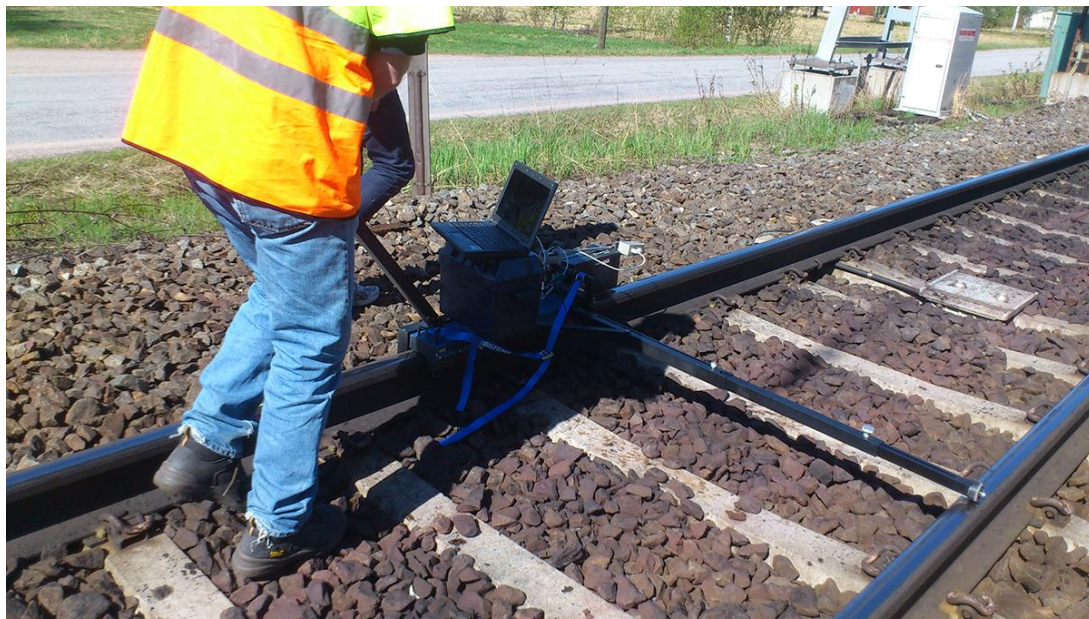
Figure 1 Friction measurement trolley LB Foster Tribometer¹.

The friction values of the considered rail section of approximately 300 meters was measured by the use of a manually operated portable friction measurement tonometer manufactured by LB Foster, see Figure 1. The friction coefficient was measured before and after the application of the friction modifier.

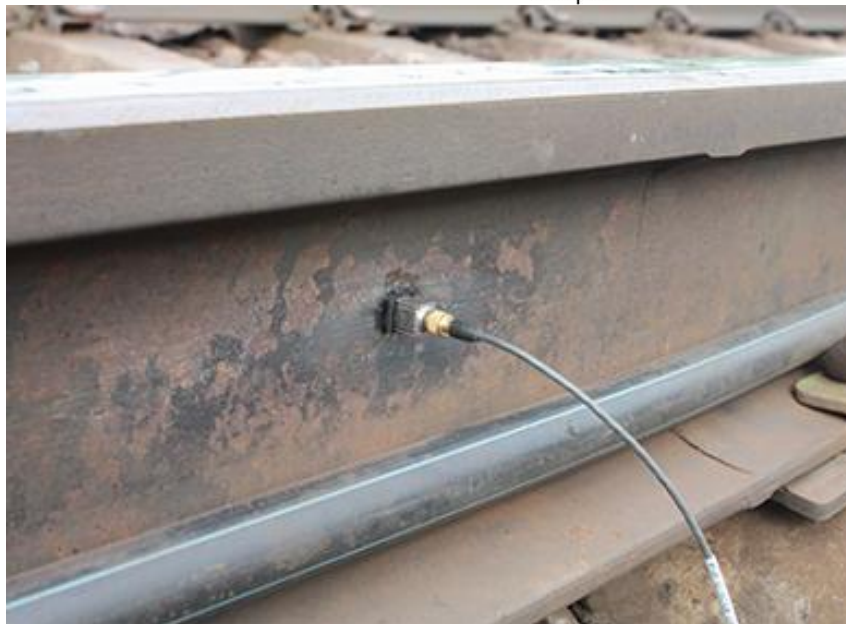
Figure 2 Drawing in the top: Measurement setup illustrating the accelerometer mounting for both Acc1 and 2 on the outer side of the rail. The figure also shows the microphone settings of both microphone pairs Mic 1&3 and Mic 2&4. Photo in the bottom: Accelerometer mounting.

Vibration and sound measurements were performed at different locations in the centre of the examined line section. Two types of sound measurements were performed. One microphone setup was used to measure the sound according to the standard (SS-EN ISO 3095:2005) where two microphones on each side of the track was positioned 7,5 m from the track centre and 1,2 m above the top of the rail head, see Figure 2 and Figure 3. A second microphone setup was mounted closer to the rail in order to focus in on the sound generation from the wheel and rail contact interphase. These two microphones were mounted on the sleepers 0,5 m from the rail web, see Figure 2 and Figure 3. The measurements were performed prior and after the application of the friction modifier. The measurement setup can be seen in Figure 2 and Figure 3. The description of the sampled channels, sample frequencies and filter-settings is listed in Table 2.

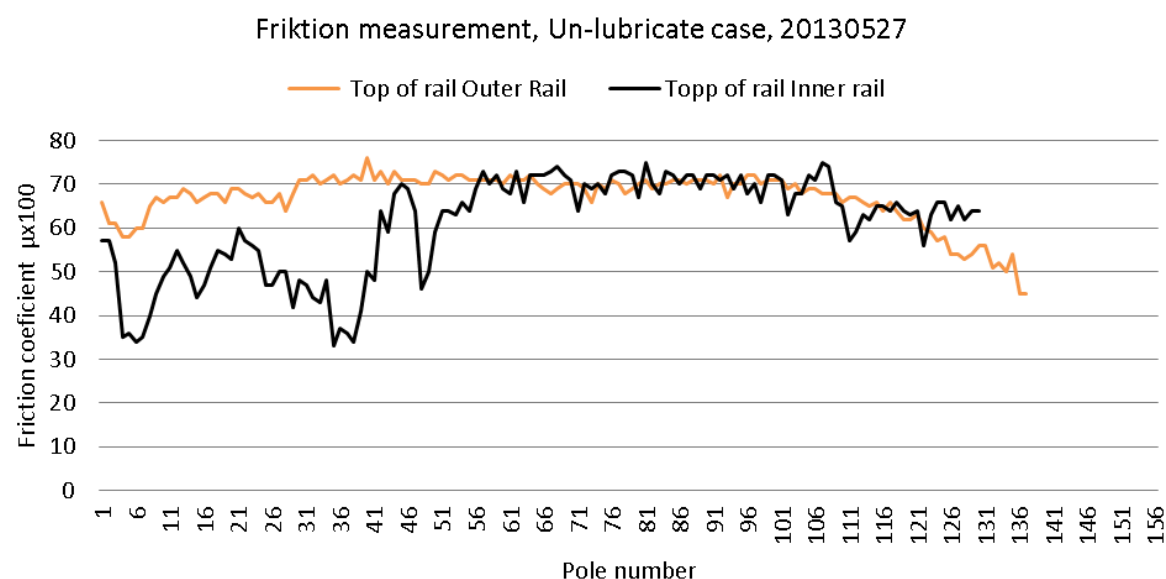
Figure 4 Friction coefficient versus track location before lubrication. Track location is defined by the poles of the electrical power system. Measurement date 130527 time 09-10, Air temperature 17,5 C°, Rail temperature 24,5 C°.

In Figure 4 the friction measurement performed prior to the lubrication can be seen. The graph shows the how the friction coefficient varies along the track. A Section of 300 meters where measured for both the outer and the inner rail. The mean values and the standard deviation for the lubricated and the un-lubricated case can be seen in Table 3. From the table it can be seen that the friction coefficient of the inner rail has a larger standard deviation compared to the outer rail prior to the lubrication. In the table it can also be seen that after lubrication the friction coefficient is reduced to a level close to the specification of the friction modifier of $\mu=0.3$.

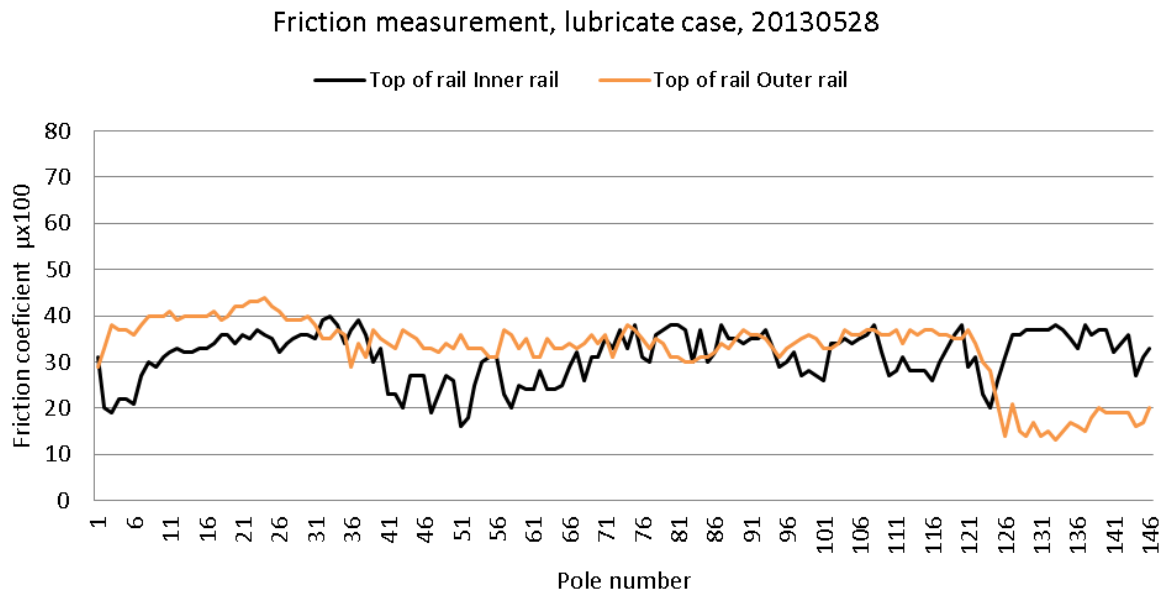
Figure 5 Friction coefficient versus track location after lubrication. Track location is defined by the poles of the electrical power system. Measurement date 130528 time 16-17, Air temperature 20,5 C°, Rail temperature 38,5 C°.

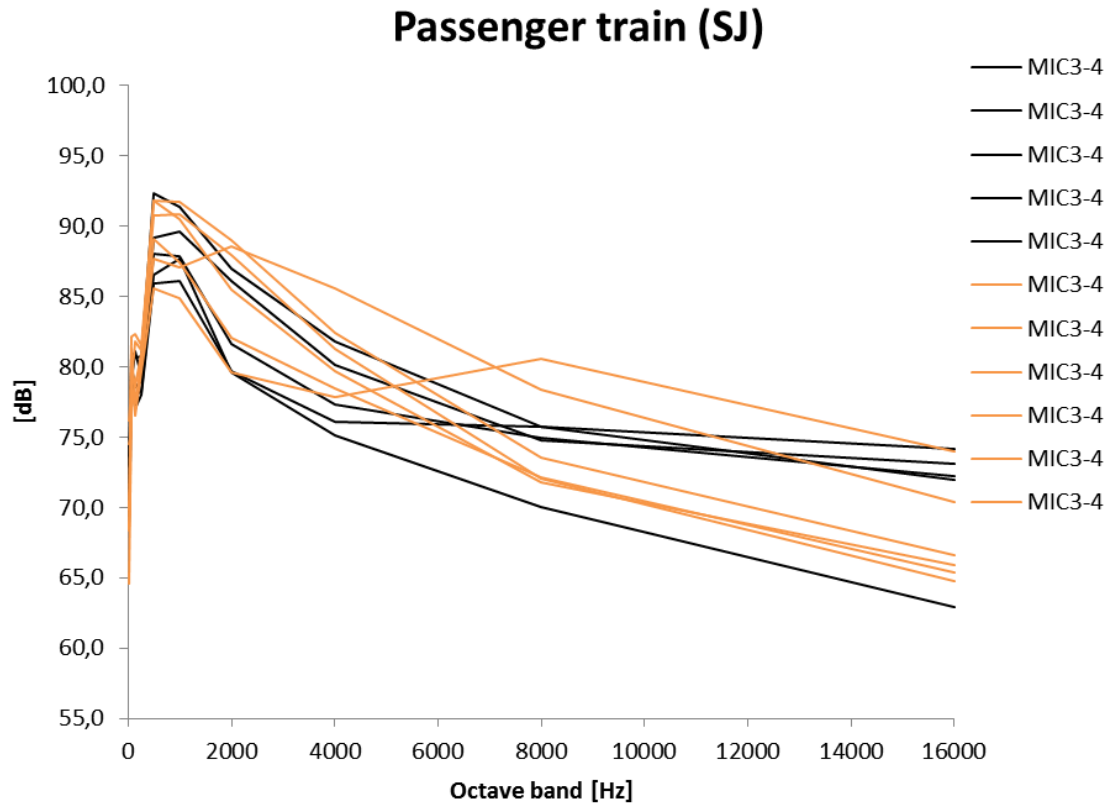
Figure 7 Measurements of passing passenger trains (Norrtåg). Black lines represent measurements of trains without friction modifier. Red lines represent measurements of trains with friction modifier. The line types within each colour represent a passing train.

In Figure 7 measurements performed for 11 passenger trains (SJ) is shown, five trains before and six after lubrication. In the figure a lower sound level can be seen for the majority of the trains for the lubricated case compared with a majority of the trains for the non-lubricated case. The measurement results for this operator showed a larger deviation from the expected outcome which would be a reduction in sound level for a lubricated track. The result also shows a higher value around 1000 Hz for this operator compared to Norrtåg. Figure 11 shows the sound levels for microphone 1 and 2. No specific difference can be detected compared to microphone 3 and 4.

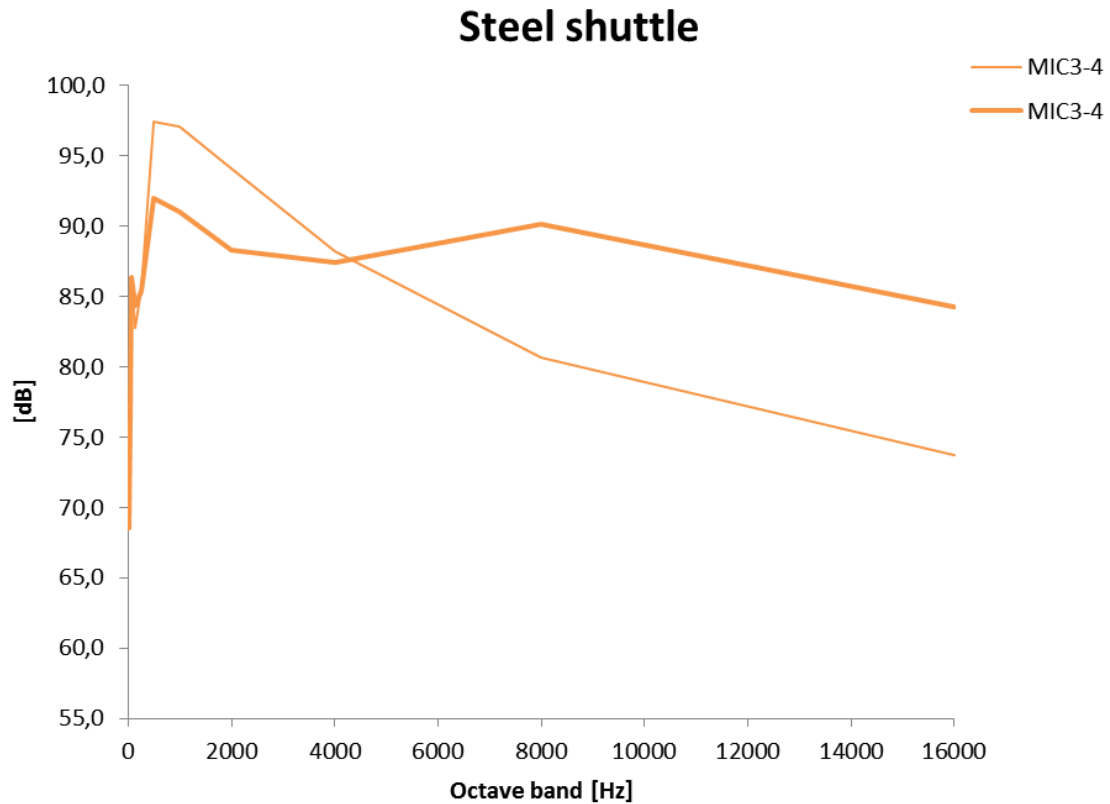
Figure 9 Measurements of two passing steel shuttle trains for a lubricated track. The thick line represents the measurement of a loaded steel shuttle and the thin line represents measurements of an unloaded train.

No steel shuttle trains passed the measurement station during the measurement of the non-lubricated case. For the lubricated case two steel shuttles passed, one loaded and one unloaded. Figure 9 displays the result of obtained from the sound measurements of the loaded and unloaded steel shuttle. The dashed line represent the loaded train while the solid line represent the unloaded. It can be seen from these two measurements that the loaded train resulted in a higher sound level compared to the unloaded train in the interval between 4kHz and 16kHz. In the frequency interval between 125Hz-4kHz the unloaded train showed a higher level than the loaded train. Furthermore the steel shuttle resulted in a similar overall sound level compared to the regular freight train.

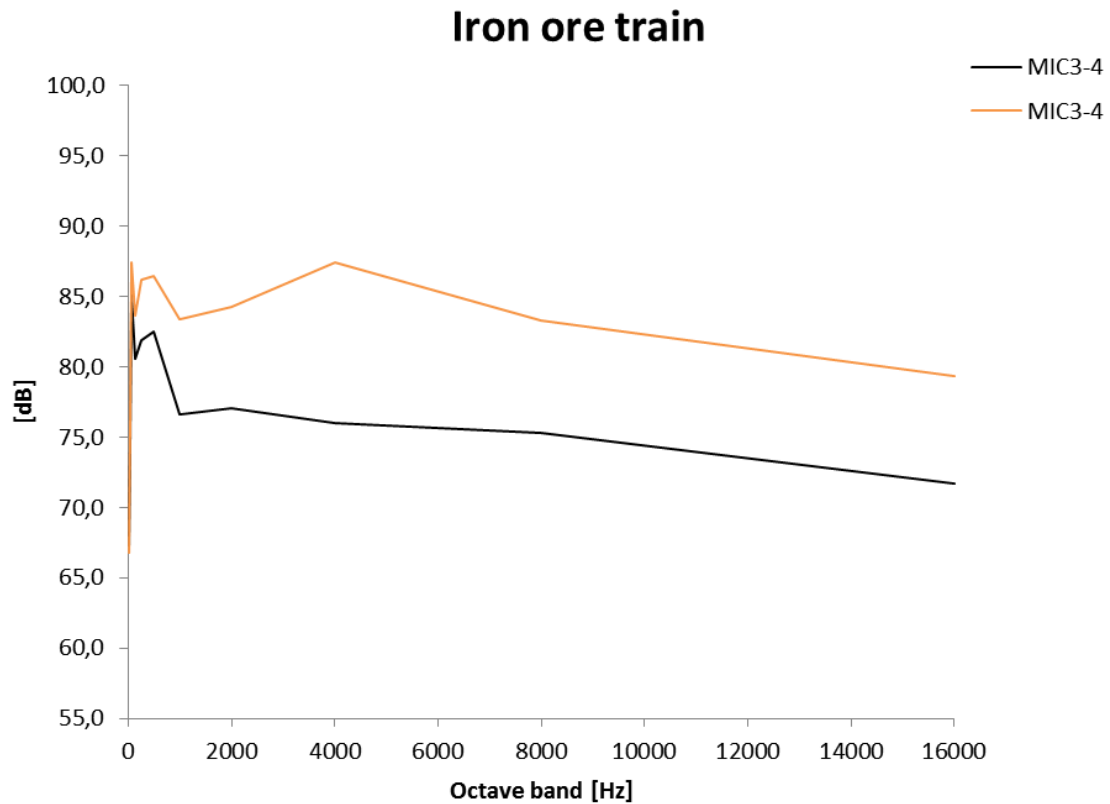
Figure 10 Measurements of passing two loaded iron ore trains. Black lines represent measurements of trains without friction modifier. Orange lines represent measurements of trains with friction modifier.

The measurement of the iron ore train showed a lower overall sound level compared to the regular freight and steel shuttle train. However the two measurements resulted in higher sound levels for the lubricated case.

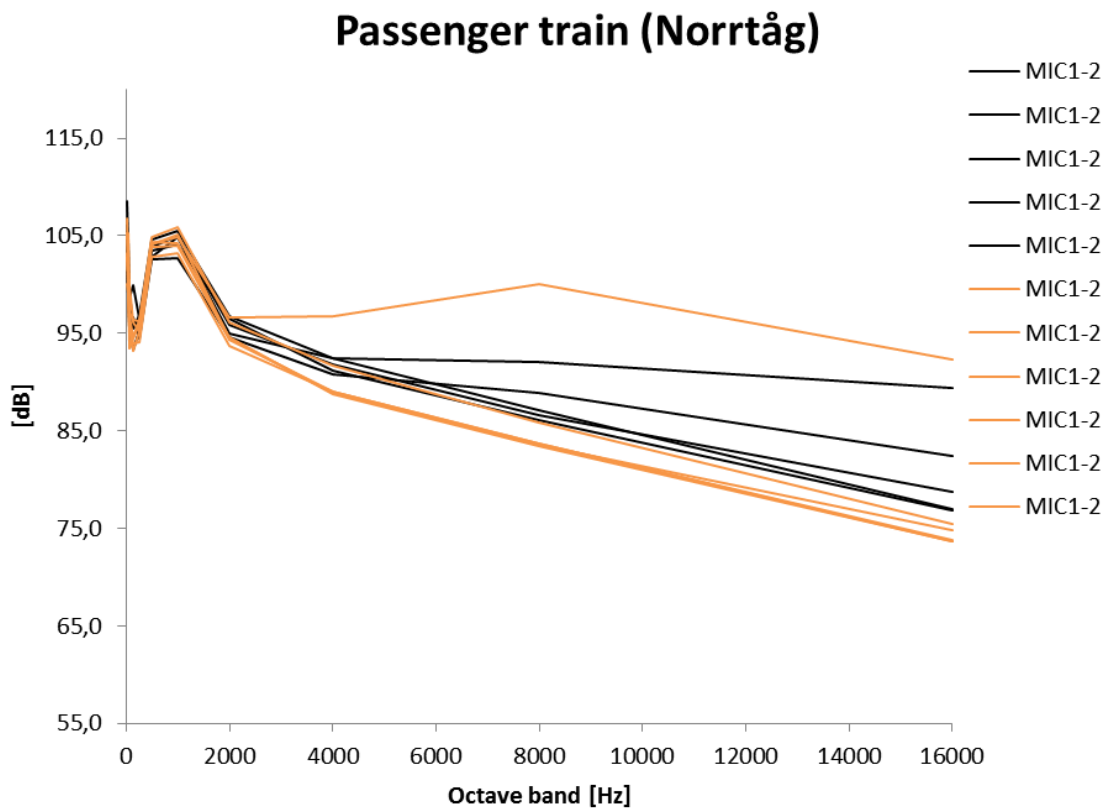
Figure 11 Measurement with microphone setup close to the rail (Microphone 1-2)

And the four following figures shows the sound levels for the microphone closer to the rail (Microphone 1 and 2) for the 5 different train types. No specific difference can be detected compared to microphone 3 and 4 for each train type.

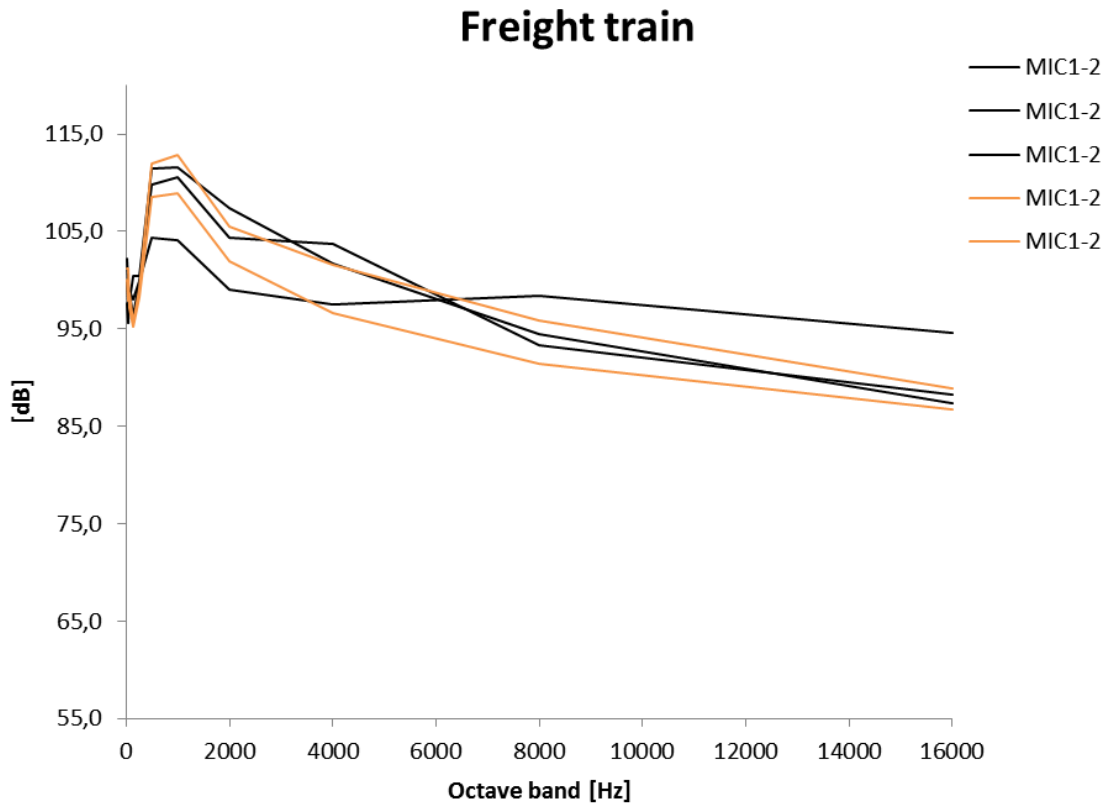
Figure 13 Measurement with microphone setup close to the rail (Microphone 1-2)

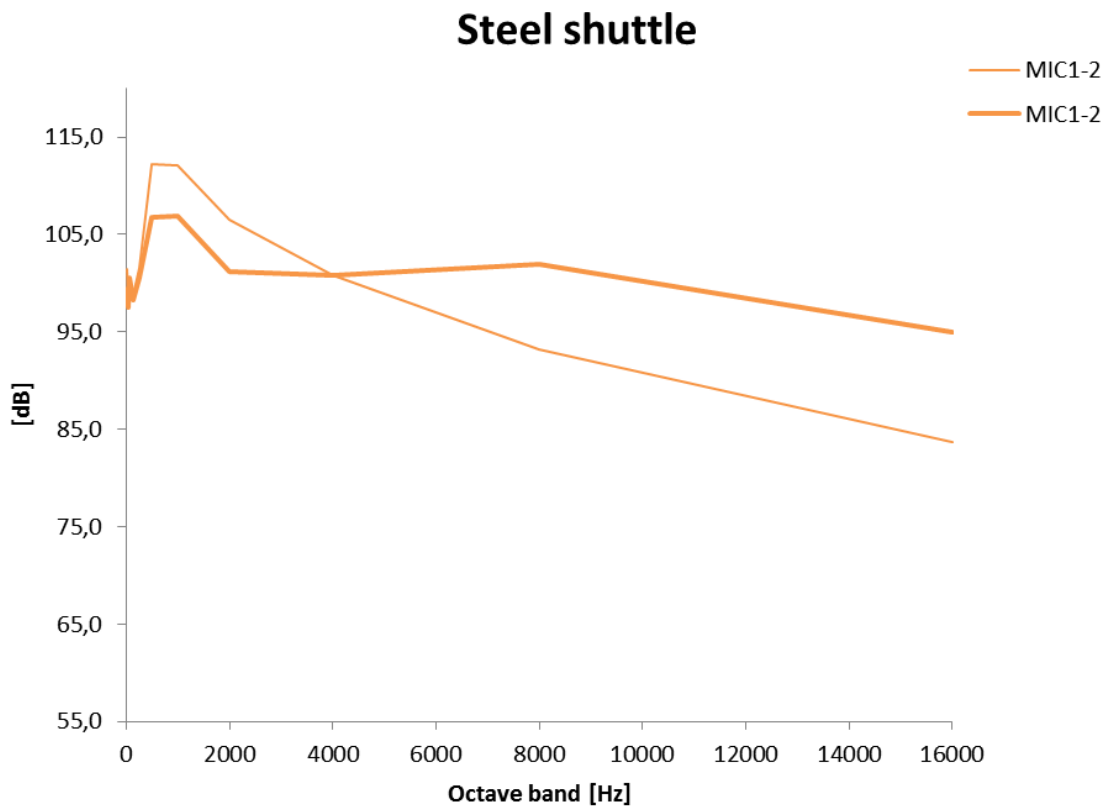
Figure 14 Measurement with microphone setup close to the rail (Microphone 1-2)

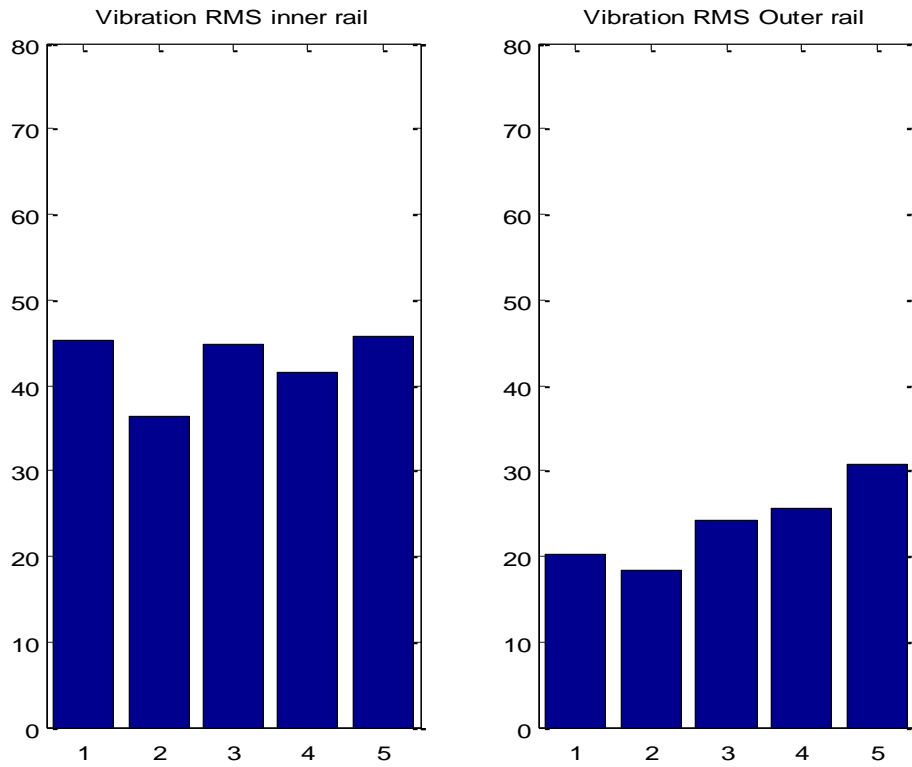
Figure 18 RMS value for each passing train for the un-lubricated case. Left graph shows the values for the inner rail and the right shows the values for the outer rail.

In Figure 16 the Rail vibration measurements of five passing passenger trains (Norrtåg) for the non-lubricated case is plotted. In the figure it can be seen that the vibration level along the track is lower compared to the vibration level in the x-direction out from the track. High peaks can also be seen in the vibration signal of the inner rail. These peaks coincide with the number of bogies and wheel sets of the Norrtåg train (Five bogies with two axels each). In Figure 17 the Rail vibration measurements of five passing passenger trains (Norrtåg) for the non-lubricated case is plotted Figure 18 shows the RMS value of the vibration signal for the passenger train (Norrtåg). The RMS of the measurements of the outer rail showed generally a lower RMS value compared to the inner rail measurements. Figure 19 shows the corresponding graph for the lubricated case. It can be seen in the figure that the deviation in the RMS between different trains increased for the lubricated case.

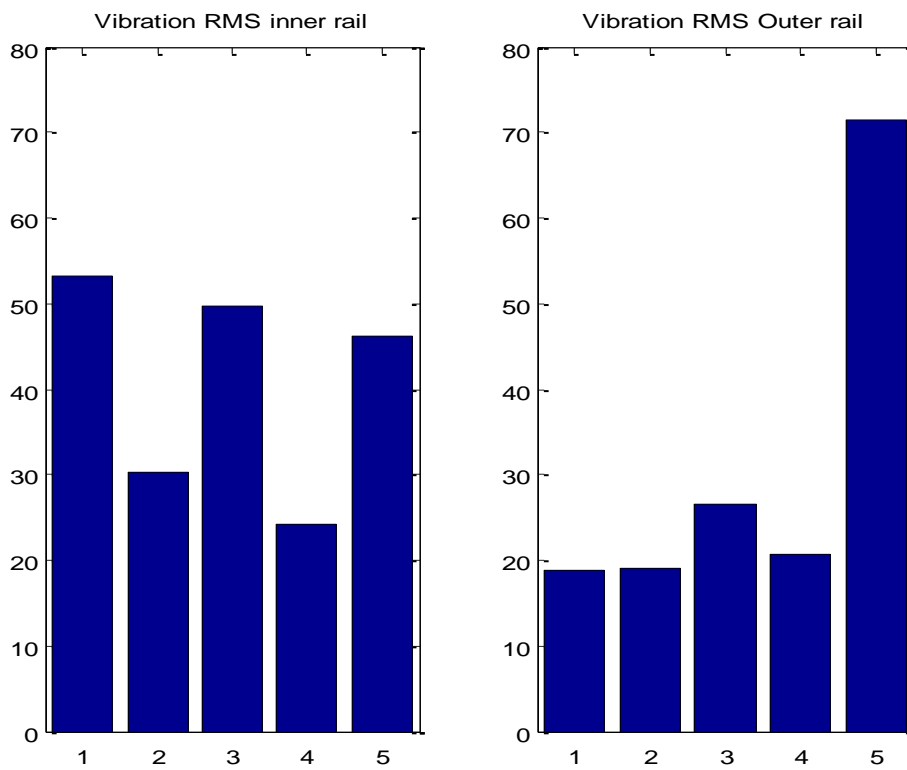
Figure 19 RMS value for each passing train for the lubricated case. Left graph shows the values for the inner rail and the right shows the values for the outer rail.
