HOW TO PROTECT LED ROAD LAMPS FROM LIGHTNING STRIKES BY CHOOSING INSTALLATION METHODS

A comparing investigation on

A research project at EMC center

Luleå University of Technology

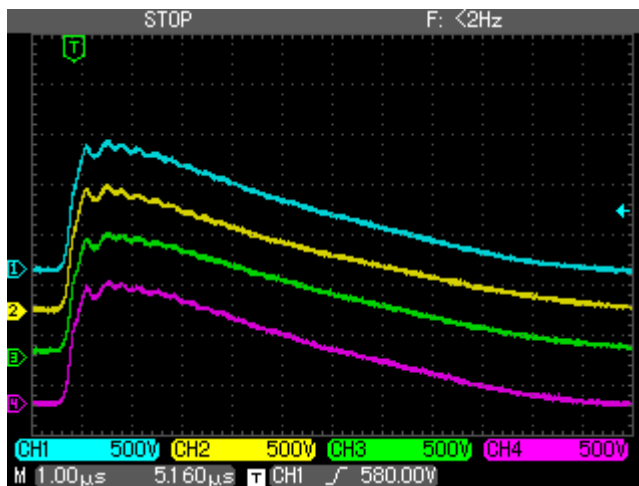
Figure 3. 000551 Shielded cable. Aluminium pole. Pulse 4 kV from Surge generator injected at the cable shield about 1.5 meters from lamp 1. All four probes connected to the same point: the incoming contact on the lower wall of the coupling box. C1= C2=C3=C4. Only one of the probes has the ground crocodile clamp connected to ground. (Ground is the straight copper tube in parallel to the cable system).

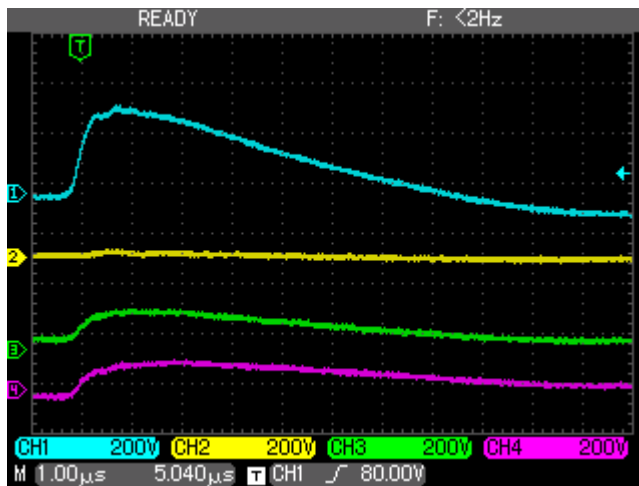
Figure 16. 00565. Shielded cable. Aluminium pole. Surge pulse on incoming shield (Sin). $R_{g1} = R_{g2} = 0 \text{ ohm}$. C1: Sin, C2: S2, C3: L1, C4:N1. Lamp1 will break, but Lamp2 is saved.

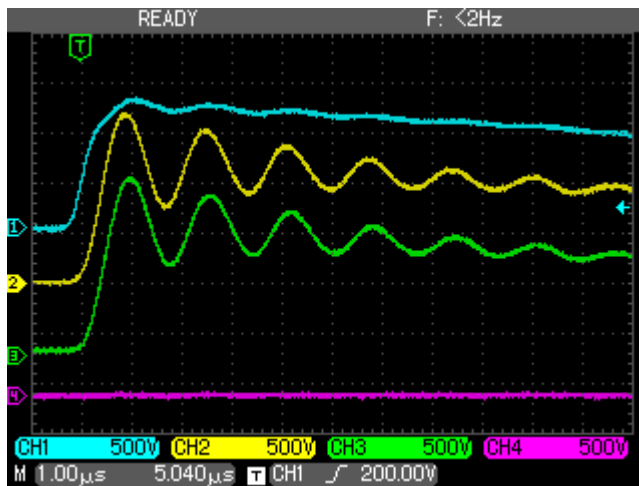
Figure 20. 00569. Shielded cable. Aluminium pole. Surge pulse on incoming shield (Sin). $R_{g1} = R_{g2} = 6 \text{ kohm}$. C1: Sin, C2: S2, C3: L2, C4: N2. High magnitude oscillations on both S2(=Shield2) and L2(=Line2) due to high value of R_{g2} (Mismatch).

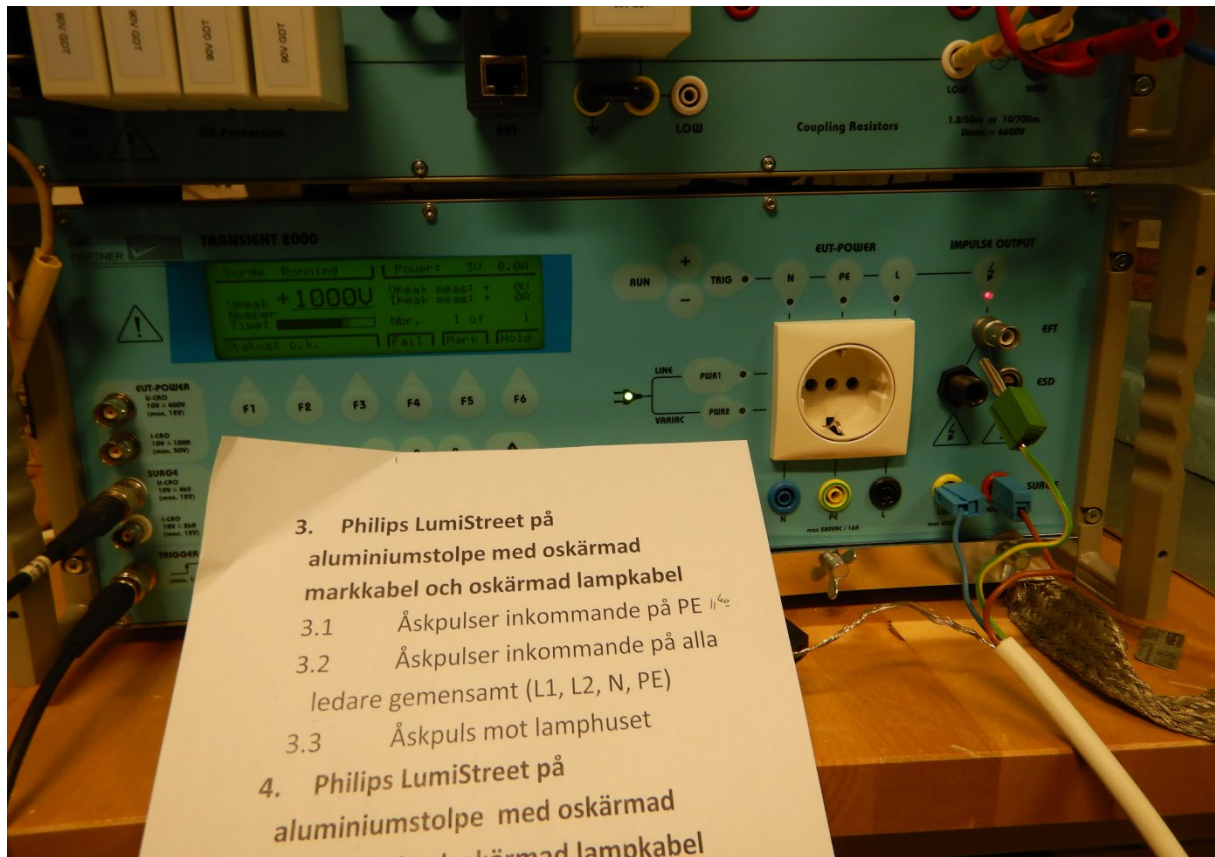
Figure 96. Front of Surge generator T1000. In this case: Peak voltage 1000 V.

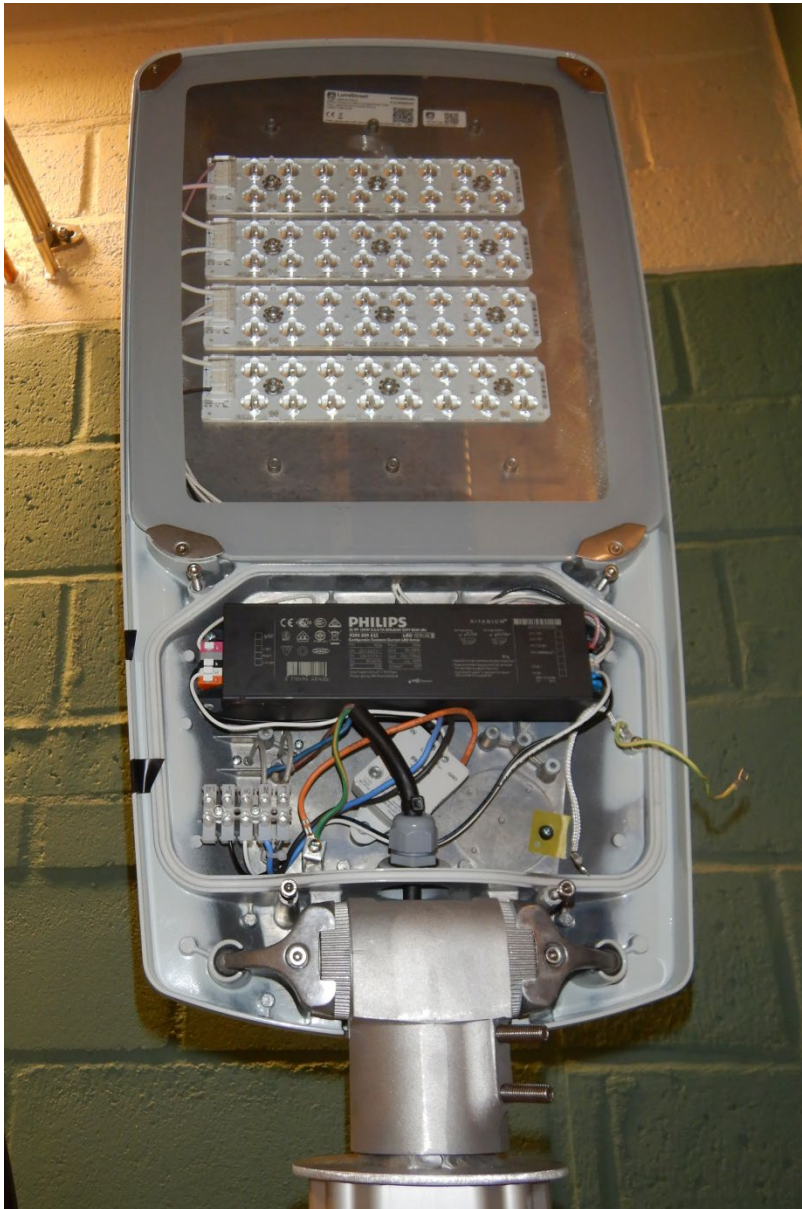
Figure 100. Front view of Lamp1 with aluminium pole. High voltage probes connected to the ports for Line1 (L1), and Neutral1 (N1) at the back of the lamp.

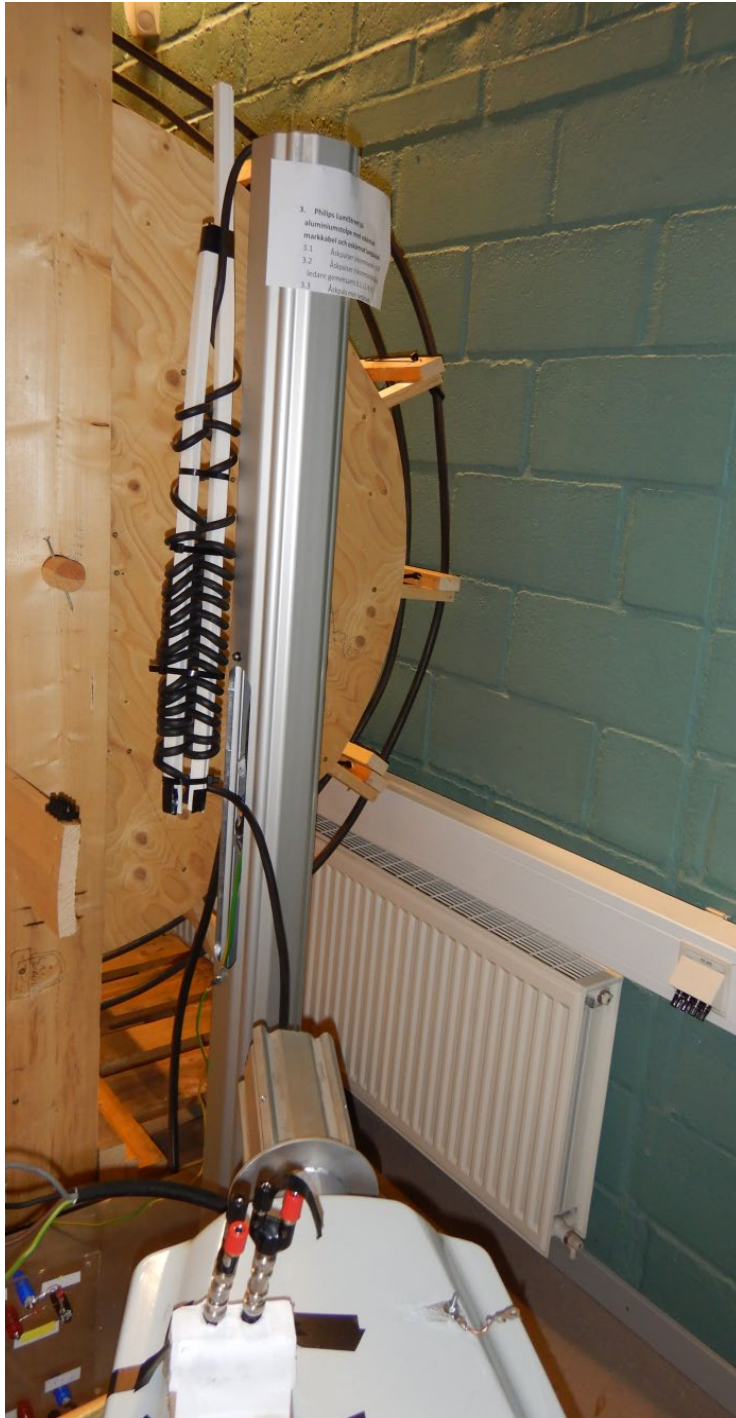
Figure 102. Back of Lamp1, with shielded cables for measuring voltages at Line1, and Neutral1. The input port for injection of direct pulses at the outside of Lamp1 is located to the left, at the lower part of the picture, without isolation, in contact with the metal housing.

Figure 102. Back of Lamp1, with shielded cables for measuring voltages at Line1, and Neutral1. The input port for injection of direct pulses at the outside of Lamp1 is located to the left, at the lower part of the picture, without isolation, in contact with the metal housing.....	97
Figure 103. 8 m power cable winded before installation inside the lamp-pole.	98
Figure 104. Interior view of a composite pole. To the left: A piece of plywood for coupling gear.	99
Figure 105. Exterior of a composite pole. Metal lid removed.....	100
Figure 106. The top of a composite pole.....	101
Figure 107. Shielded power cable . The shield is made of relatively sparse web of copper wires, without metal foil.....	102
Figure 108. This aluminium box was used for injecting lightning (surge) pulses at the cable shield. The endings of the three cable-conductors (N, L, PE) are locked to the center of the box by two pieces of wood. The cable shield consists of a sparse web of copper wires. These shielding-copper wires were pressed against the outside of the left wall, covered with aluminium foil, and taped against the external surface of the box. The surge pulses were injected by means of pressurized contact against the external surface of the right wall. The opening was covered by an aluminium lid, making a Faraday cage.....	103

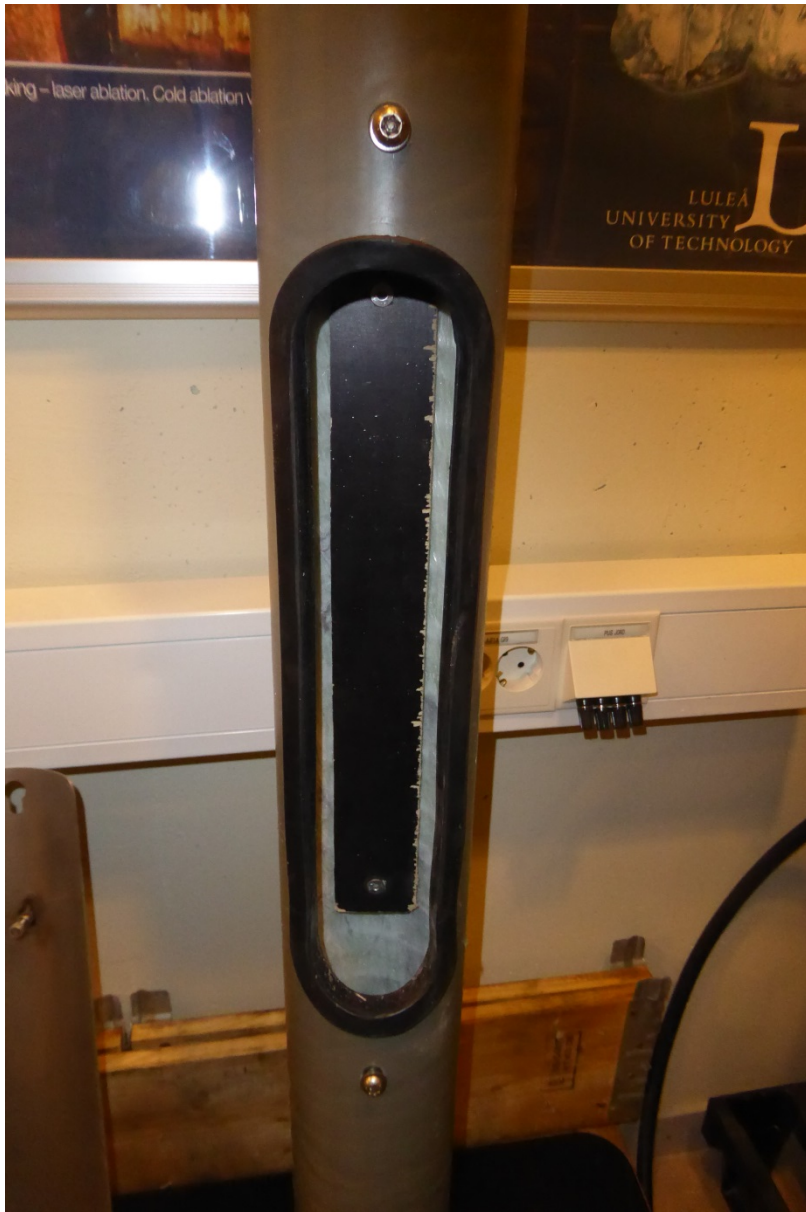
Figure 104. Interior view of a composite pole. To the left: A piece of plywood for coupling gear.

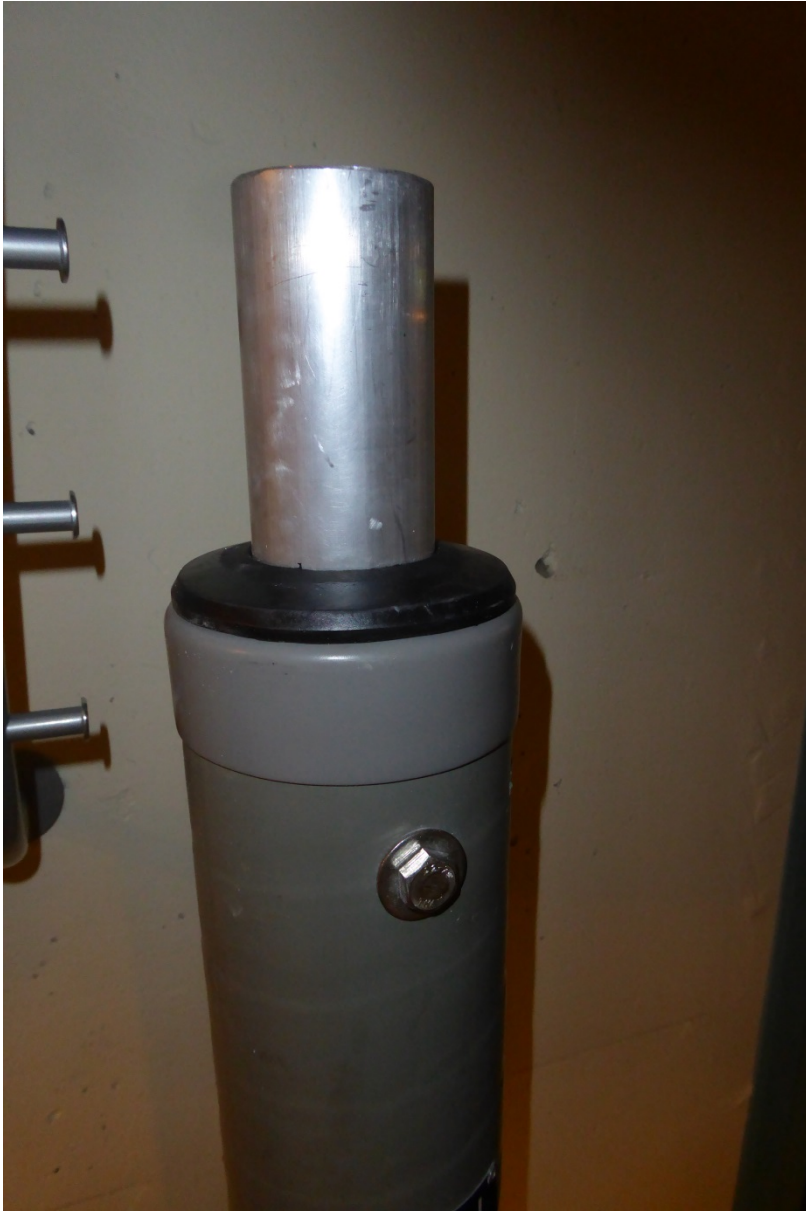
Figure 105. Exterior of a composite pole. Metal lid removed.

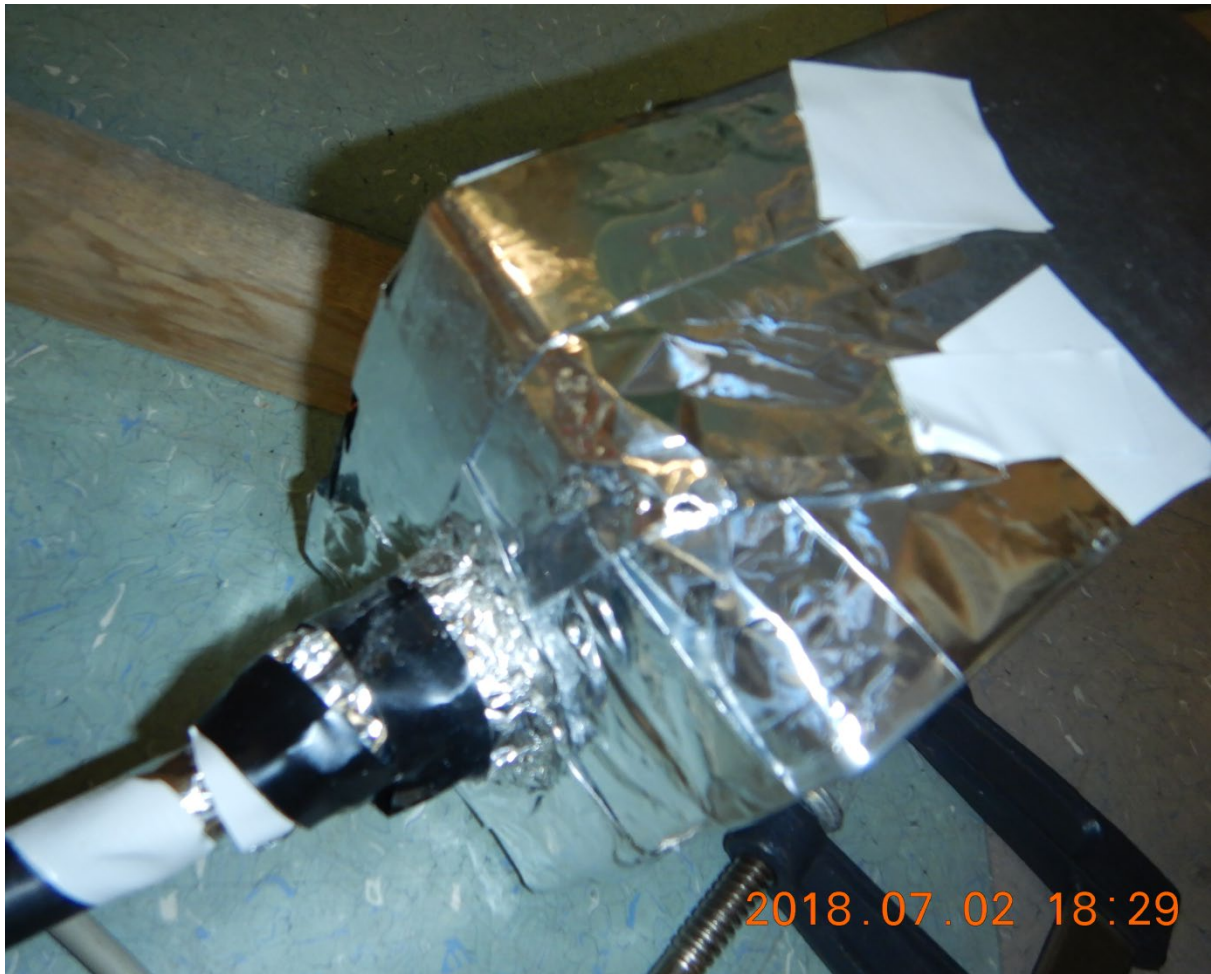
Figure 108. This aluminium box was used for injecting lightning (surge) pulses at the cable shield. The endings of the three cable-conductors (N, L, PE) are locked to the center of the box by two pieces of wood. The cable shield consists of a sparse web of copper wires. These shielding-copper wires were pressed against the outside of the left wall, covered with aluminium foil, and taped against the external surface of the box. The surge pulses were injected by means of pressurized contact against the external surface of the right wall. The opening was covered by an aluminium lid, making a Faraday cage.
