Luping TANG, Ying FU and Alberto LEÓN

Rapid Assessment of Reinforcement Corrosion in Concrete Bridges

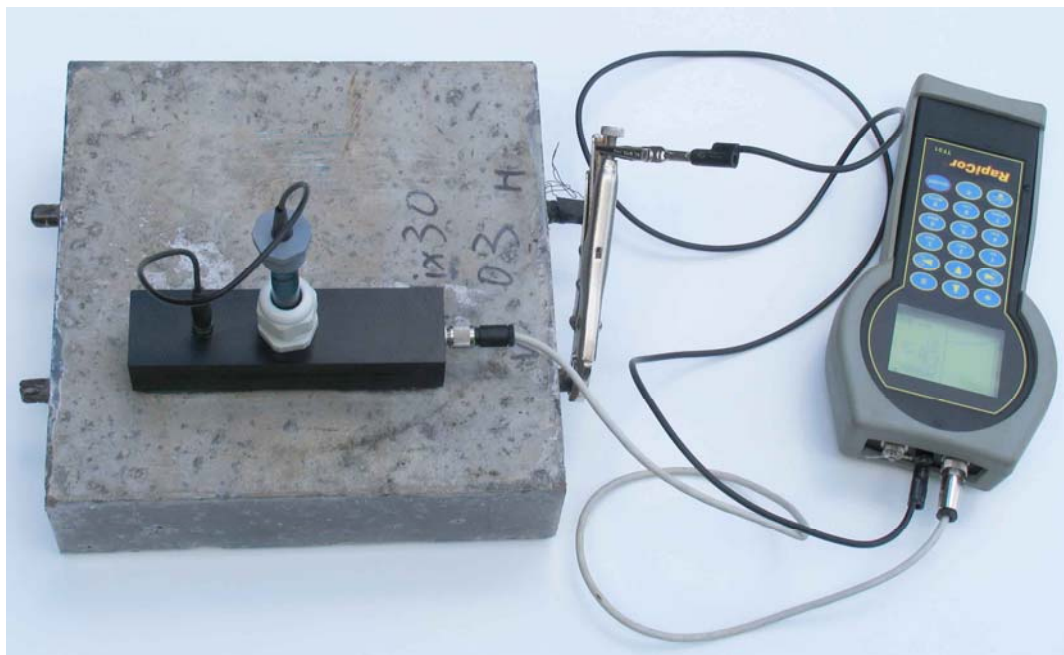
Figure 3.2 Example of the corrosion measurement on the concrete slab.

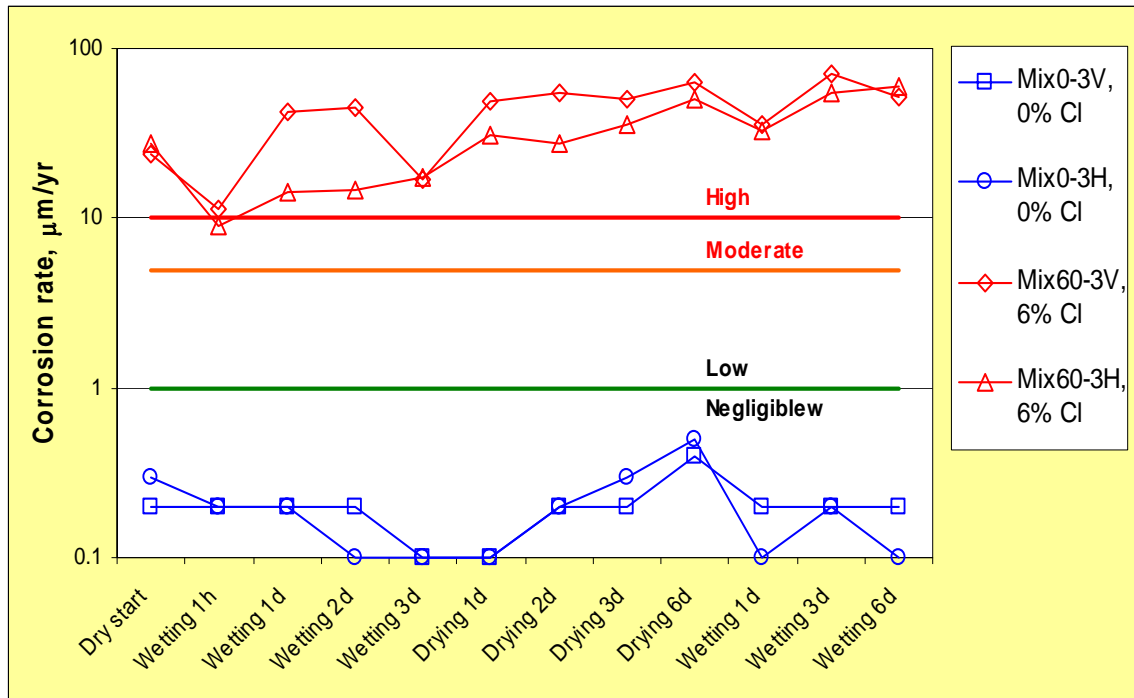
Figure 3.5.1 Corrosion rate of steel bars in concrete without chloride (0%) and with 6% introduced chlorides.

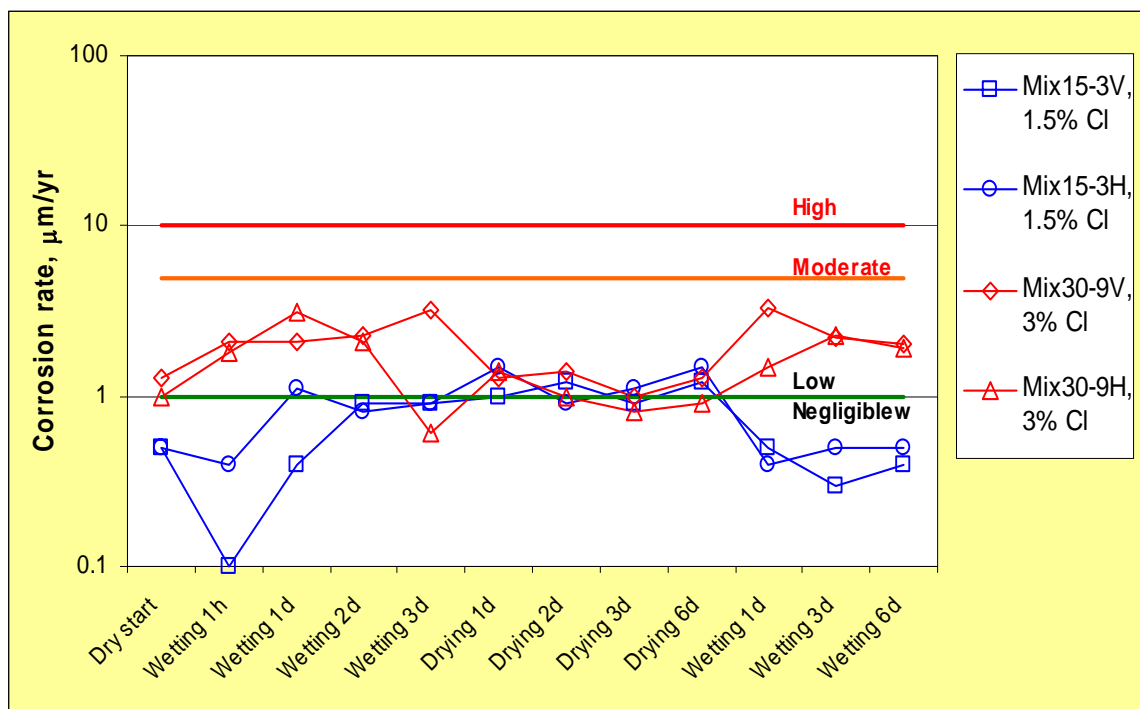
Figure 3.5.4 Corrosion rate of steel bars in concrete with 1.5% and 6% introduced chlorides, respectively.

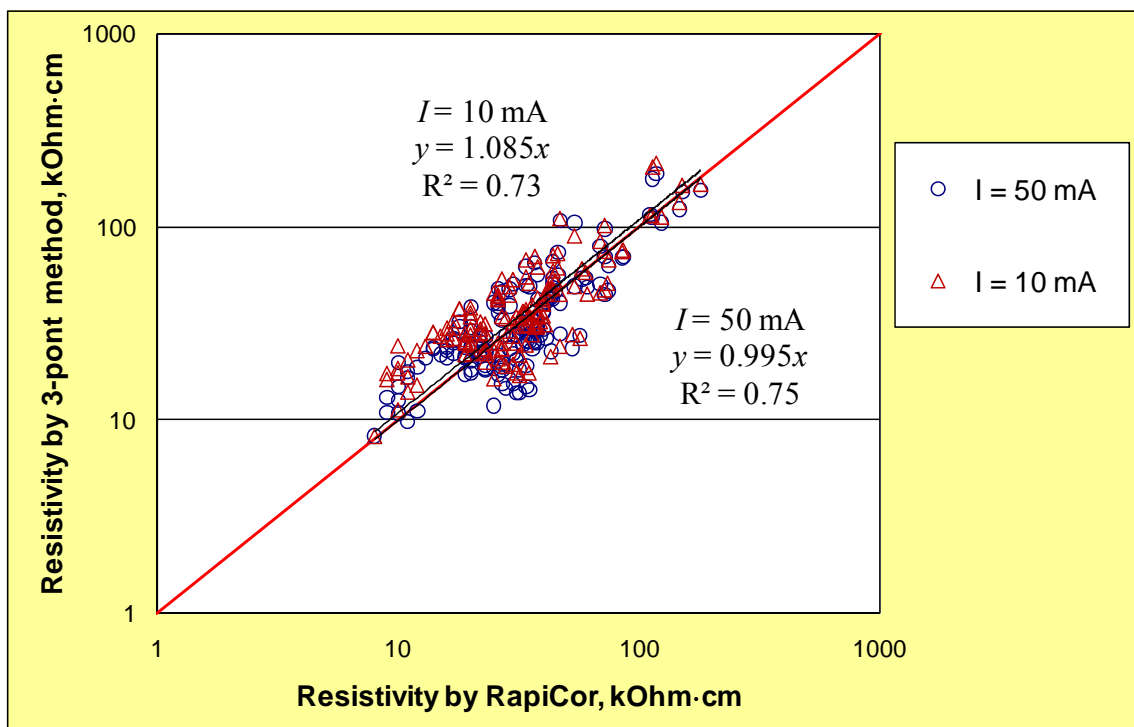
Figure 3.6.2 Comparison between resistivities measured by the three-point method and the RapiCor.

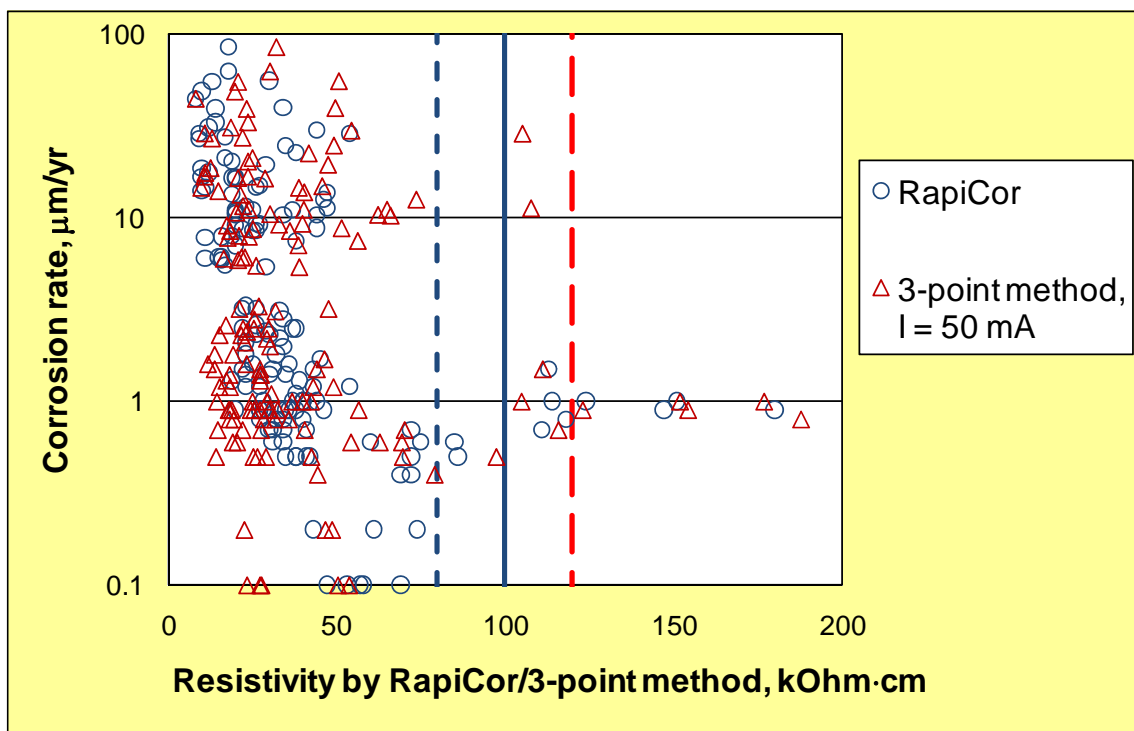
Figure 3.7.1 Relationship between corrosion rate and resistivity measured by the the RapiCor and the three-point method.

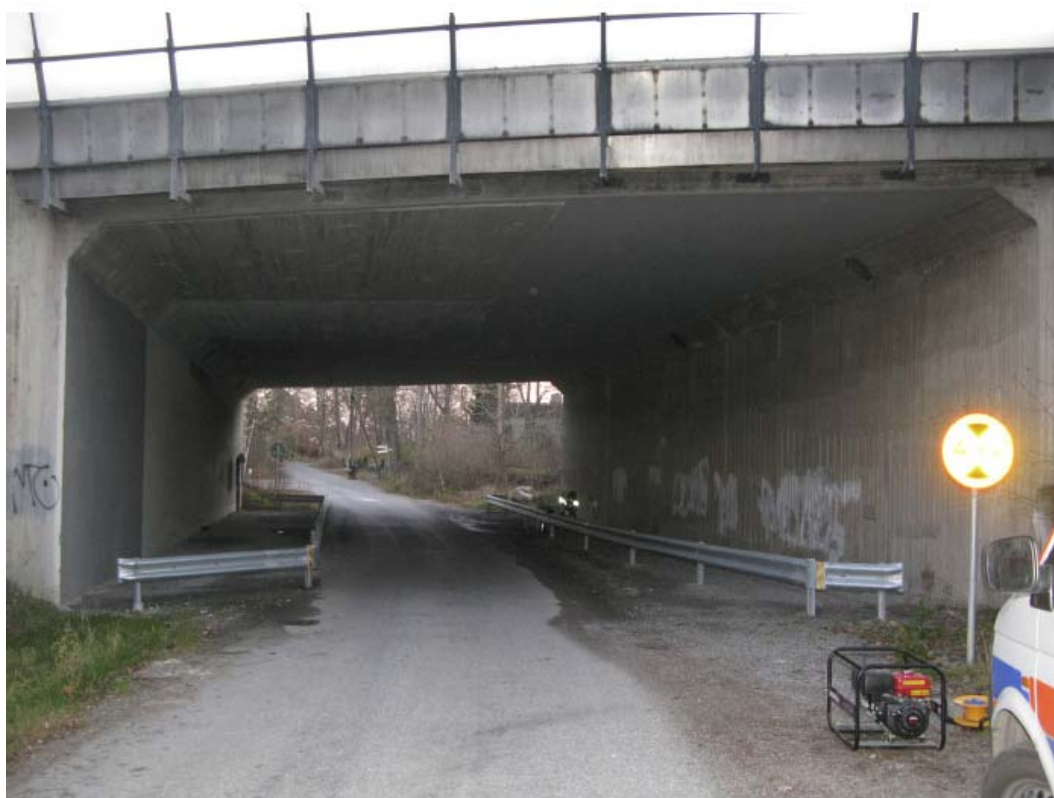
Figure 5.2.1 View of Bridge 2-583-1 from the north.

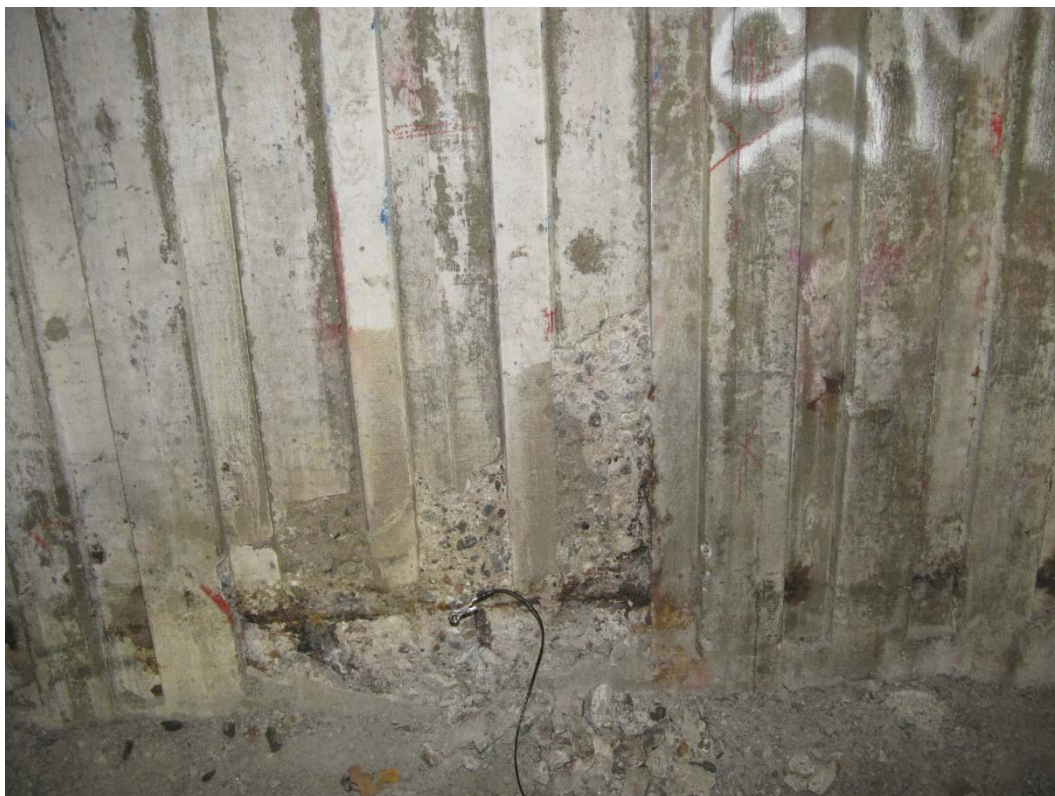
Figure 5.2.5 Black cable connection in the first measurement.

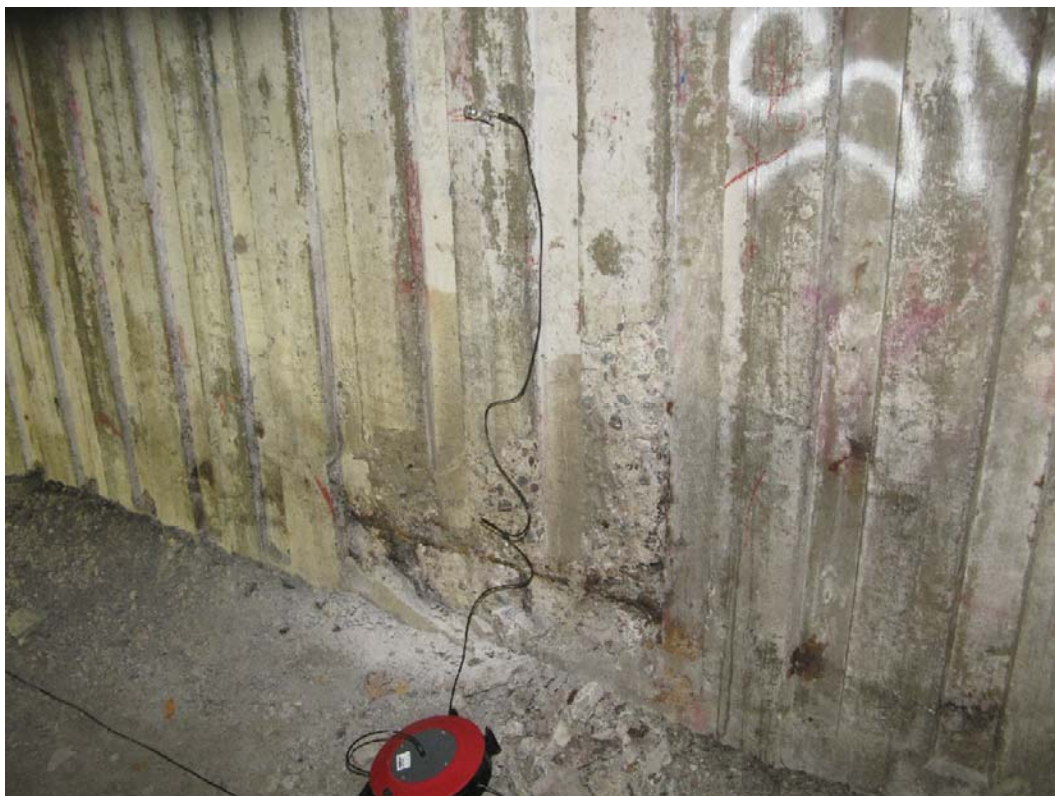
Figure 5.2.6 Black cable connection in the second measurement.

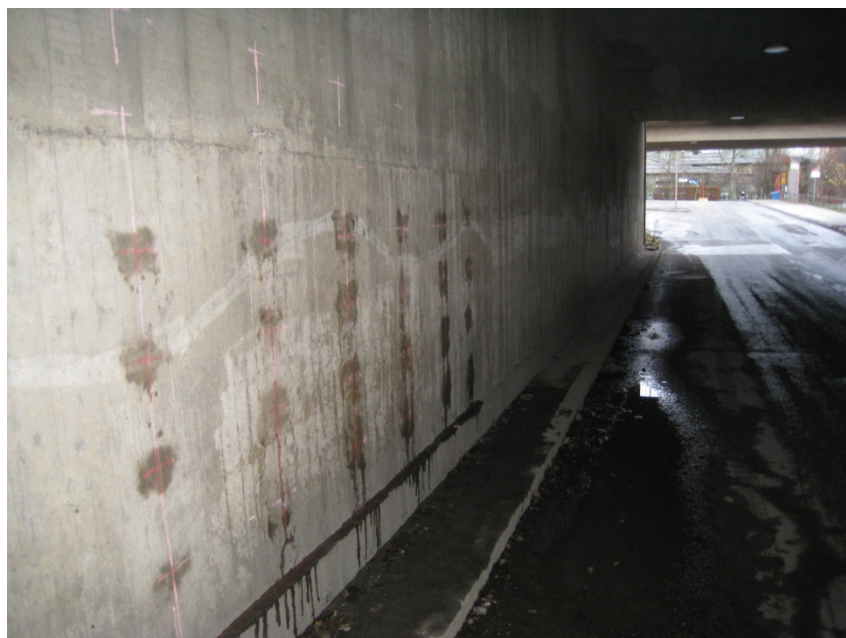
Figure 5.3.1 View of the measurement area on the abutment of Bridge 2.

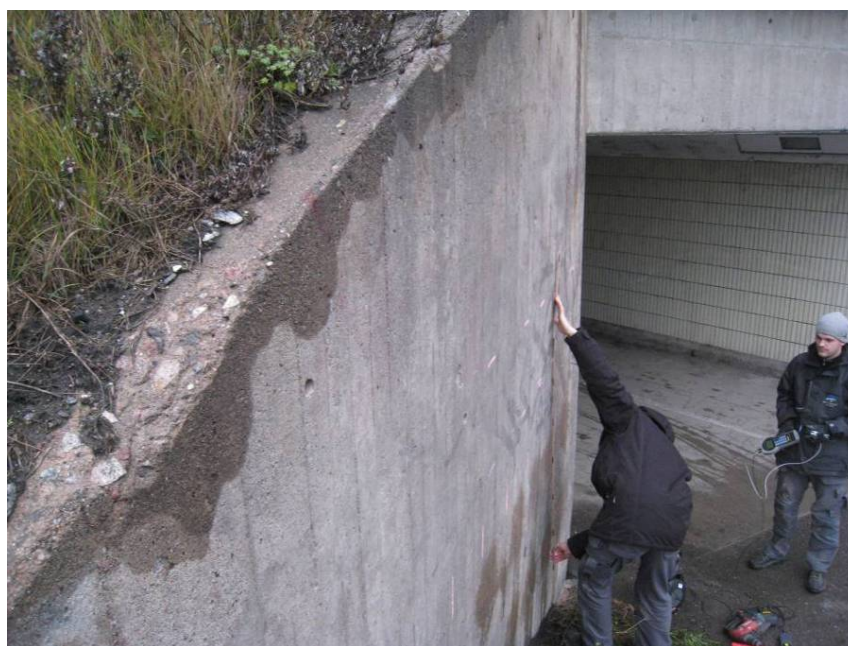
Figure 5.3.3 View of the measurement area on the wing wall of Bridge 3.

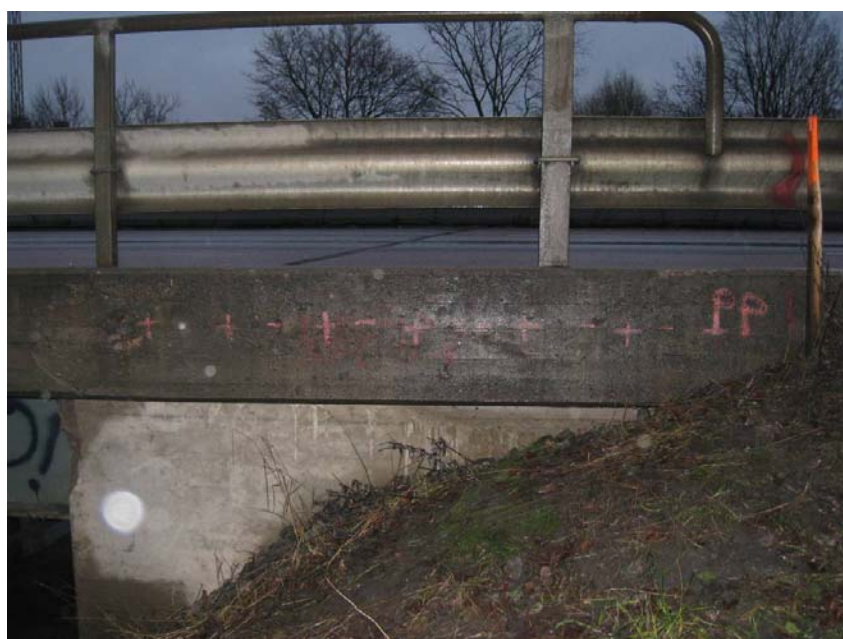
Figure 5.3.5 View of the measurement area on the edge beam of Bridge 5.

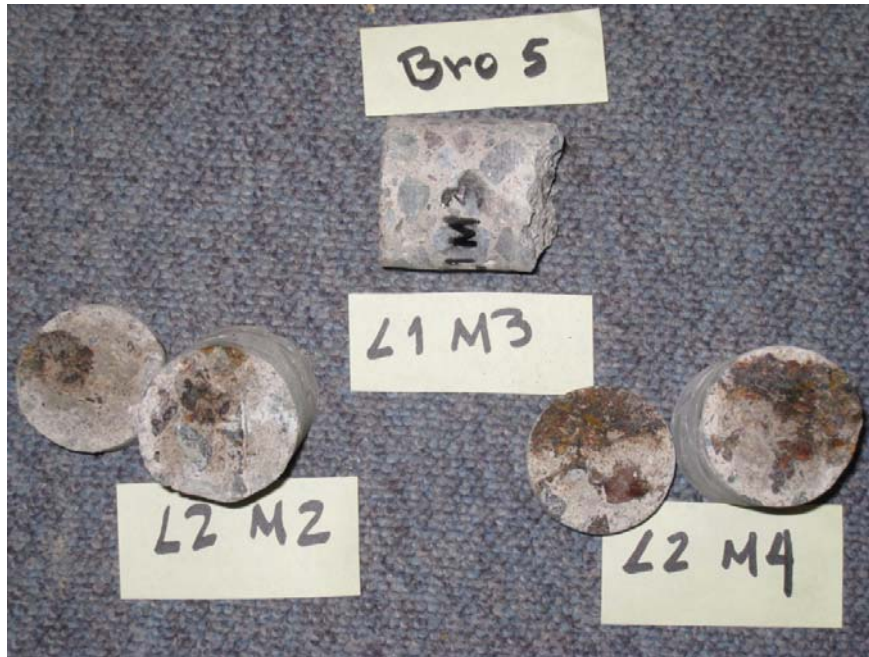
Figure 5.3.7 Corrosion on the steel bars in cores L2M2 and L2M4 drilled from Bridge 5.

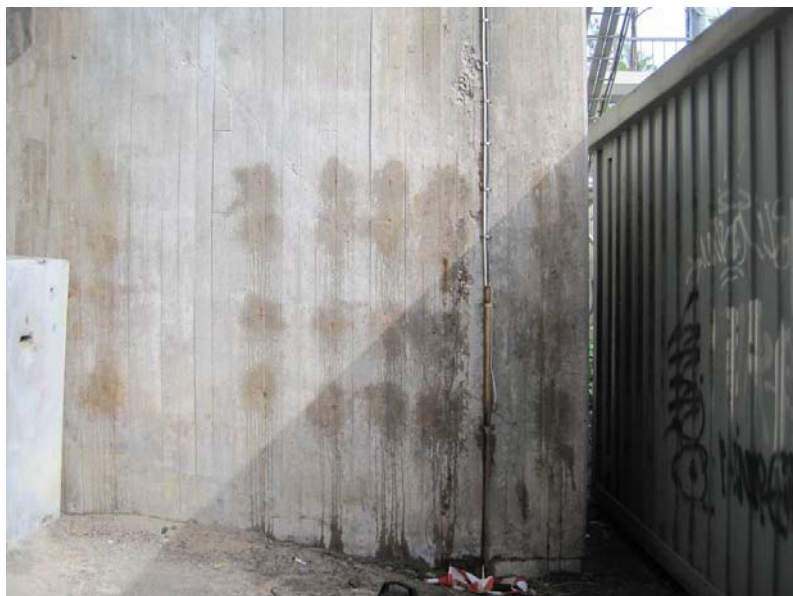
Figure 5.3.8 View of the measurement area on the abutment of Bridge 6.

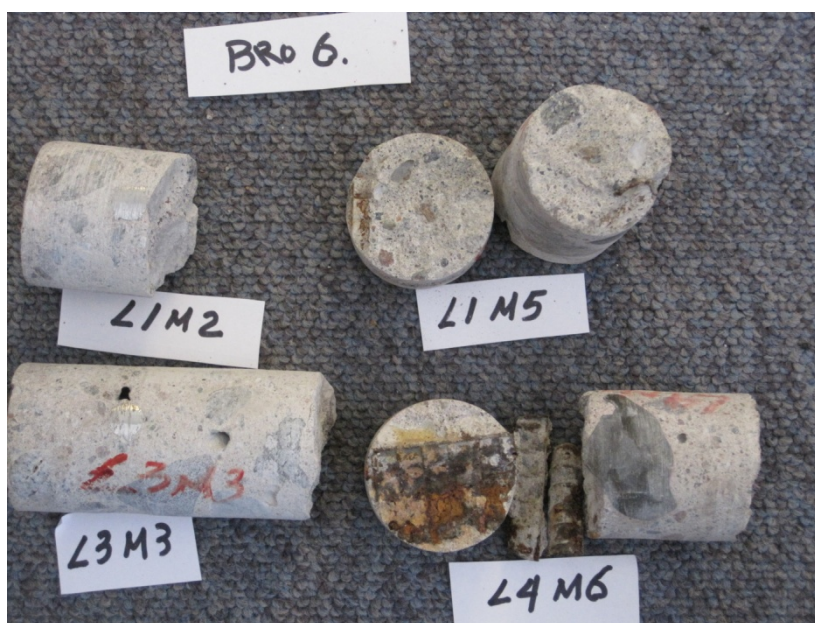
Figure 5.3.10 Corrosion on the steel bars in cores L1M5 and L4M6 drilled from Bridge 6.

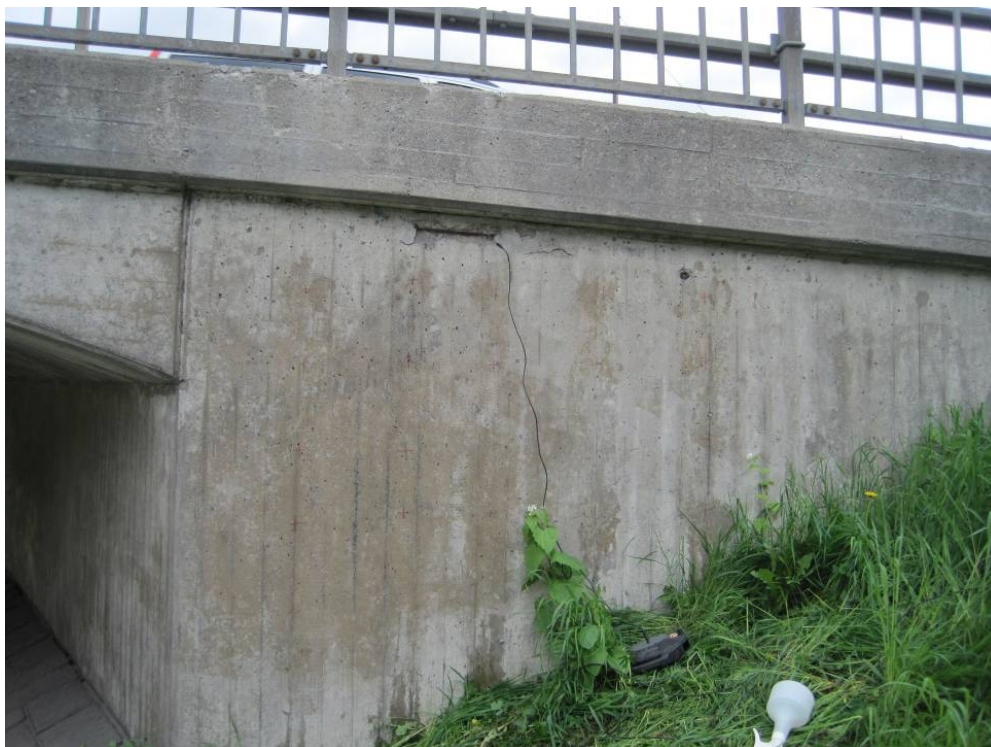
Figure 5.3.11 View of the measurement area on the wing wall of Bridge 7.

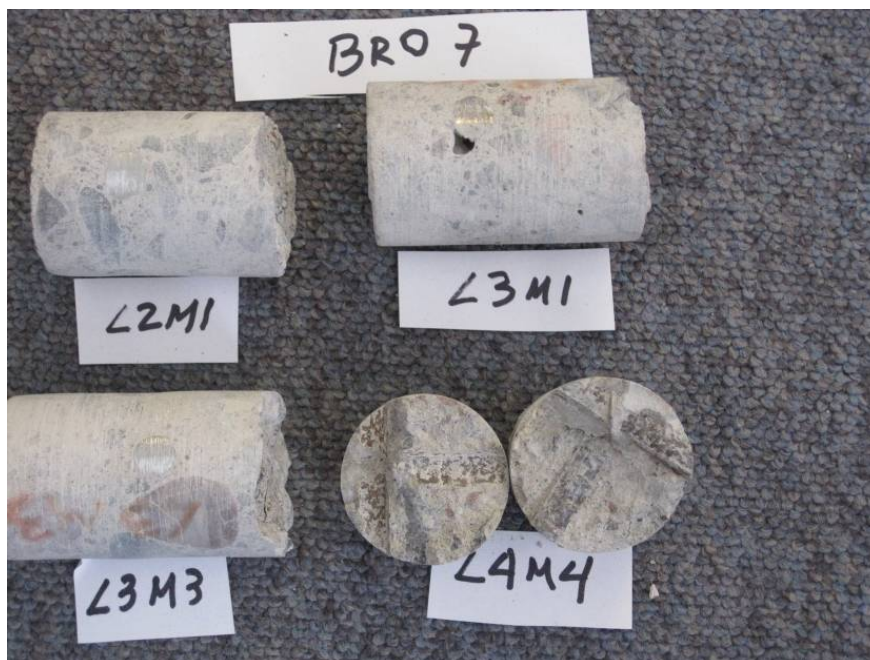
Figure 5.3.13 Superficial corrosion on the steel bar in core L4M4 drilled from Bridge 7.

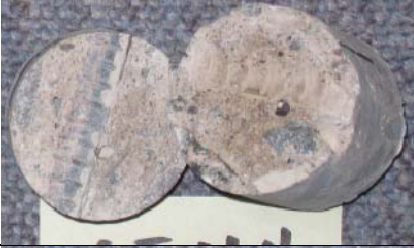
No visible corrosion
R1

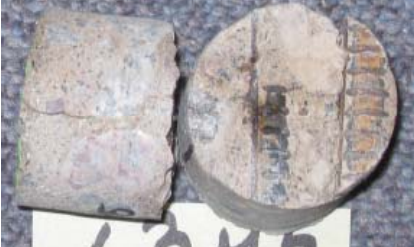
Small rust spots on the ribs, superficial corrosion, or only yellow colour on the reinforcement surface
R2

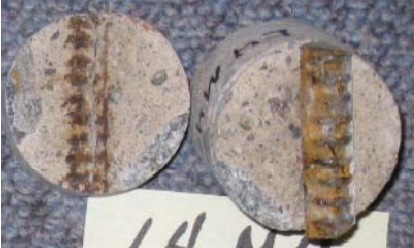
Significant rust spots on the ribs and reinforcement surface, < 1 mm severe rust spots, or general corrosion with poor bond
R3

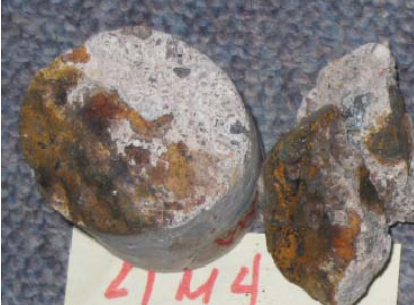
Disappeared ribs due to corrosion, or severe rust spots about 1 mm deep on half or entire curved surface
R4

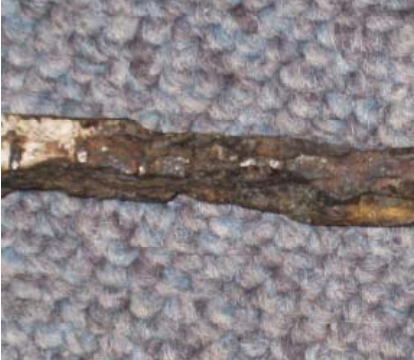
Disappeared ribs due to corrosion and severe rust spots deeper than 1 mm on half or entire curved surface

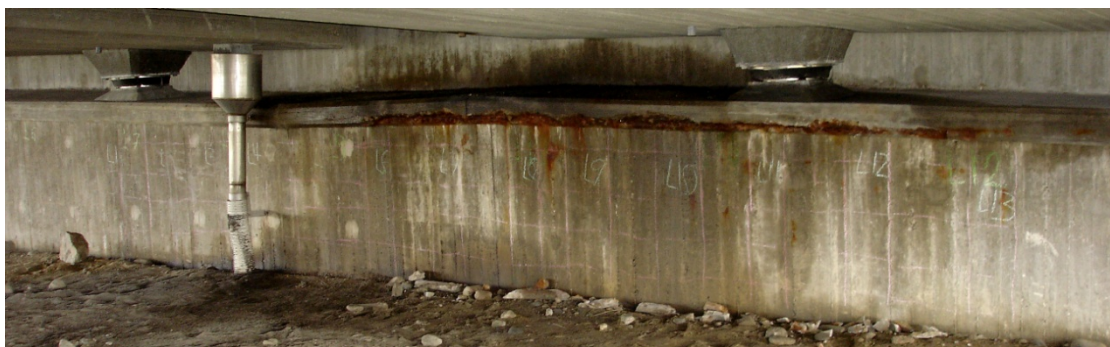
Figure 5.4.1 Spalling on the southern bearing seat of Bridge 19-388-1 [Lind & Wikslund, 2010]

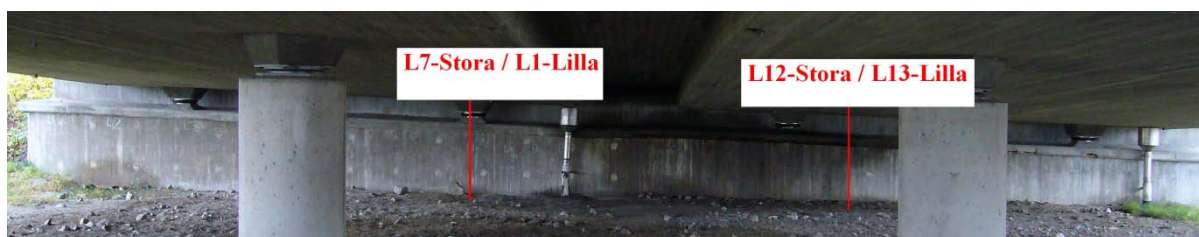
Figure 5.4.2 A wide view of the measurement area on the southern bearing seat of Bridge 19-388-1 [Lind & Wikslund, 2010] (Stora= Lines in the 1st measurement; Lilla = Lines in the 2nd measurement)

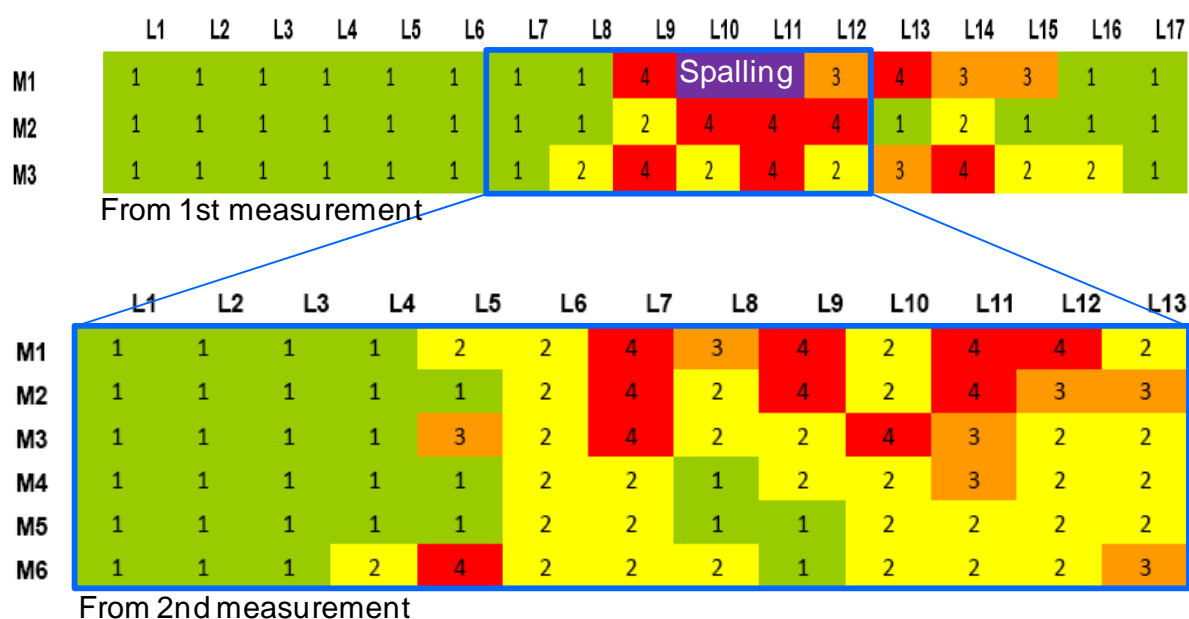
Figure 5.4.6 Map of corrosion index on the southern bearing seat of Bridge 19-388-1, based on [Lind & Wikslund, 2010]

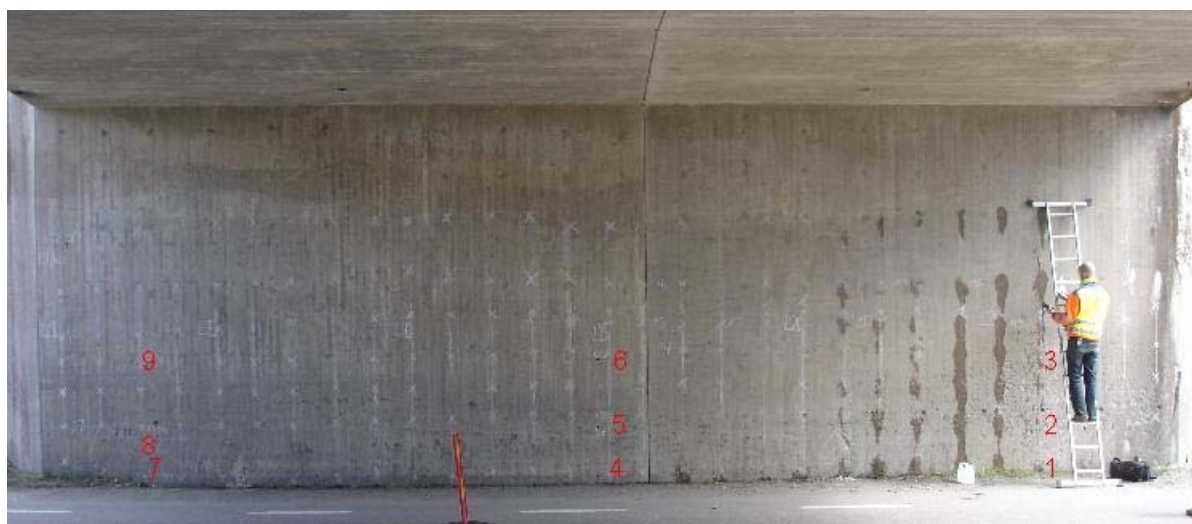
Figure 5.4.7 A view of the measurement area on the eastern front wall of Bridge 19-380-1 [Lind & Wikslund, 2010]

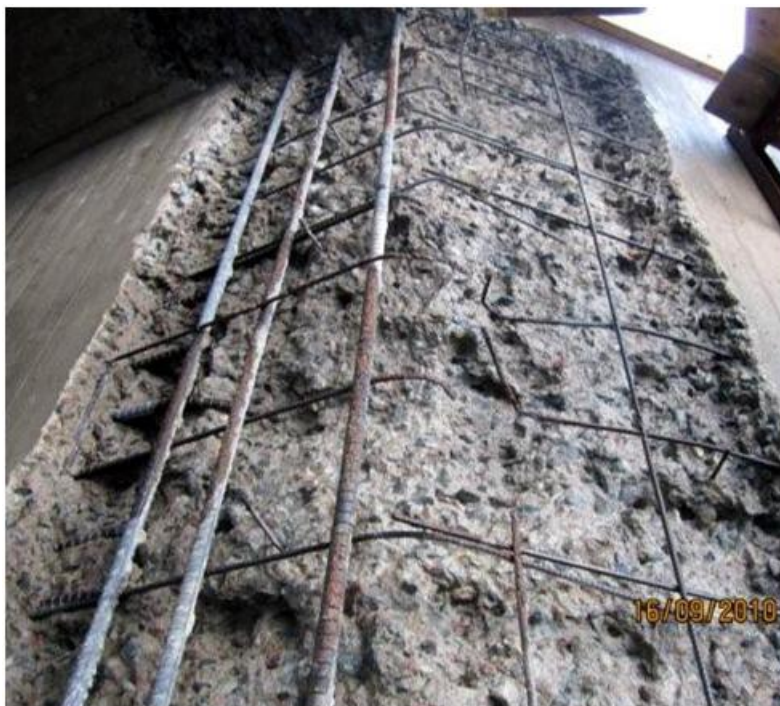
Figure 5.4.12 Reinforcement bars after removal of concrete at the southern opening of the eastern front wall of Bridge 19-380-1 [Lind & Wikslund, 2010]

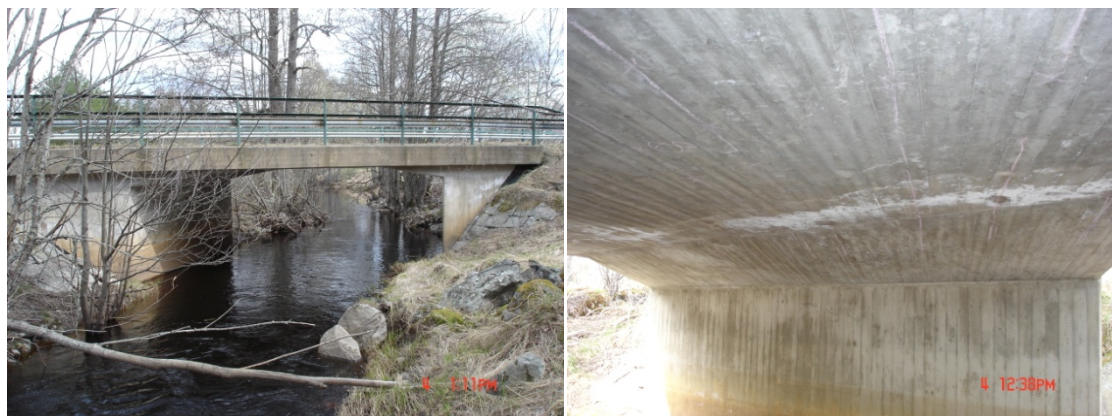
Figure 5.4.13 Concrete bridge 19-117-1 [Lind & Wikslund, 2010] (Left: a view from side; Right: Lime precipitations underside the bridge slab).

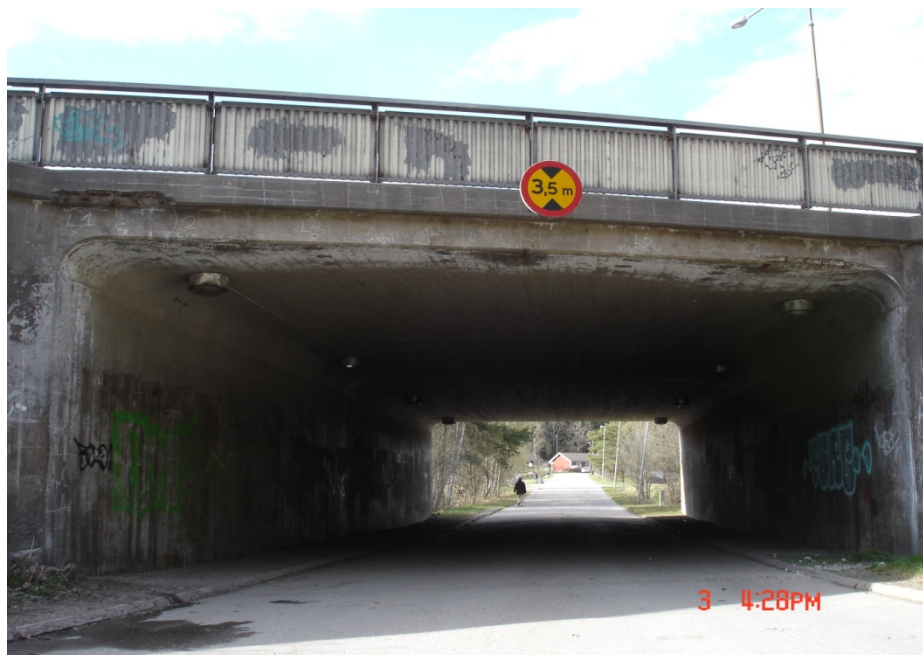
Figure 5.4.18 A view of Bridge 19-386-1 from the south side [Lind & Wikslund, 2010].

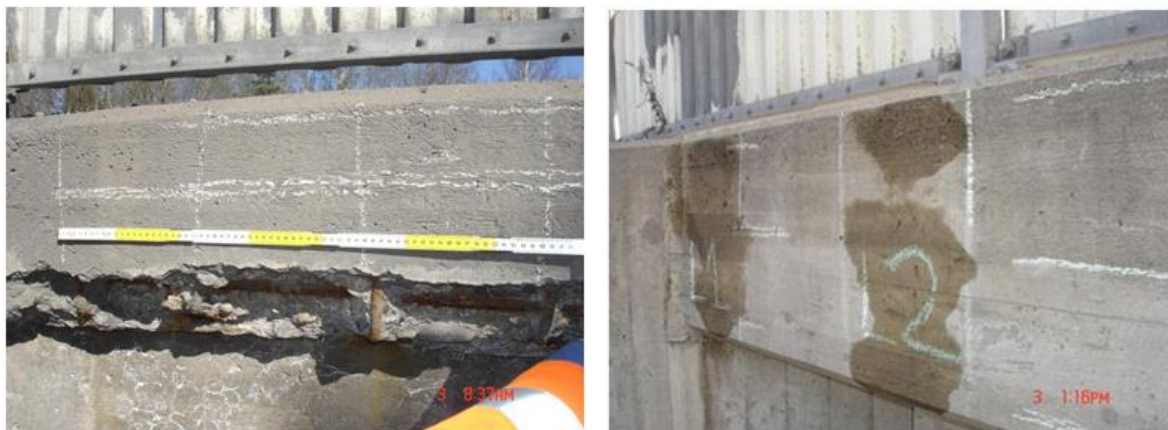
Figure 5.4.19 Measurement grids on the southern edge beam (left) and the northern edge beam (right) of Bridge 19-386-1 [Lind & Wikslund, 2010].
