The ageing of safety barriers. Functional limits for safety barriers that deviate from the nominal in height and/or perpendicular position

Issued by: Göran Fredriksson, BARRIER TECH AB

Report number: 1301-1

Ordered by: Hans Holmén, Technical Specialist. Swedish Transport Administration

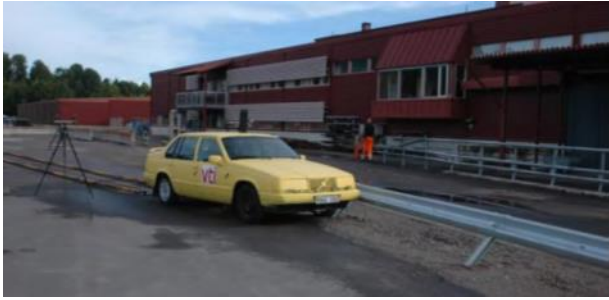
Figur 2. Test fordon vid kollisionspunkten med 20° angreppsvinkel innan kollisionstesten genomförs.

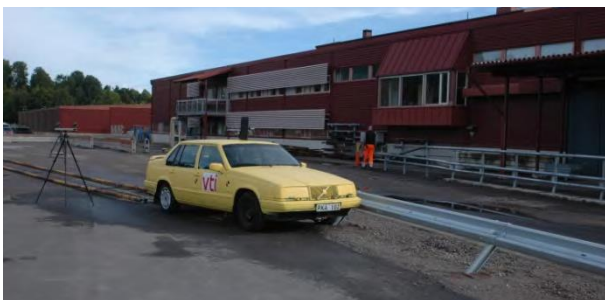
Figure 2. Test car at impact point using the 20° approach prior to collision test.

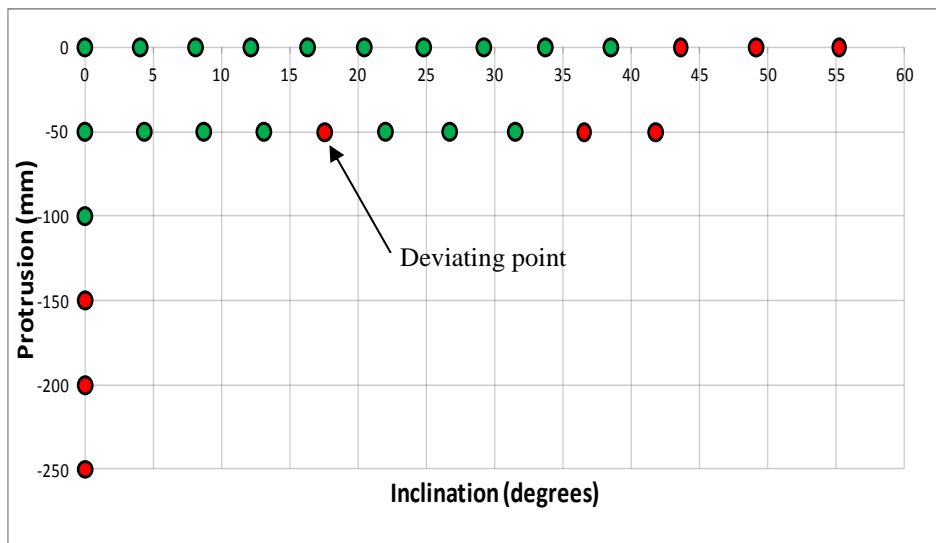
Simulation points and their outcome as pass (green) or fail (red) is presented in figure 4:

Figure 4: Parameter study results.

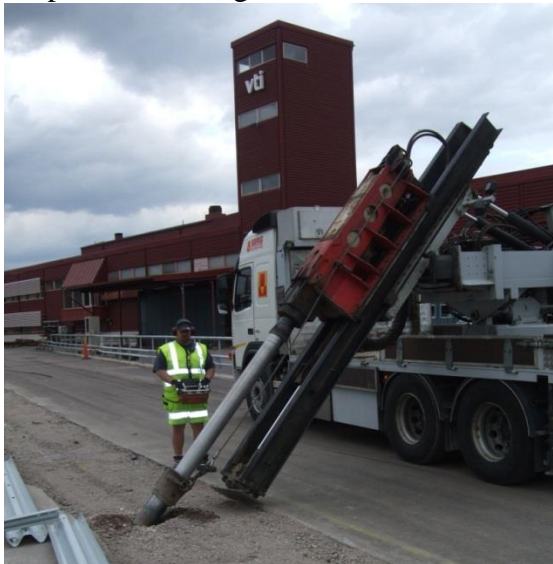
Punching of holes for an inclined barrier.

Installing a barrier at almost 45° angle is not a straight forward everyday job, but due to the ability of the machine to tilt the punch it could be achieved with relative ease.

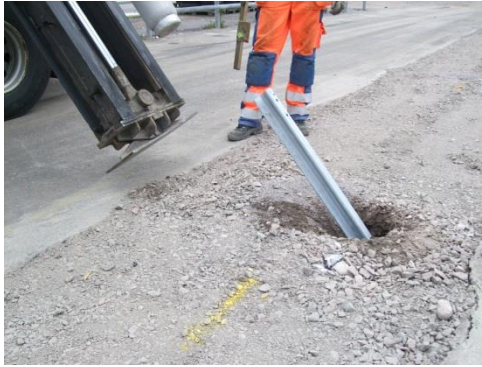
Post inserted

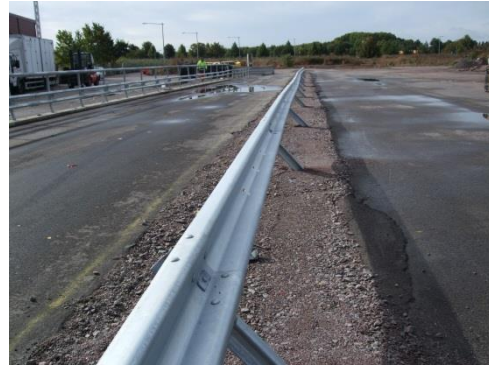
Final result

- Installation should contain “slack” to simulate a real installation. Meaning that the profiles are not pulled apart before tightening the screws at the joints.
- Anchoring of the barrier at the ends are done in an ordinary straight position as these should not be the cause of failure and the barrier can be gradually inclined anyway to the desired position. It would also save doing the anchoring all over again before each test run.
- Holes were punched at the desired angle instead of the post being pushed sideways whilst still in the ground until the inclination angle was achieved.

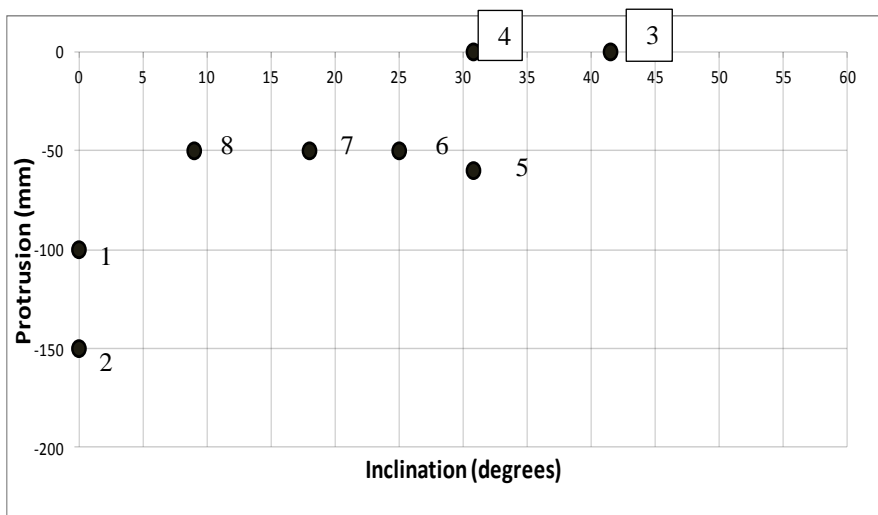
Below, in figure 5, the actual positions tested and the order in which they were performed are shown on a chart.

Figure 5, Tested barrier positions, numbered in the order they were performed.

It is evident, that when only height or inclination was tested it took only two impacts to establish limits between pass or fail whereas the combination of the two parameters was not entirely clear even after 4 impacts. This is because even at 50 mm decreased post protrusion and approx. 9° inclination the test vehicle rolled over in a manner that is not acceptable, although still on the “right” side of the barrier as it did not override, see 4.5 Results of crash tests.

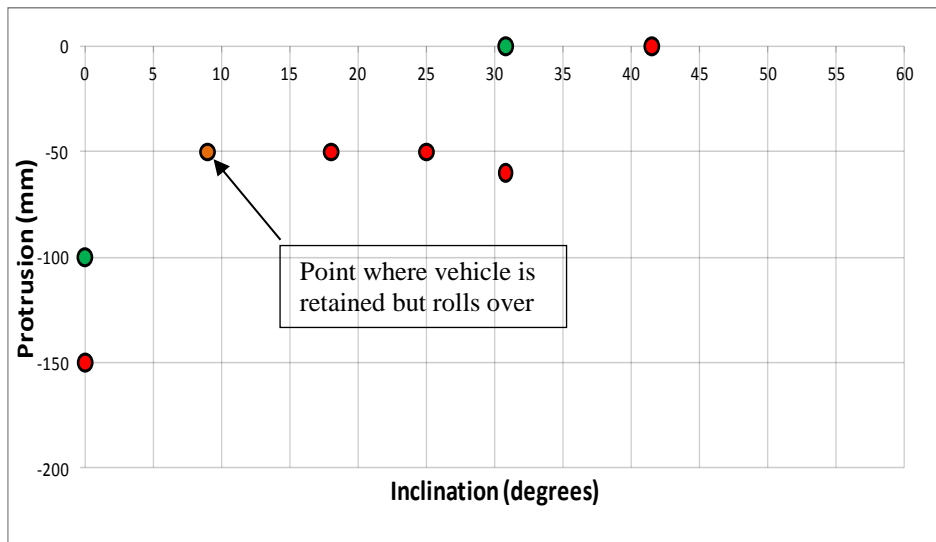
Figure 4 below shows the outcome of the crash tests in the same type of chart as previously presented. Green points mean pass and red points fail. The yellow point also represents fail, but then due to the vehicle not overriding barrier but rolling over after impact instead.

Figure 4, results of crash tests. Pass = green, fail = red or yellow.

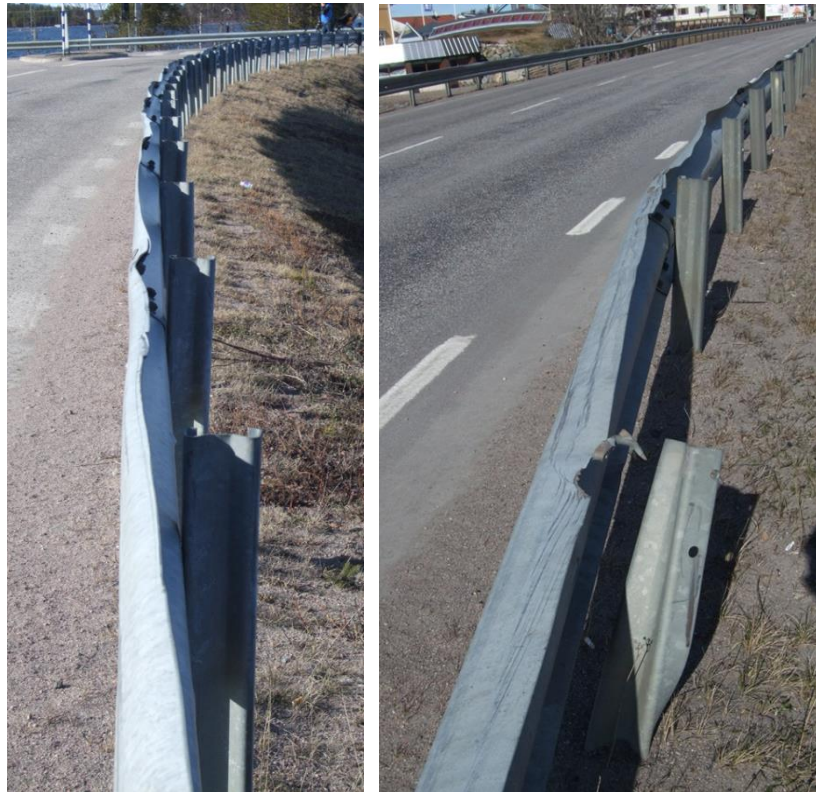
- c. Snow removal not only contributes to the forces that make the barrier starting to be tilted away from the roadside but also deforms the W-beam profile itself. The deformation that is considerable in places, see photo below, is yet another factor that would make barrier behavior even more unpredictable when combined with a deviating position. A longer distance than the commonly used 50 mm between paving edge and barrier front to roadside would reduce the forces and damages from snow removal to the benefit of barrier function as well as general lifetime expectancy.

Examples. W-profiles deformed from snow removal.

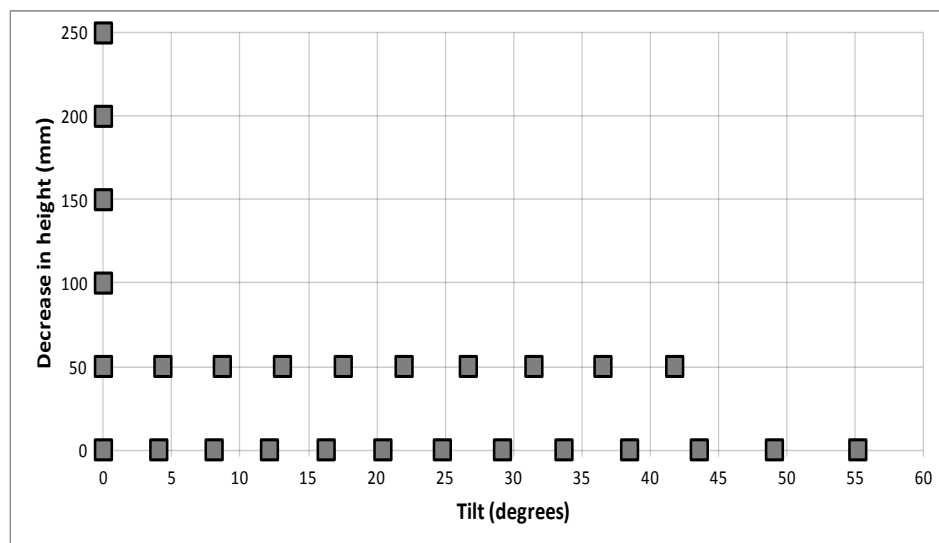
The Design-Of-Experiments (DOE) for the parameter study is shown in and Figure 3. The DOE consists of 27 simulations. Each simulation was studied and estimated as “fail” or “pass”, where “fail” means that the vehicle passes over (override) the barrier.

Figure 3: DOE for the parameter study (diagram form).

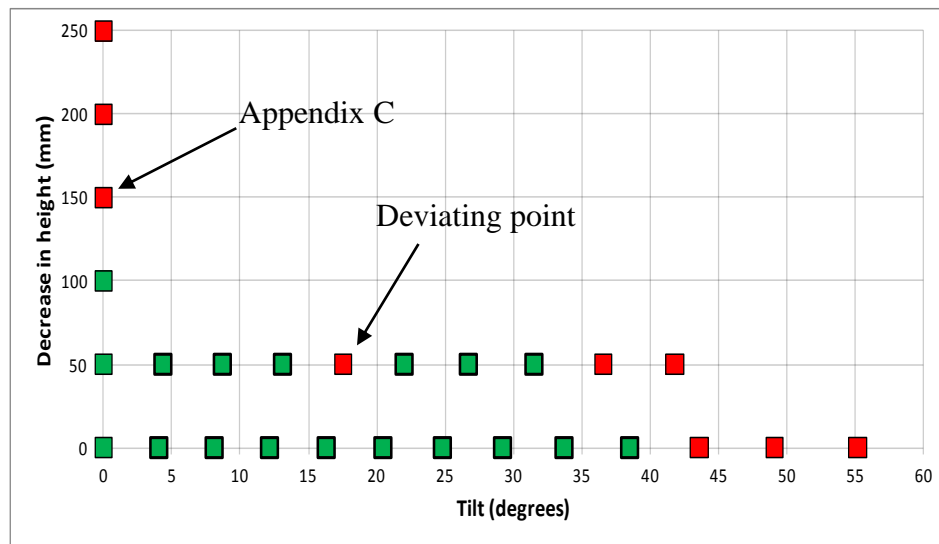
Each of the 27 simulations in the parameter study was checked and estimated as “fail”, see red squares in Figure 4, or “pass”, see green squares in Figure 4, where fail means that the vehicle passes over (override) the barrier. The first red square on the y-axis, i.e. for a decreased height of 150 mm is shown in Appendix C.

Figure 4: Parameter study results.

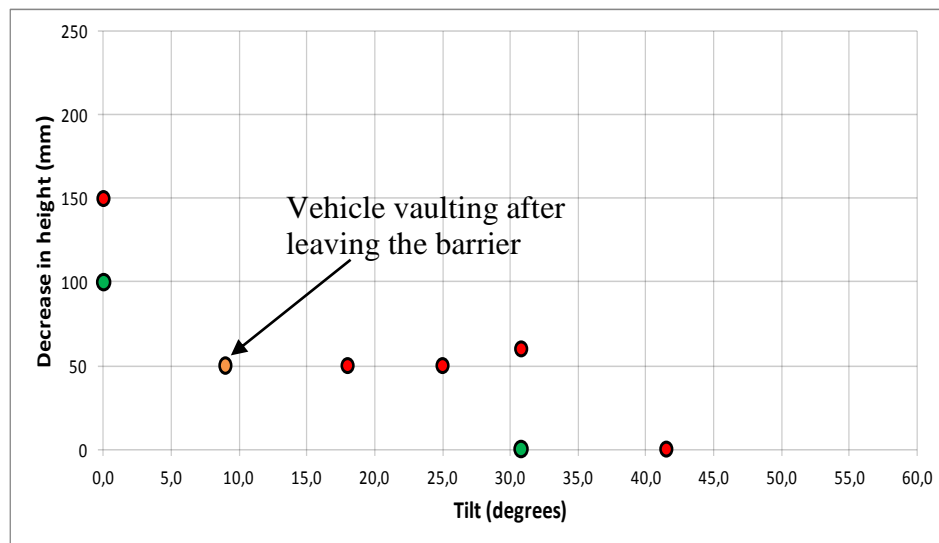
The physical test results are shown in Figure 7. It turned out that the DOE worked well. Critical tilt and height was determined with only four tests as hoped for. The combined “Decrease in height” and “Tilt” case was, as predicted by the simulations, more complicated. We had three red “failed” tests where the vehicle overrode the barrier and a final test where the vehicle did not override the barrier but vaulted as it left it. The test was not a “fail” based on our, in this project, definition of fail, i.e. it did not override the barrier. However, it would not be approved in an EN 1317 test. In addition, vaulting is potentially dangerous. It was decided to make this point “yellow”. The point is in between green and red.

Figure 7: Physical test results.

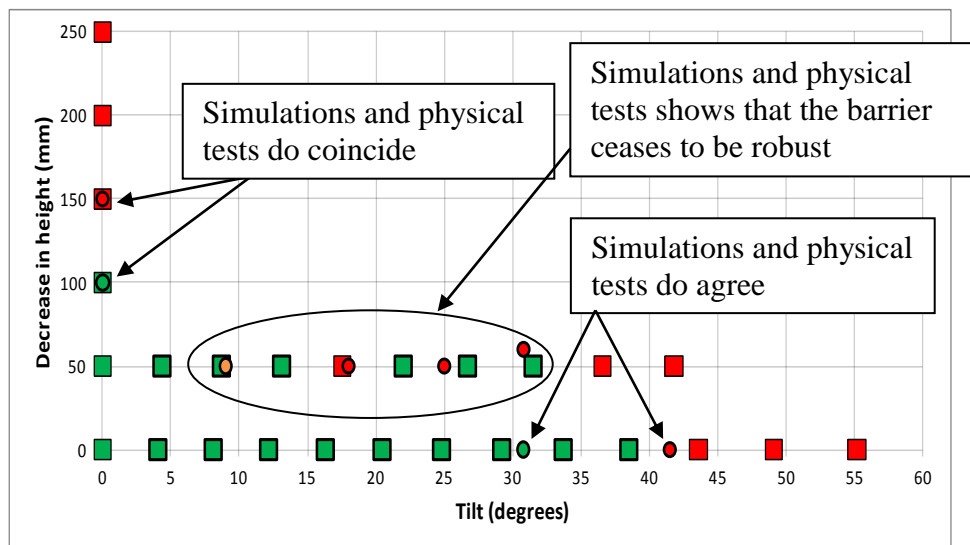
The simulation results and the subsequent physical tests results are shown in the same diagram, see Figure 9. The squares are the 27 simulations and the circles are the 8 physical tests. The x and y axes agree or coincide. It turned out that when the height of the barrier is decreased by only 50 mm the barrier ceases to be robust when tilted. This has been shown both by simulations and physical tests.

Figure 9: Simulation results and subsequent physical tests.

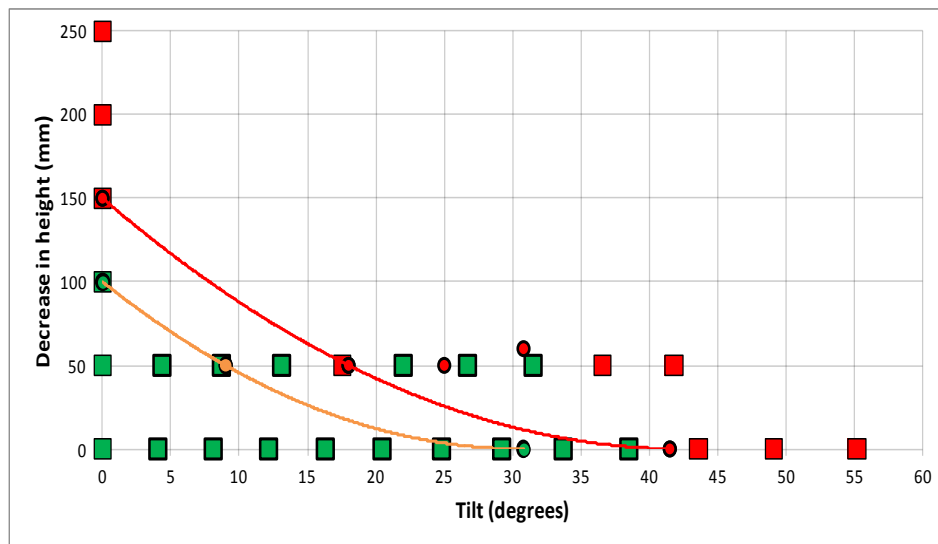
Figure 10 shows the results with two trend-lines (polynomial of order 2) drawn between the physical test red points as well as the physical test green/yellow points. This is one way of interpreting the results.

Remark: It would have been desirable to be able to draw a green line between green “pass” points in the diagram. However, there was a test where the vehicle did not override the barrier but vaulted after leaving the barrier. It was decided that this test was between a “pass” test and a “fail” test according to the definition used in this project. Hence the test was given a yellow point instead of a green or red point in the diagram. This is why the line is set yellow between the two green points and the yellow point in between.

Figure 10: Trend-lines between physical test points.

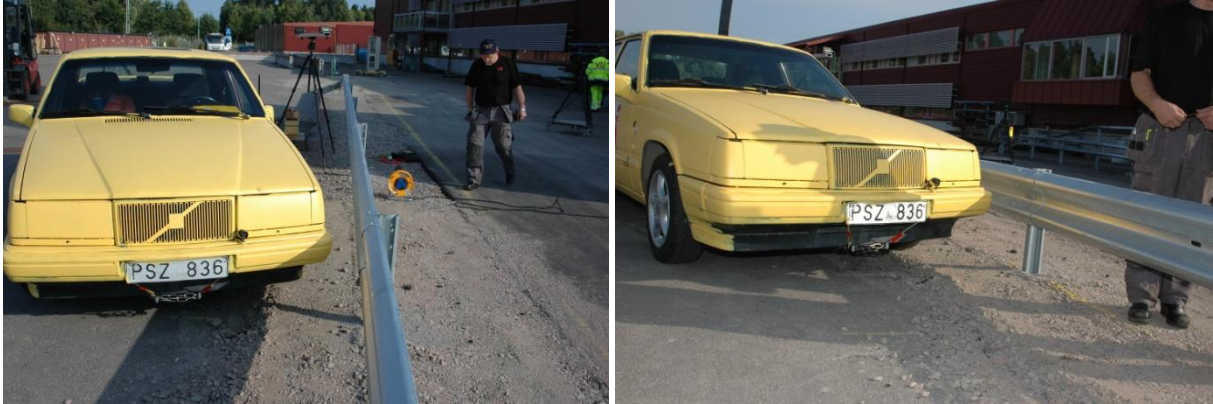
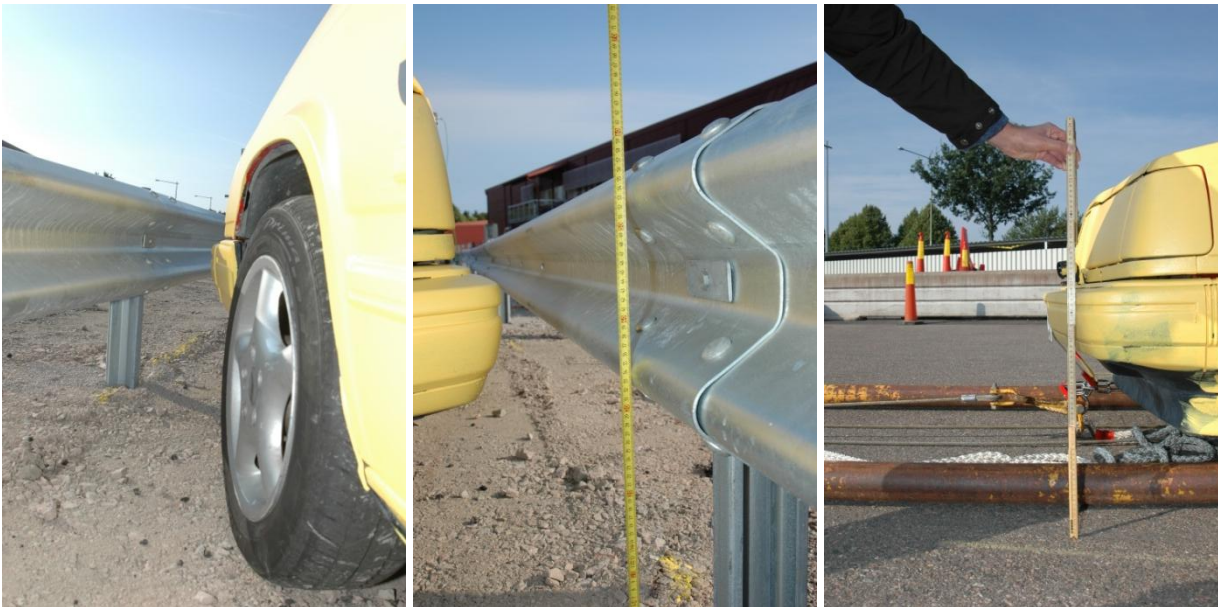
Test 1

The first test was run on the 10th of September 2012 (2012-09-10). The installation was a vertical post with no angle, but cross member intentionally installed 100 mm to low, which equals a height of 450 mm to the middle line of the W-beam. Speed was 113,6 km/h.

The prediction was that it was about 50% probability of breaching the barrier. The test did nevertheless result in a redirection, even though the roll angel of the vehicle was about 90 degree. In a more formal EN1317-2:2010 T32 crash test, this had been regarded as a failure, since rolling on to the vehicle side during or after impact is not allowed.

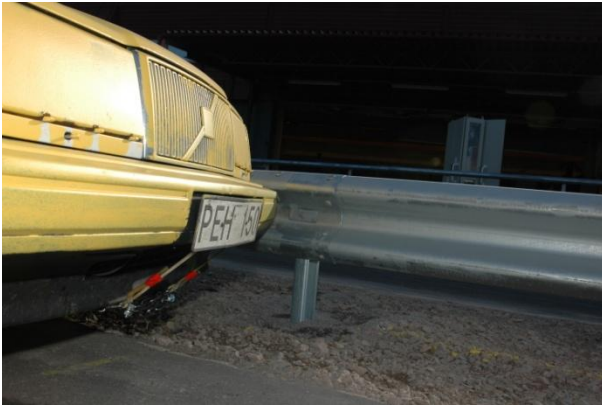
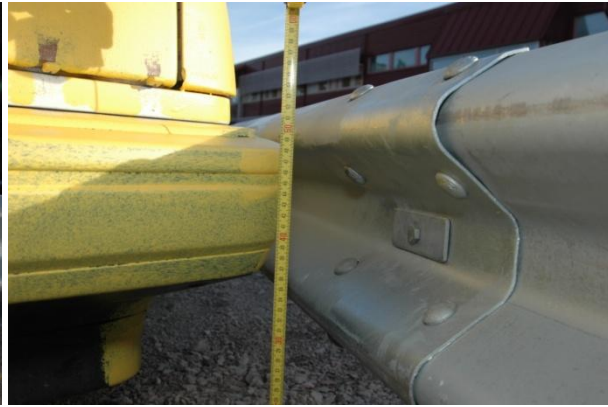
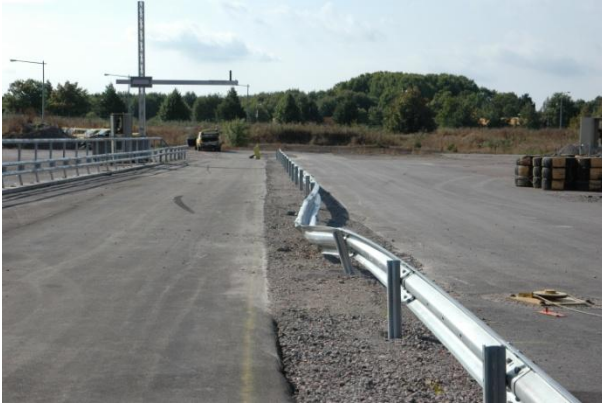
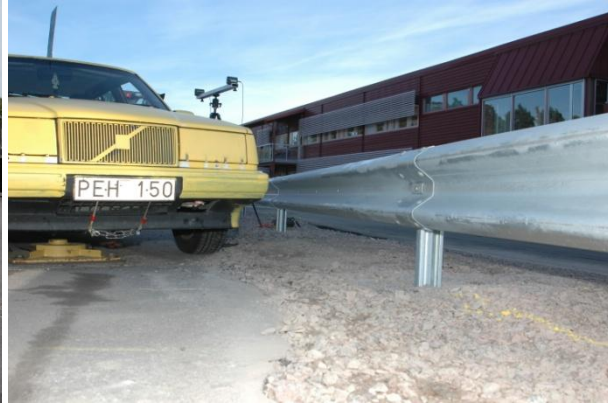
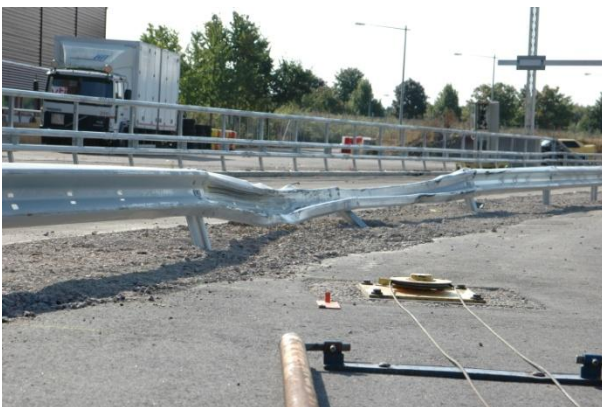
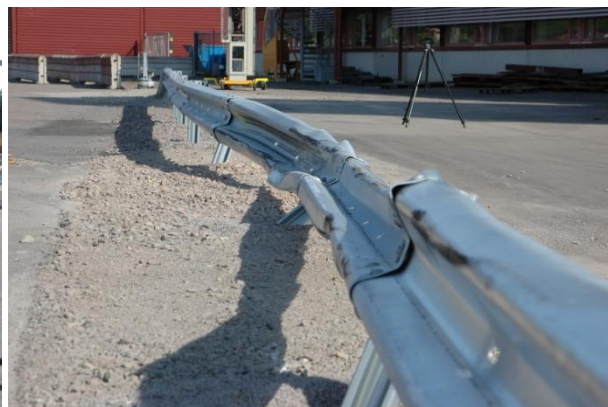
The second test was run on the 11th of September 2012 (2012-09-11) and for this test the barrier was lowered yet another 50 mm, still being vertically oriented, or now with the middle line/middle screw of the W-beam situated only 400 mm above the asphalt surface. The result was, as expected, a full breach of the barrier with the vehicle hitting an extra safety barrier behind the tested barrier (causing more severe vehicle damage than produced by the tested barrier). Speed was 113,6 km/h.

It is quite obvious that, for this combination of vehicle, barrier type, soil strength and angel of supporting post, the limit for functional performance in respect of barrier height is situated somewhere between test 1 and 2, i.e. between the height 400 and 450 mm.

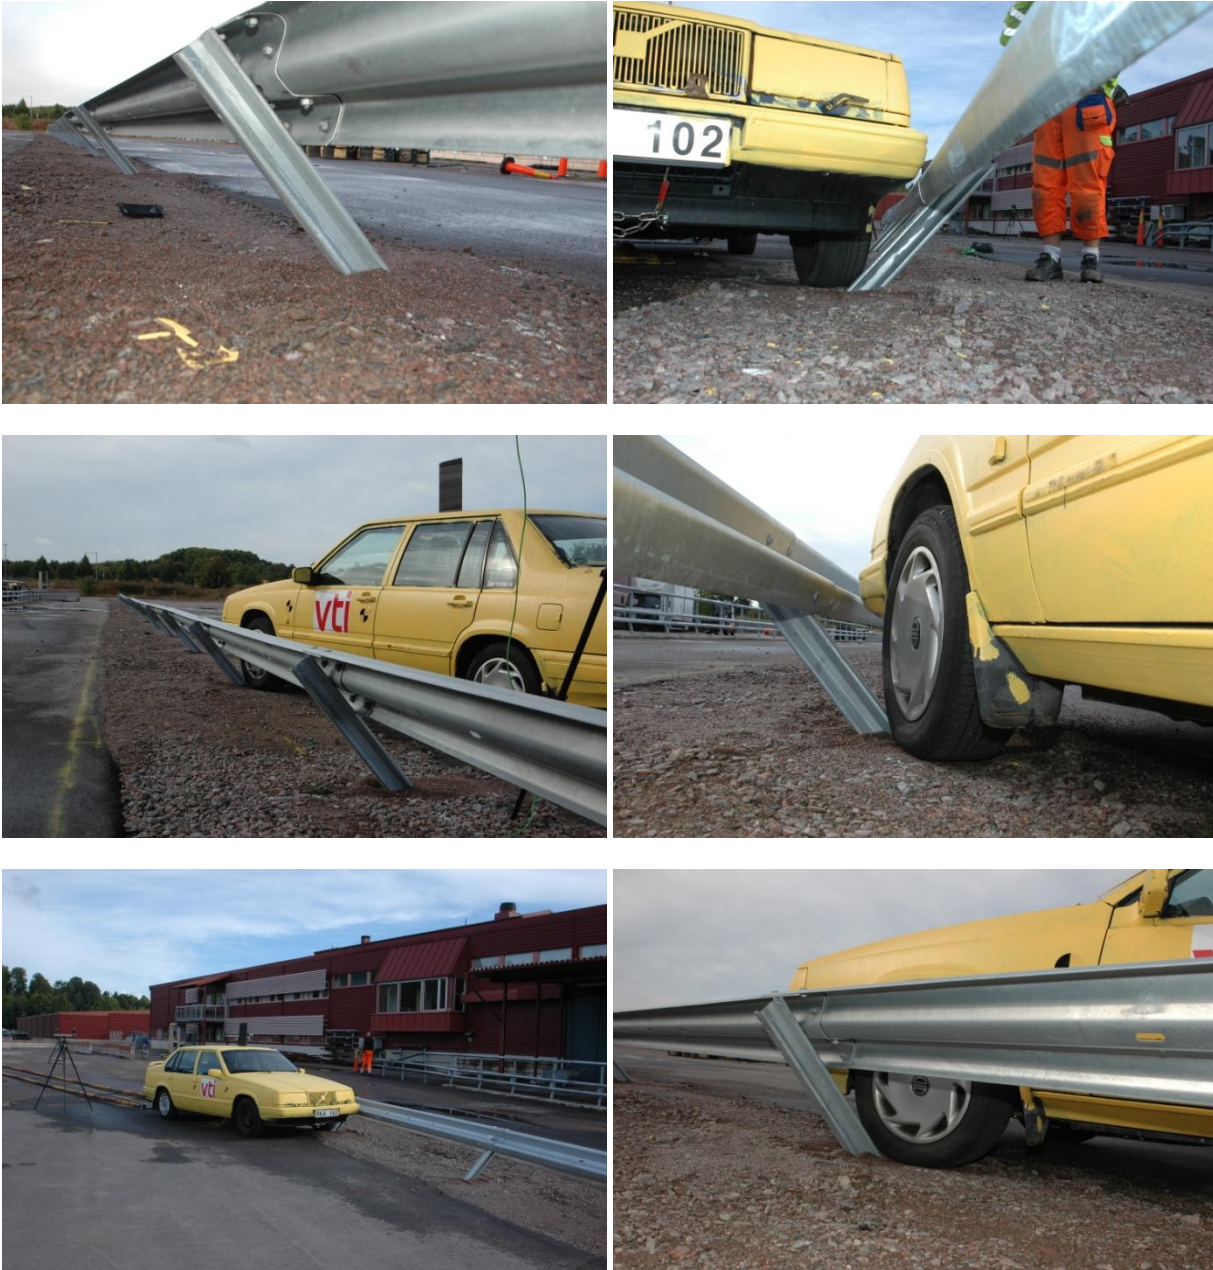
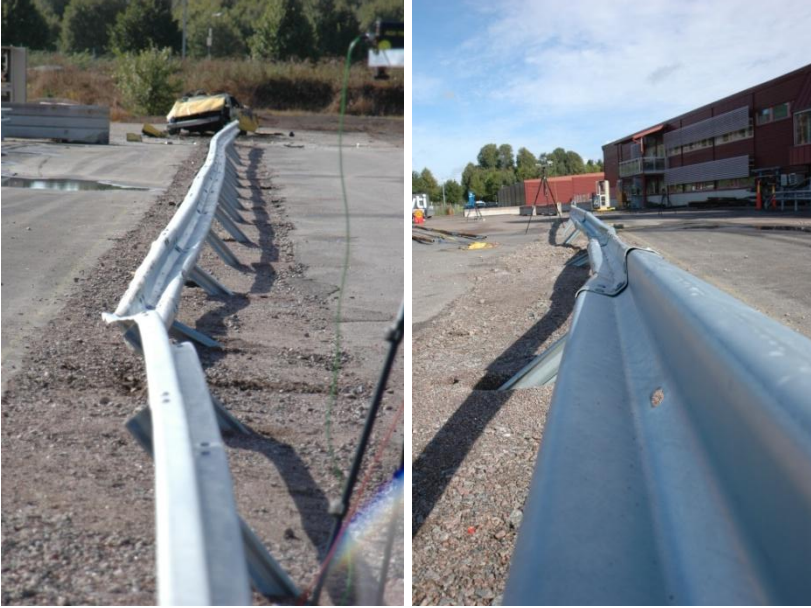
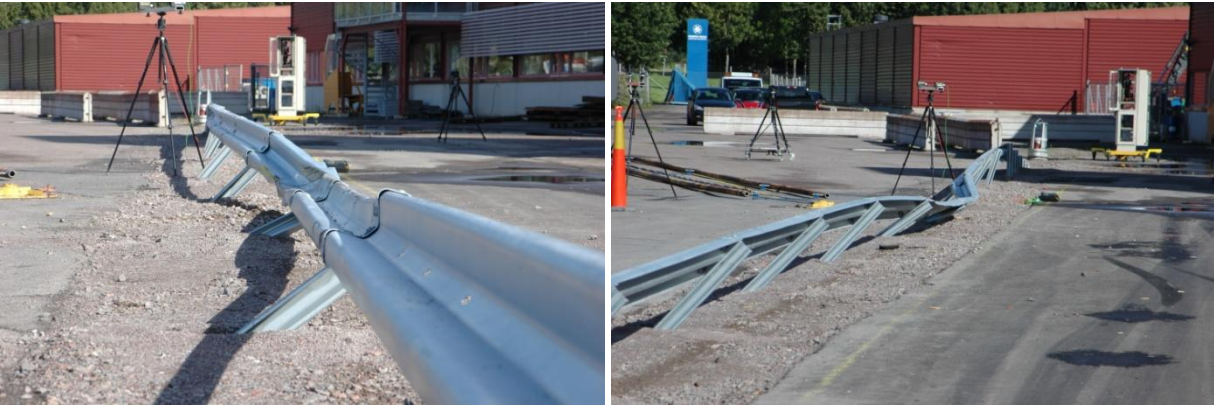
The third test, run on the 12th of September 2012 (2012-09-12—1) was then aiming for the performance on barriers where the posts had been pushed backwards, a tilting post. We started with a barrier that held an effective height of 450 mm, going back to test 1 where 450 mm had held the vehicle back, but with a quite extreme tilting of the post at 48,5°. Although extreme, the simulation had indicated a possibility of acceptable performance. Speed was 113,6 km/h.

It did result in a full breach of barrier. Really interesting to see that no bolts were sheared off, the angled beam did press the posts to ground without disconnecting from the posts. Obviously, the tilted W-beam does start pressing the posts already at first contact with vehicle.

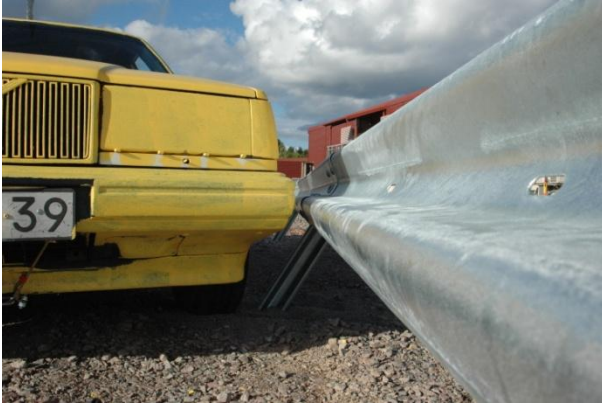
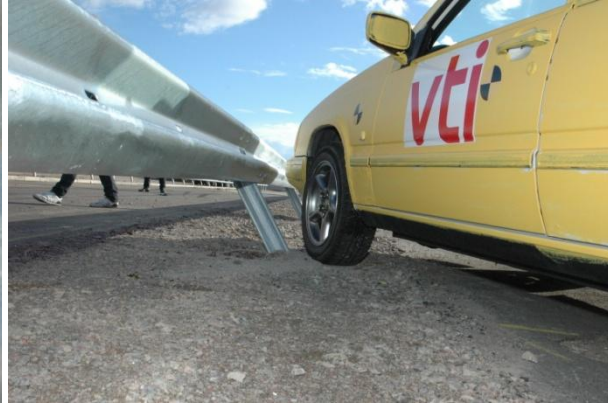
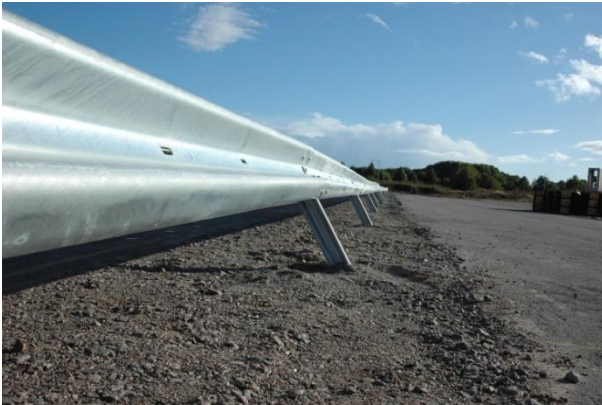
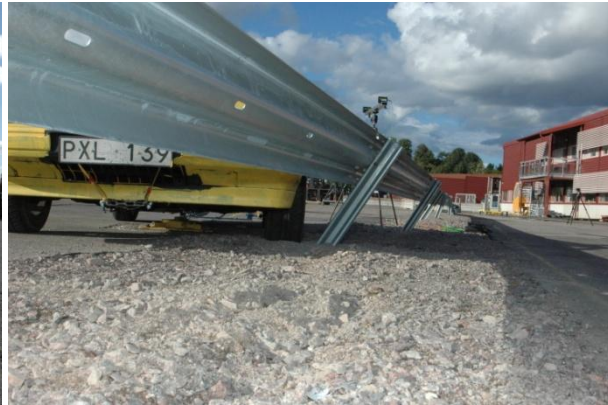
In test 4, performed on the afternoon of the 12th of September 2012 (2012-09-12—2), the barrier was slightly raised from the previous tilted installation. The new angle was 59,2° and the resulting barrier height (for the middle line of the cross beam) was now 500 mm. Although aggressive, we now had a test where the vehicle was still contained by the barrier. Speed was 113,2 km/h.

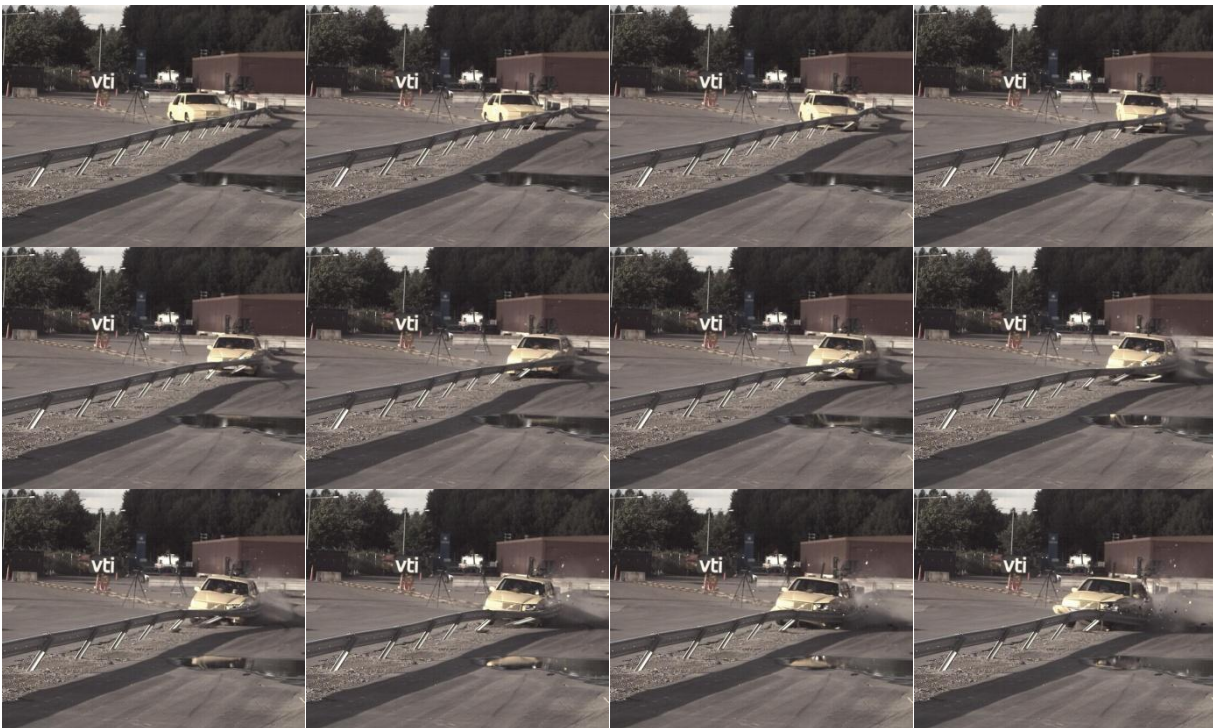
Bolts were shered off. At the same time, it is interesting to notice that the tilted posts did result in posts being pulled out of the ground.

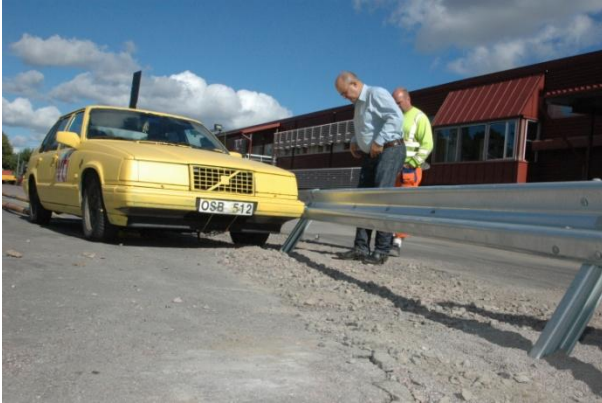
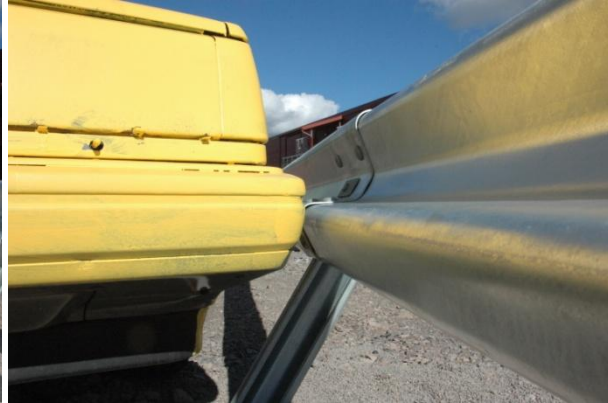
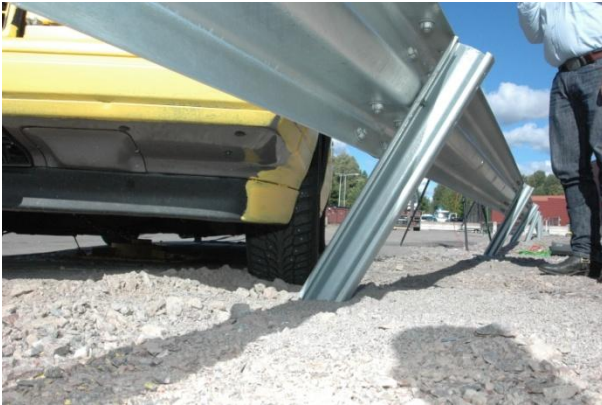
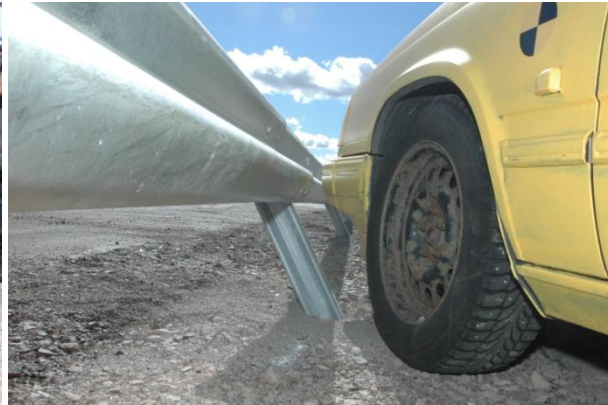
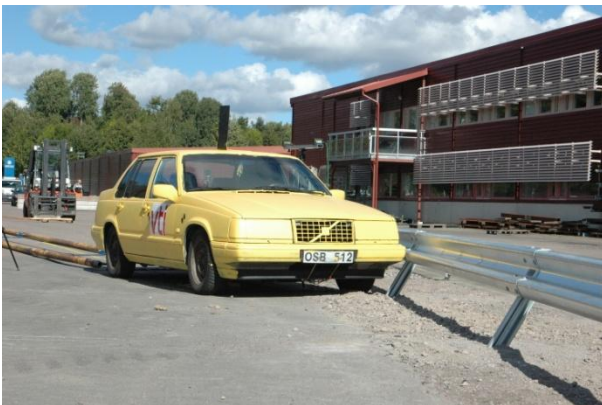
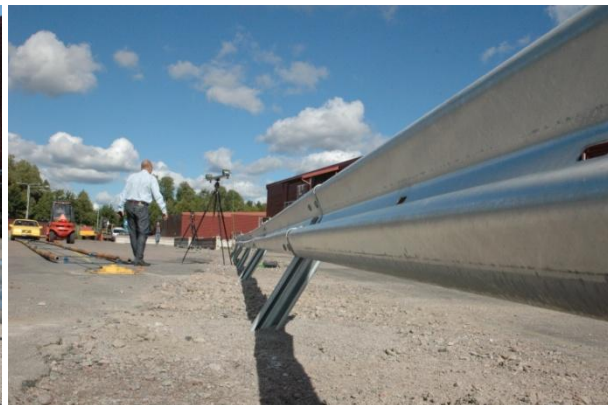
For test five, run on the 13th of September 2012 (2012-09-13), the angle of posts was kept from previous test, 59,2°, but the effective height of the barrier was adjusted downward 50 mm to 450 mm from previous test 500 mm. This resulted in yet another breach of barrier, the cross-member being pushed down by vehicle front a front wheel of vehicle. Speed was 116,5 km/h.

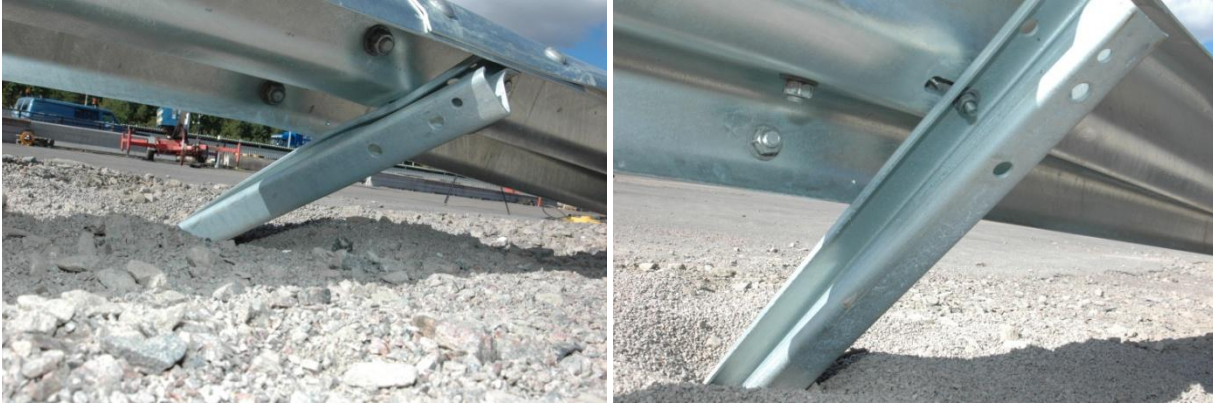
It is obvious that the combination of height and angle once again contributed to that the posts was pressed down towards ground without disconnecting the crossmember from the posts, and essential factor for barrier success. We did as well also note a tear in the W-beam, although not investigated never the less an interesting detail.

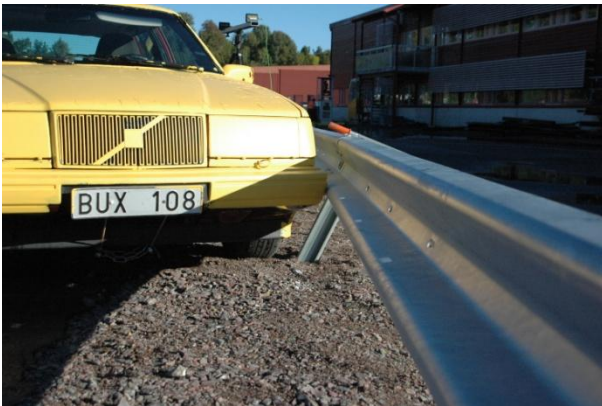
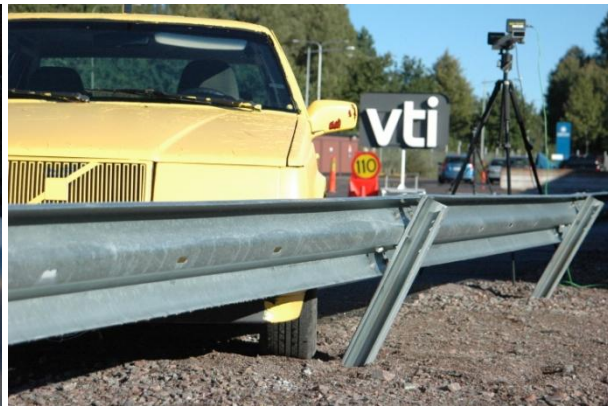
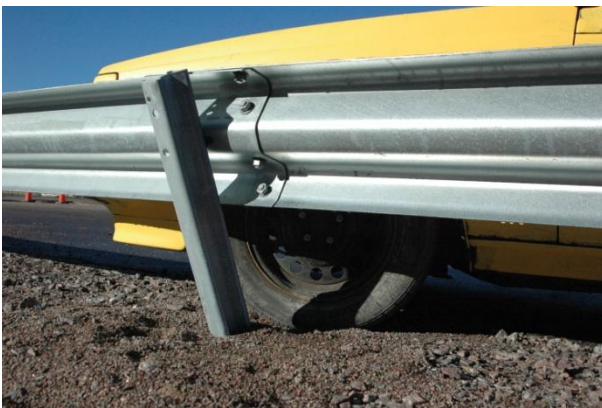
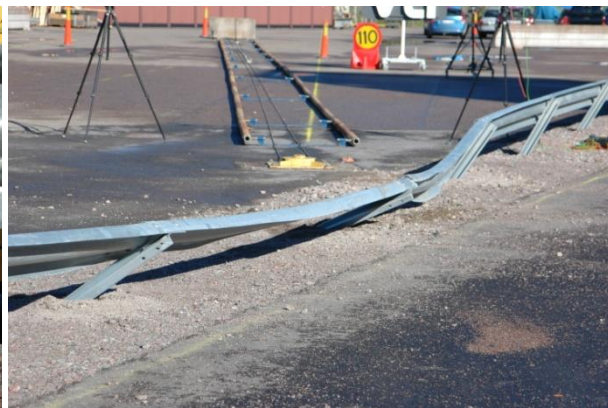
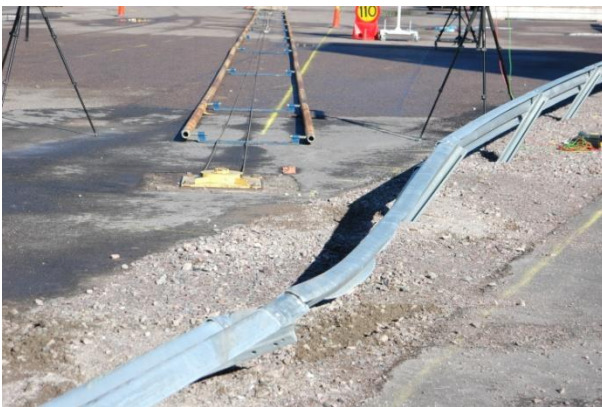
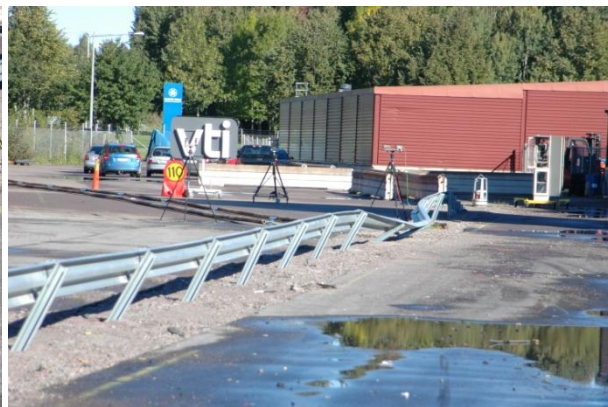
Barrier was too low and too angled, bolts did not shear off, resulting in a breach of barrier. Did see cracks and tear of the cross member.

The test 6 was run on the 24th of September 2012 (2012-09-24—1). For this test the posts was once again raised, this time to 65°. The effective height of (middle line) of barrier was 475 mm. Speed was 113,6 km/h.

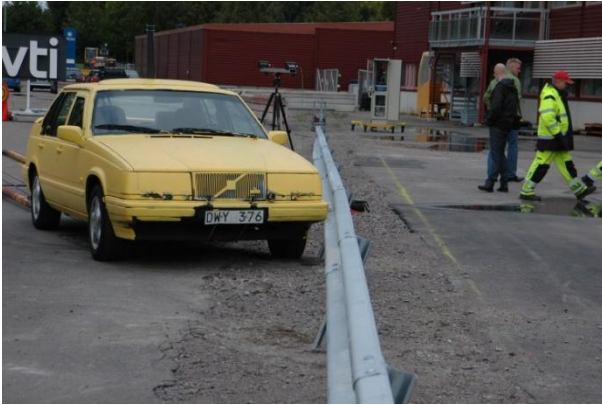
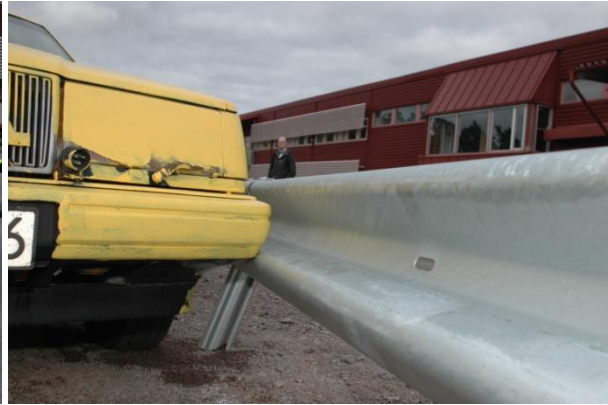
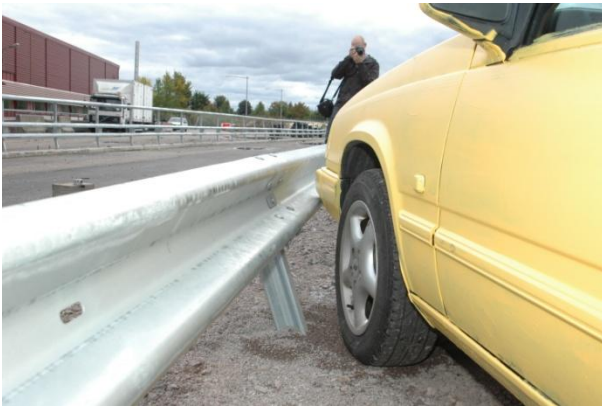
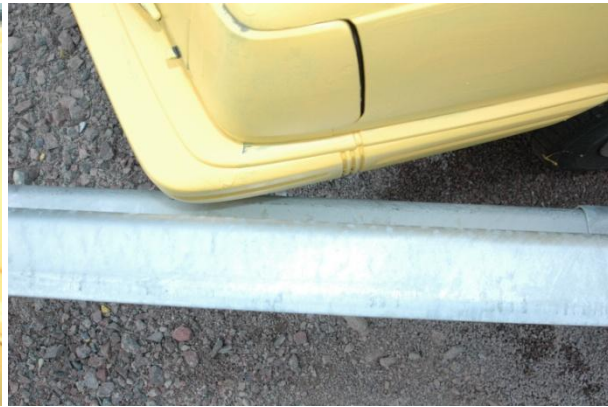
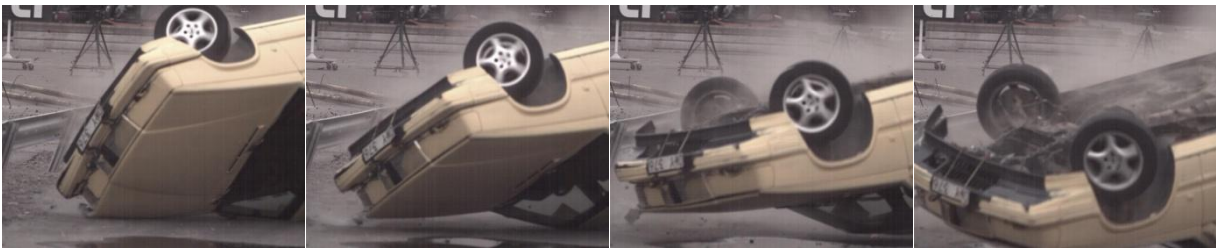
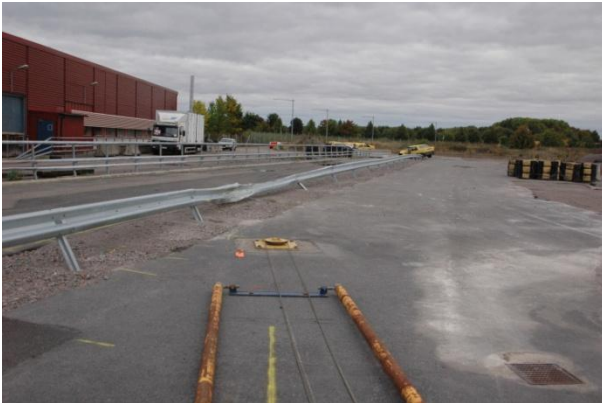
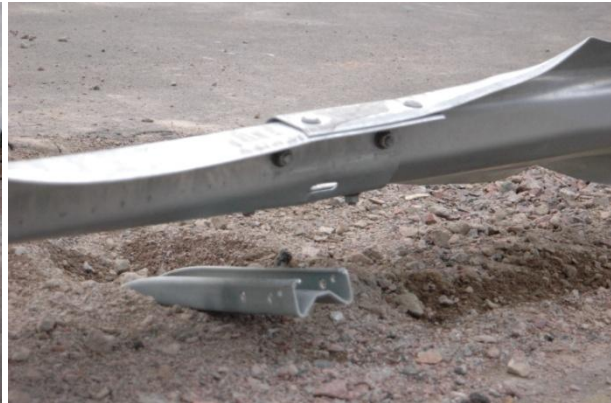
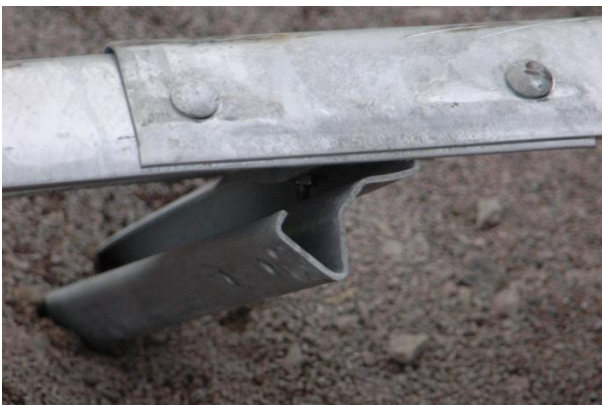
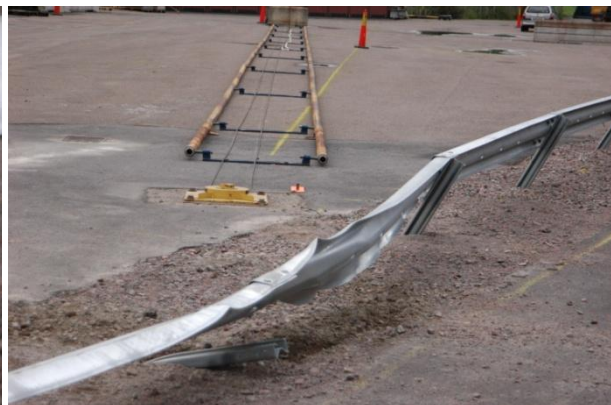
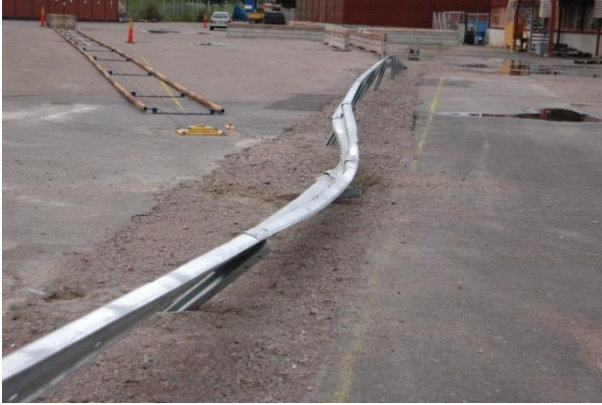
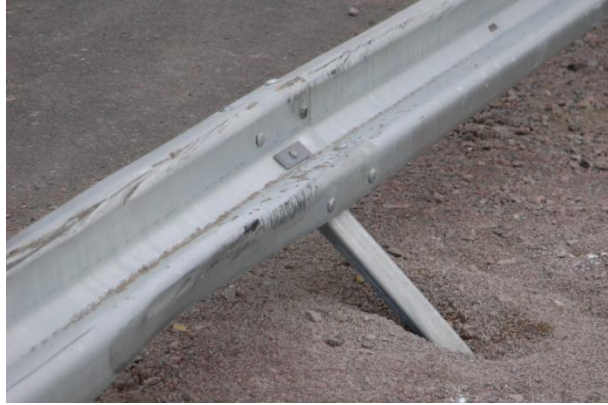
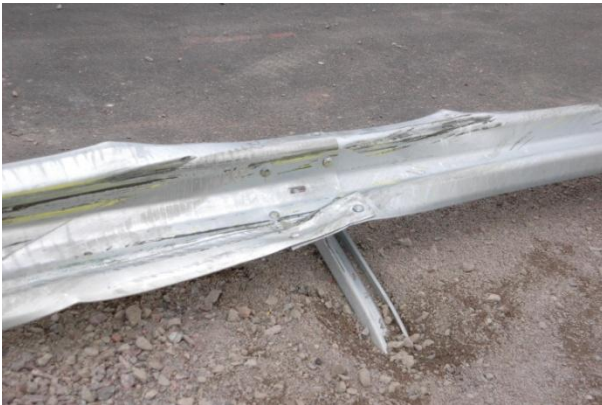
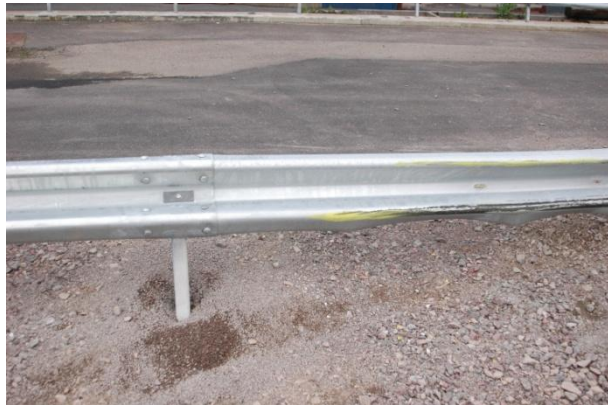
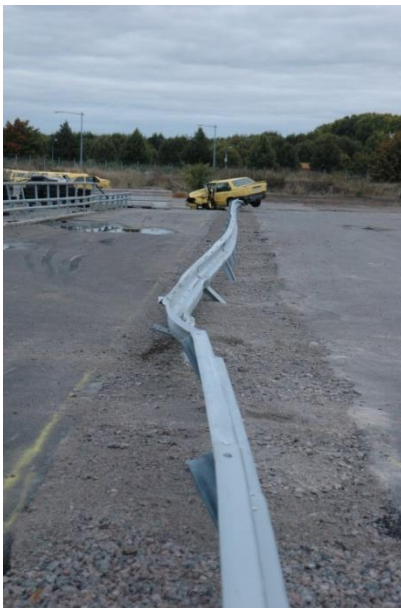
Even for this combination, the vehicle does breach the barrier. One post is sheared off, as it should be, but most of the barrier is once again pressed down under the vehicle front and wheel and does not disconnect properly.

For the seventh test, performed on the 24th of September 2012 (2012-09-24—2), the post was once again raised to a more upright position. This time 72° and with the cross member at 493 mm height. Speed was 113,6 km/h.
