The ageing of safety barriers. Functional limits for safety barriers that deviate from the nominal in height and/or perpendicular position

Issued by: Göran Fredriksson, BARRIER TECH AB

Report number: 1301-1

Ordered by: Hans Holmén, Technical Specialist. Swedish Transport Administration

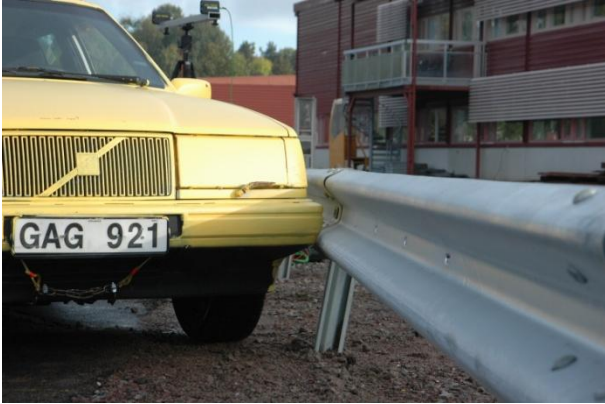
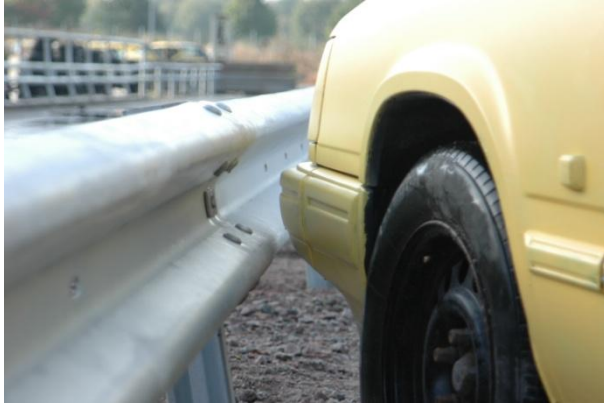
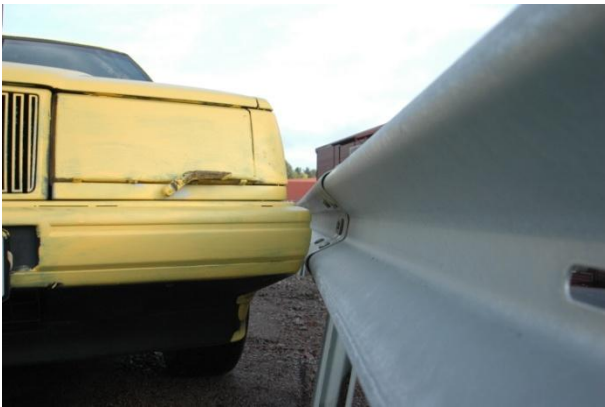
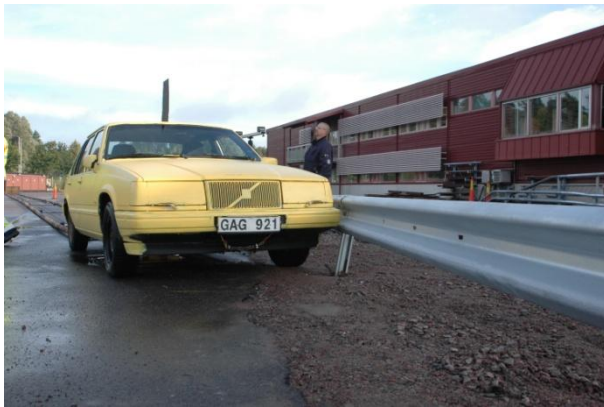
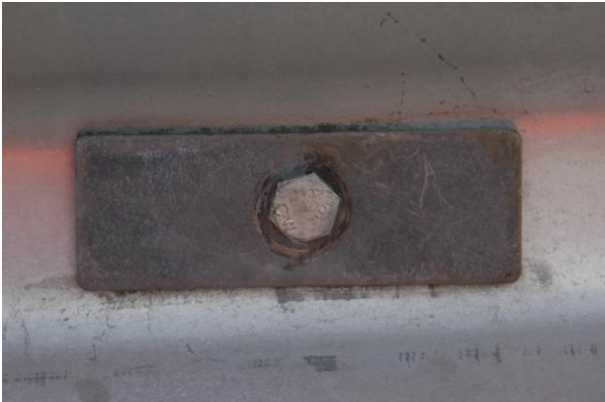
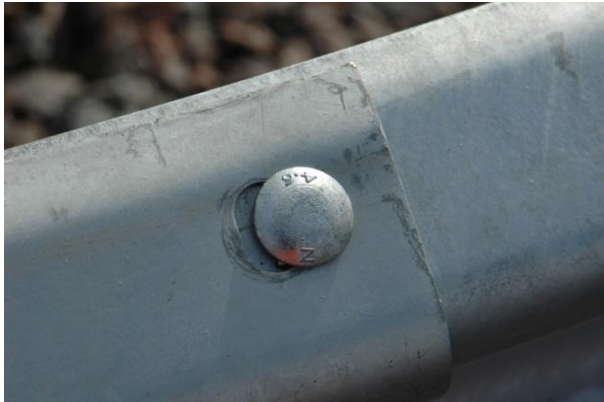
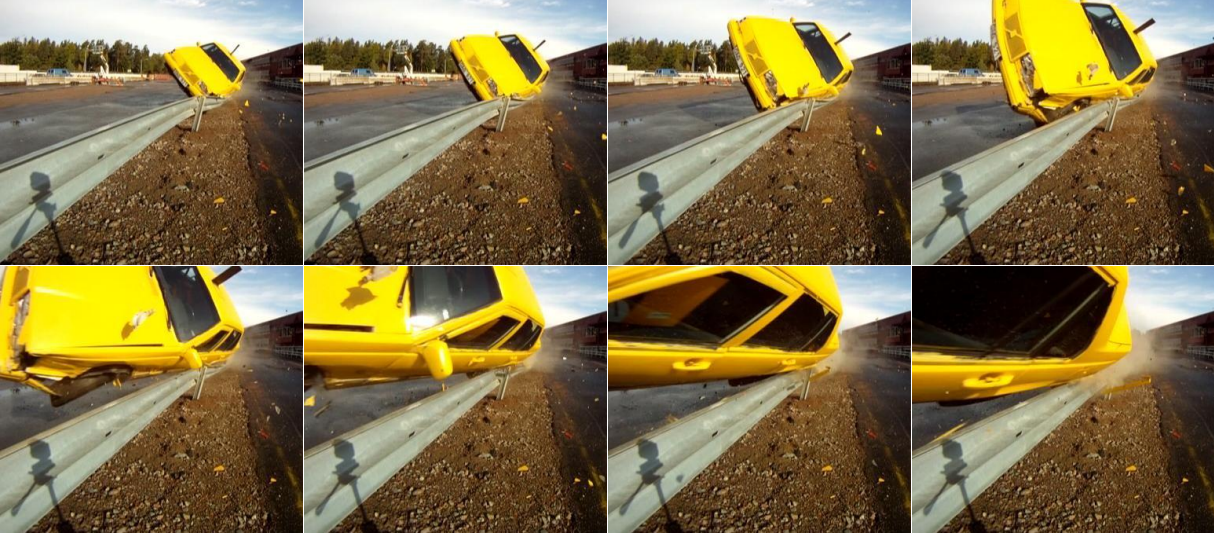
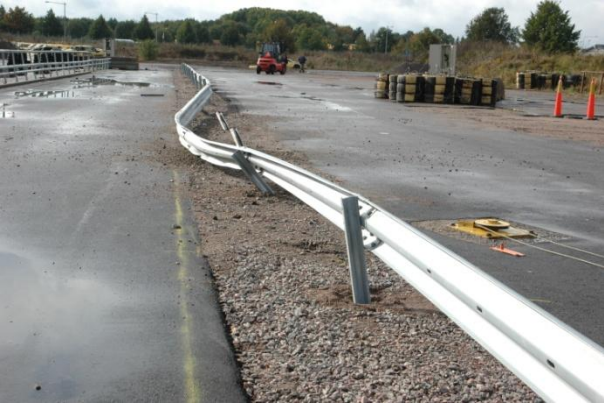
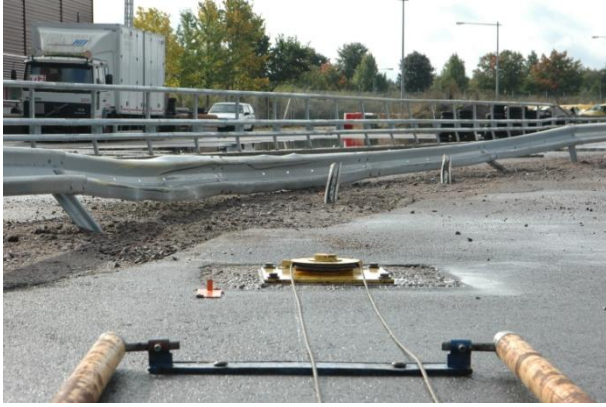
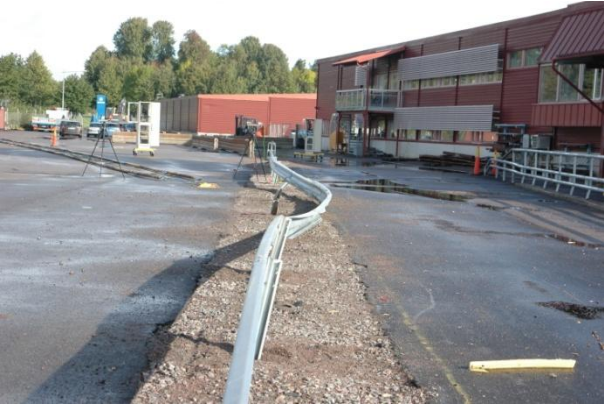
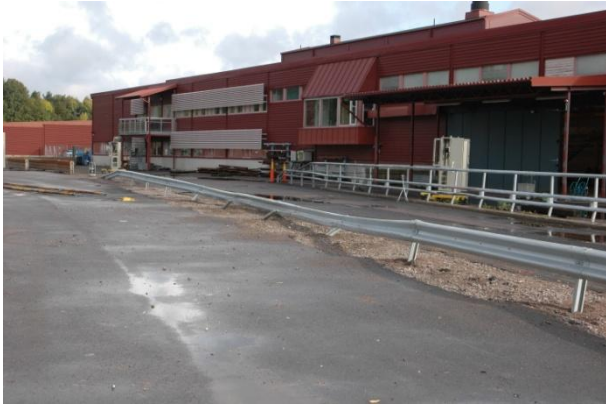
We are almost back to the original number one test, the vehicle is contained but the vehicle roll is substantial. In an approval test according to EN1317-2:2010, this would have been a failure. It seems that already this slight post angle causes some severe rotation of the test vehicle, and some of the posts and screws does not detach as supposed.

Last test, performed on the 26th of September 2012 (2012-09-26), at the speed 112,1 km/h. For this test, the posts were erected slightly more, now to 81°. (90° regarded to be a fully vertical post.) The effective height of the cross member was 503 mm.
