Dependability issues of Track Circuits - A hybrid approach

Emilio Rodríguez, Víctor Simón and Diego Galar

Luleå University of Technology, Division of Operation, Maintenance and Acoustics
University Campus, Porsön, 97187, Luleå, Sweden, telephone: +46(0)920492818
emilio.rodriguez@ltu.se, victor.simon@ltu.se, diego.galar@ltu.se

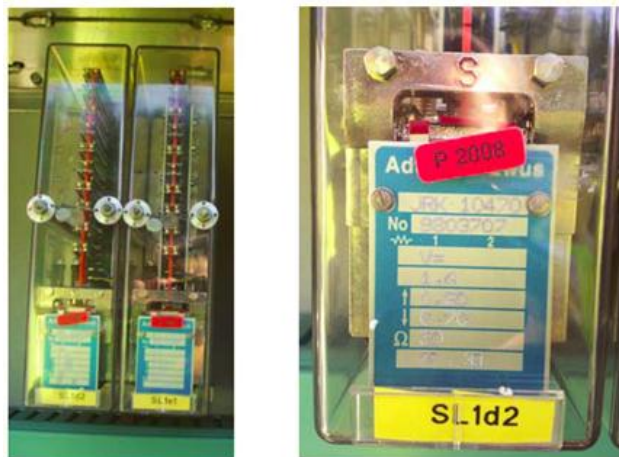
Figure 1. Detail of the most used relay in Sweden, model JRK 10470.

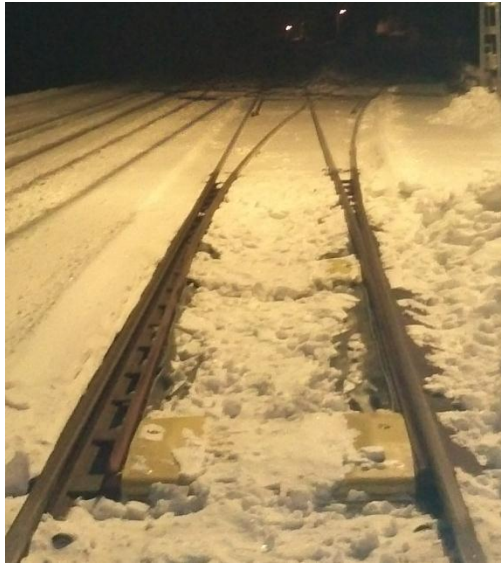
Figure 3. Switch on the track.

- Ballast resistance.
- Grounding of the I-rail, making the voltage drop below 1.7 V DC (voltage state change), even in the absence of a train.
- Rail structure.
- Switches and crossings (figure 3).
- Obstacles on the track.

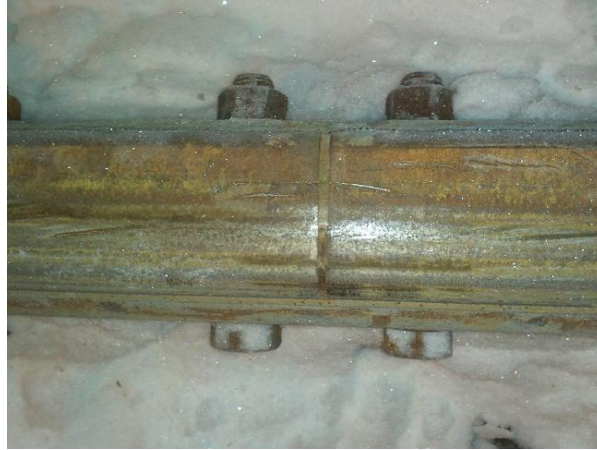
The insulated rail joint (Figure 5) is a simple but important component of the train detection system. It electrically insulates two consecutive rails and acts as a bond between to form a long track distance. The wheels roll over the insulated joint, milling the rail ends; the physical gap between the two rails becomes smaller each time a train passes, and may create an electrical connection. The problem is a wear out one, but the outcome is a signalling fault, as dictated by the fail-safe principle.

Conducting iron-powder-bridges might electrically connect two consecutive track sections. If this is bridged by a metal piece, the voltage in both sections could drop enough to generate an occupied track state on both sections. Magnetic fields make iron particles stick together, building conducting bridges over insulated joints, especially in areas where the traffic is heavy and the wearing of wheels is extreme. Typically this issue does not lead to problems on long distance tracks, but is reported in high volume areas. In such situations, extra maintenance is necessary, as for example, cleaning metallic particles from insulated junctions to avoid short circuits between adjacent I-rail sections.

Figure 5. Insulated rail joint.

Finally, with our model, it was calculated the minimum resistance that ensures the correct insulation, 2 Ohms. That means that every insulation joint with a resistance over 2 Ohms will ensure the correct performance of the track circuits, in terms of insulation between track circuit sections.

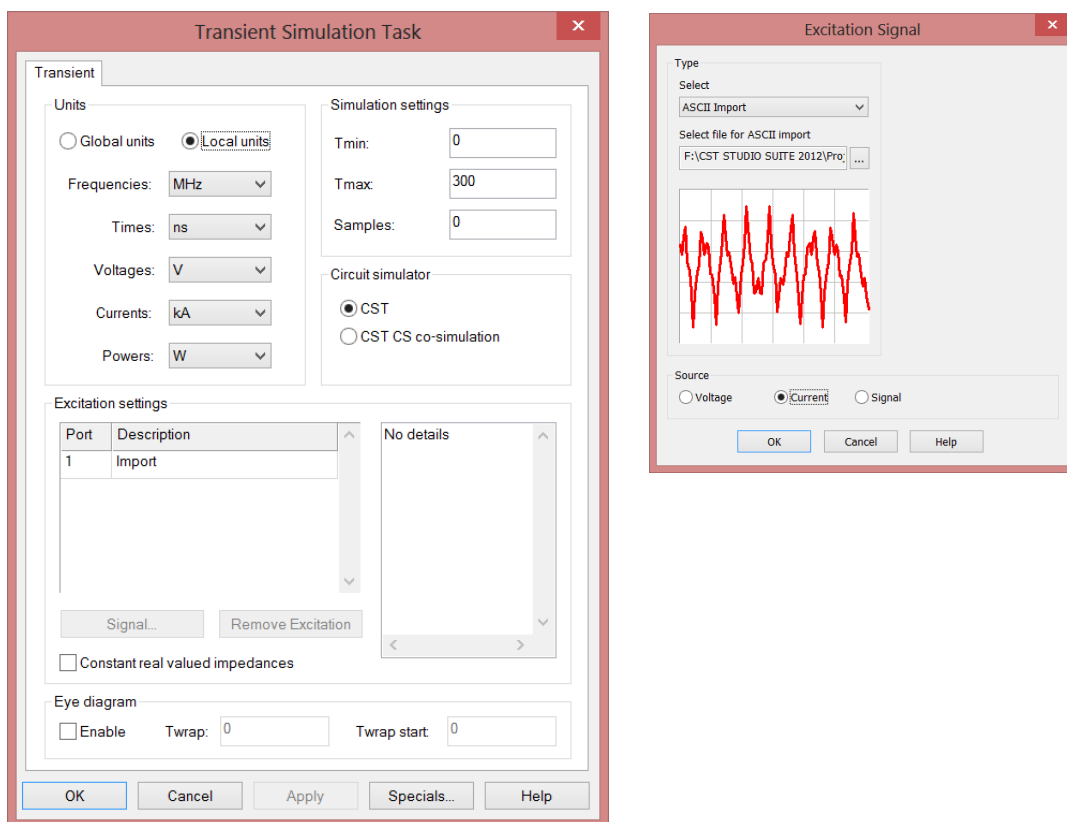
To simulate external interference, for instance by lightning, the resistance between rails should be removed, since the scenario may not need the presence of a train. As electromagnetic interference, lightning can be understood as a 30 kA current entering the railway infrastructure through the grounding impedance during 300 ns. This can be performed using a CST CABLE STUDIO® task called Transient, applied to an external port connected to the rail. To be imported, the lightning characteristics can be made transient in an ASCII (American Standard Code for Information Interchange) file, as shown in Figure 7.

The 3D model of the scenario is like the previous one, but there are two modifications in the schema: R3 is removed and port 1 included.

Figure 7. Introduction of lightning as transient voltage.

The study performed to simulate the lightning showed that this external force does not affect the track circuit system, contrary to what happens in other systems in the railway infrastructure [12].
