## Maintainability in Extreme Seasonal Weather Conditions

M. Palo<sup>1</sup>, H. Schunnesson<sup>1</sup>, P.-O. Larsson-Kråik<sup>2</sup>,  
<sup>1</sup>Luleå University of Technology, Luleå, Sweden; <sup>2</sup> Trafikverket, Luleå, Sweden

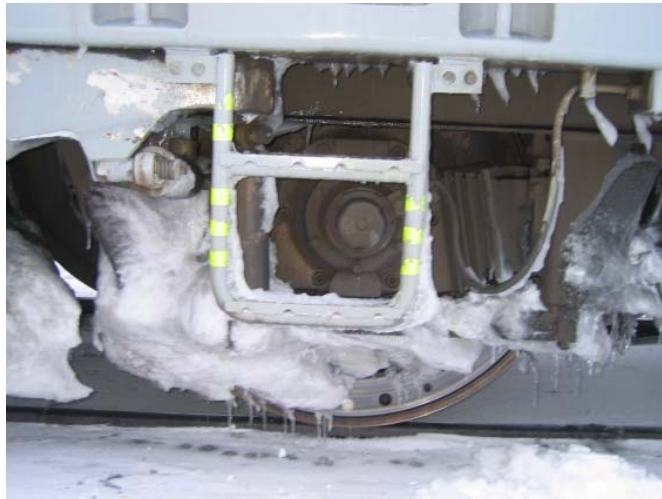
Figure 2. Train wheel covered in snow

Northern Sweden has harsh climatic conditions, with cold snowy winters and extreme temperatures ranging from  $-40^{\circ}\text{C}$  to  $+30^{\circ}\text{C}$  [18]. An example of the extra stresses that ice and snow put on wheels can be seen in Fig. (2). In Sweden, train operators need to carefully plan their maintenance to take environment and weather conditions into account.

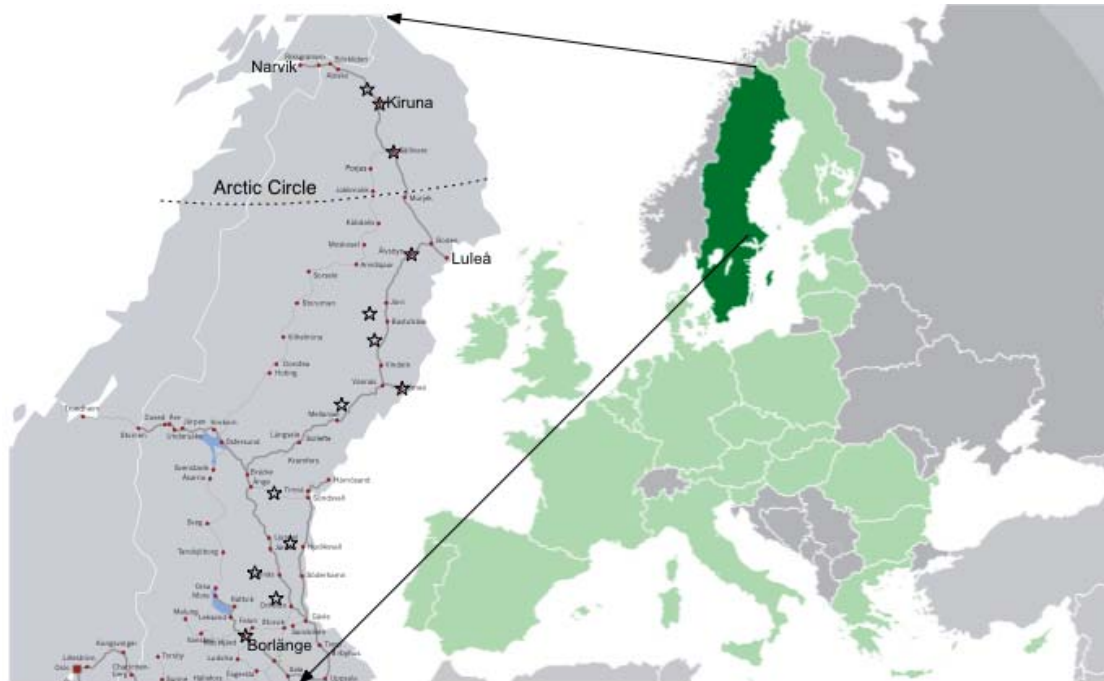
Figure 3. Map of the investigated area, showing the Swedish railroad network with weather stations marked by a star

In Sweden, only two workshops do wheel maintenance, one in Gothenburg and the other in Luleå. In this paper, only data from the northern workshop in Luleå are used (Fig. 3). The majority of wheel maintenance at the workshop in Luleå is done on iron ore wagons and steel shuttle wagons; there is also a wheel pool to service trains transporting goods and passenger trains.

In the investigated area (Fig. 3), there are large differences in climate and temperature. In the northern part of the region, the cold normally arrives earlier and stays longer. The study uses average values for daily temperature and humidity, tracking data from 13 different weather stations along the track, see Fig. (3) and Table (3).

The steel train from Borlänge passes weather stations 1 through 10; the iron ore train passes stations 11 to 13 (Fig. 3 and Table 1).

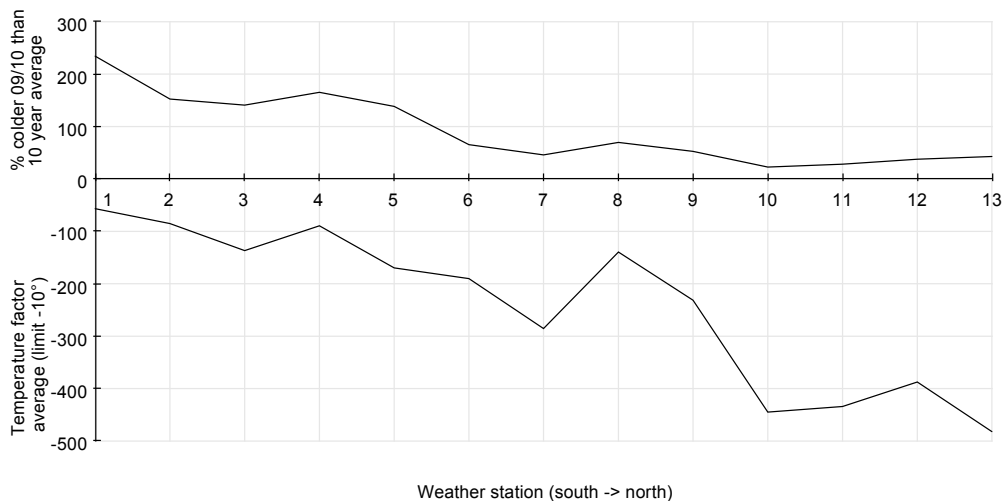
Figure 5. Temperature factor for 2009-10 at -10°C and difference to average

As noted, the winter of 2009-10 was generally cold in Scandinavia, but there were some variations in different parts of the studied railway line. Fig. (5) shows the average temperature factor for the 13 stations (south to north). The top graph shows the difference between 2009-10 temperatures and the average values. The temperature along the entire track was colder than normal. However, in the north where the iron ore train operates, it was only slightly colder than normal, while in parts of the south, it was over 200% colder than normal, as defined by the temperature factor. This large deviation from normal temperatures is likely to influence wheel maintenance and affect the number of wheels that require re-profiling.

The winter of 2009-10 was colder than normal in Sweden, and the whole country was covered in snow for longer than usual. However, the temperature deviation in the investigated geographical areas varied significantly. Compared to the average temperatures, there were many more cold days in the south than in the north, as shown in Fig. (4,5).
