**Title: FUNCTIONAL LIMITS OF THE W-BEAM GUARDRAIL**

Authors: Göran Fredriksson,  
Swedish Safety Barrier Association  
Box 3010  
720 03 Västerås  
Sweden

Hans G Holmén  
Swedish Transport Administration  
Röda vägen 1  
781 89 Borlänge  
Sweden

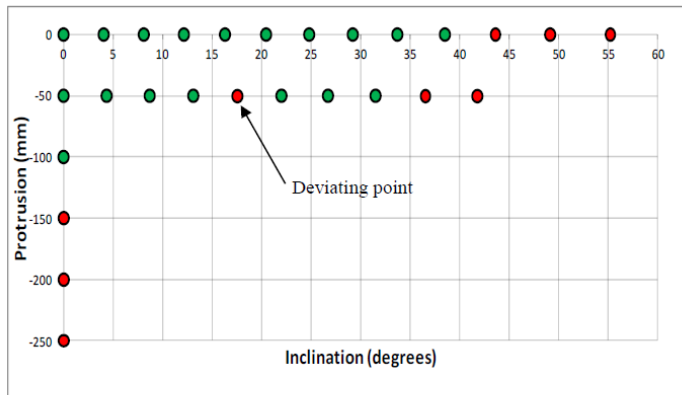
Simulation points and their outcome as pass (green) or fail (red) are presented in figure 3:

Figure 3. Parameter study results

The results from the simulations showed that a guardrail mounted too low, but perpendicular, ceased to contain the vehicle at a height of 450 to 400 mm which is a 100 to 150 mm lower than nominal.

Further simulations of an inclined guardrail indicated that when the barrier approached a 40° angle, the limit for pass criteria was exceeded. However, when inclination and low position was combined in the simulations, it was not that clear where the critical position was. A deviating point appeared among the “pass-points” and it was uncertain why this occurred, but it indicates that the guardrail behavior is not robust in the sense that it is at, or close to, the limit where it cannot anymore reliably uphold its function.

The next task for the project team was to create a Design-Of-Experiments (DOE) for the subsequent physical tests. The DOE was created based on the experience gained from the simulations, i.e. the parameter study. The strategy was to determine the x and y axes of the “Decrease in post protrusion” vs. “Inclination” diagram with a minimum amount of physical tests. Optimally, only four tests would be needed to determine the x and y axes with reasonable accuracy leaving the remaining tests to the, what it seemed, more complicated case with combined “Decreased protrusion” and “Inclination”. Experience from the simulations showed that the x and y axes would be rather straight forward to determine, i.e. we needed one green “pass” point and one red “fail” point on each axis of the diagram. The simulation results for the combined cases were more difficult to interpret. There was one deviating “red” point among the green points, see figure 3 above, indicating sensitivity in the guardrails behaviour.

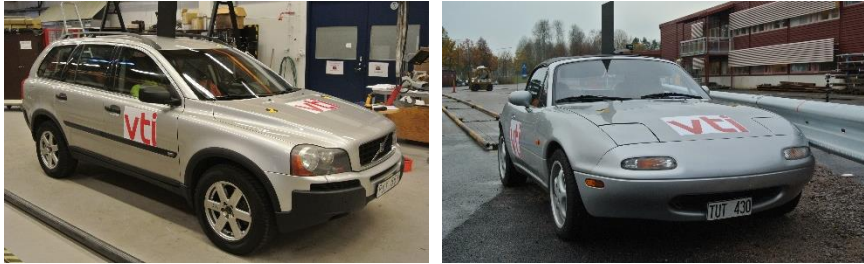
Figure 5. Volvo XC90 and Mazda MX-5 as used in the full scale tests.

impact was more of a challenge here, as there is no suitable computer model of the XC90 publicly available. Instead the simulation team had to use a modified computer model from Ford explorer. Depending on the outcome (fail at height 550 mm was assumed) the next step would be to raise the barrier approx. 100 mm to 650 mm. With this increase “pass” is expected for the XC90 and if so, what will happen if a small sports car hits a barrier of that height? The choice of sports car fell on one of the most common models in the world, Mazda MX-5 “Miata” and again the simulation team noted that no computer model was available, see figure 5 with photos of the tested car models.

The Volvo XC 90 used in the physical test was substituted for a Ford Explorer and the Mazda MX-5 for a Suzuki Swift in the simulations. The cars are similar in terms of dimensions, but are of course not identical. The structural composition of the cars used may also differ but this has not been addressed [13].

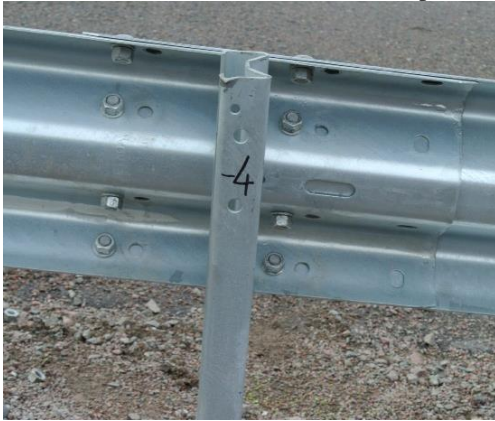
Figure 10. New holes made in one of the overlap joints to compensate for the gradual stretching of the guardrail.

It is important for the following to bear in mind that some parts of the guardrail used in the tests are still the original 76 m from the first test run and that the sloped 12 m anchored terminals remained the same during all the consecutive test runs. After each test the guardrail was inspected and all damaged parts were exchanged. This meant that the parts of the guardrail that remained was gradually stretched out, especially at the anchor points, due to the load of the impacts. Compared to a common guardrail found along any road the tested can most certainly be said to be more rigid in the sense that it has been pre-stretched, especially for the later tests. Figure 10 below show how this had to be compensated at one of the joints after a number of test collisions.
