# FE Analyses of Corrosion-Damaged RC Beams Strengthened with FRP Components

Master's Thesis in Structural Engineering

Omar Darwish and Akash Roshan

Department of Architecture and Civil Engineering  
CHALMERS UNIVERSITY OF TECHNOLOGY  
Master's Thesis ACEx30  
Gothenburg, Sweden 2022

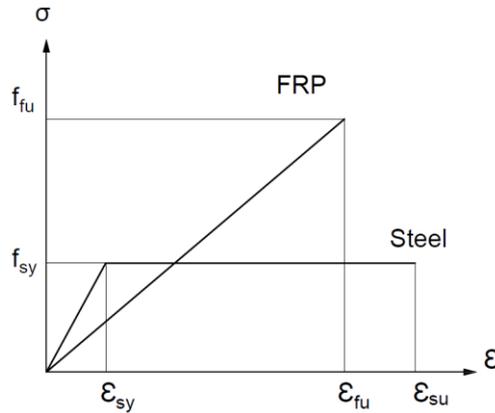
Figure 1: A comparison of stress-strain relationship between steel and FRP, redrawn from [6].

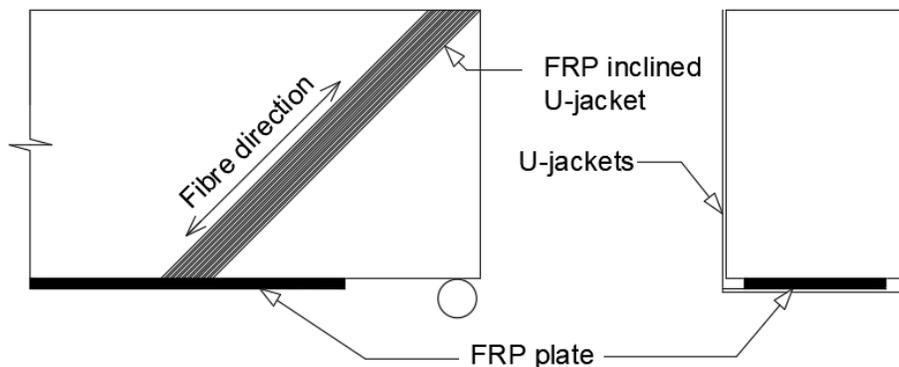
Figure 2: The orientation of the inclined U-jackets at the supports, redrawn from [15].

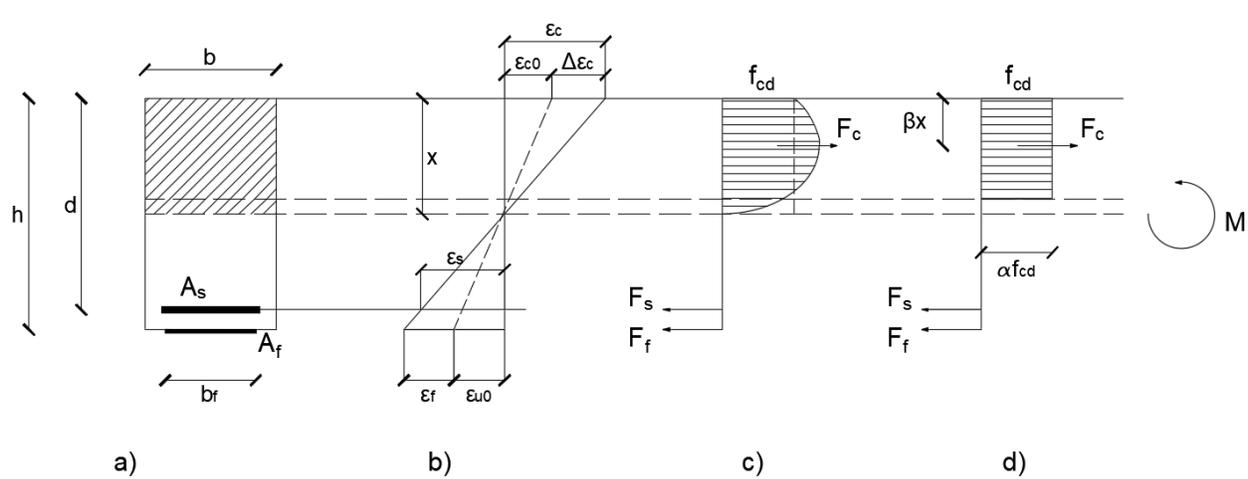
Figure 3 shows the stress and strain distribution over the cross-section of a reinforced concrete beam strengthened with FRP sheets on the bottom surface of the beam. In Figure 3b, the dotted line represents the strain distributions before strengthening and when the beam is loaded in the serviceability limit, where  $(\epsilon_{co})$  is the compressive strain and  $(\epsilon_{uo})$  is the tensile strain on the top and bottom surface of concrete respectively. The solid line in Figure 3b represents the strain distributions after strengthening and when the beam is loaded to the ultimate limit state, where  $(\Delta\epsilon_c)$  is the additional compressive strain in concrete. On the tensile surface of the beam, it can be observed that there is an increase in strain  $(\epsilon_f)$  in the section after the addition of FRP in the ultimate limit state. Also, the neutral axis is slightly shifted downwards. At stage III, there is full utilization of the constituent materials, and a stress block is developed as shown in Figure 3c. This can be simplified as shown in Figure 3d for design calculations and sectional analysis [6].

Figure 3: Stress distribution over a concrete section before and after strengthening redrawn from [6].

where  $A_s$  is reinforcement area,  $f_y$  is the yield strength of the reinforcement,  $\varepsilon_{fu}$  is rupture strain and  $E_f$  is Elastic modulus of FRP whereas  $d, h$  are presented in Figure 3. The area of FRP needed for the design moment capacity is found by rearranging Equation 2.1.

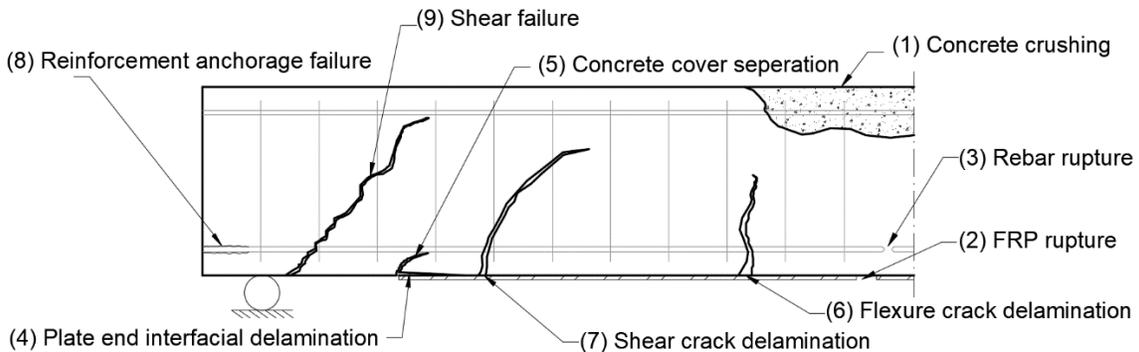
Flexural, shear, or anchorage failure are the main failure modes for FRP strengthened RC beams. They can occur depending on if composite action between concrete and FRP or between concrete and reinforcement is maintained. The types of flexural failure when concrete-FRP and concrete-reinforcement composite action is maintained are: (1) Concrete crushing, (2) FRP rupture (3) Rebar rupture. If not, other types of failure can occur at the end or at the mid-span in terms of debonding of FRP laminates, separation of concrete due to cracking or anchorage failure [17]. They can be further categorised as follows: (4) Plate end interfacial delamination (5) Concrete cover separation (6) Flexure crack delamination (7) Shear crack delamination (8) Anchorage failure of main reinforcement. When the section does not have sufficient shear capacity the beam fails due to (9) Shear failure. The possible failure modes are illustrated in Figure 4.

Figure 4: Different failure modes of FRP strengthened RC beams redrawn from [18].

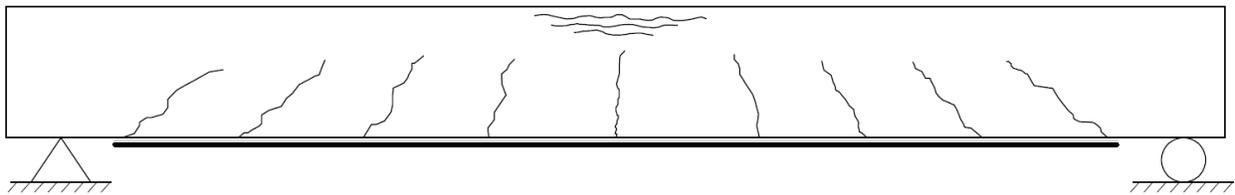
The strength of RC beams is highly dependent on the reinforcement ratio whilst varying this will result in a different failure mode. A heavily reinforced beam will usually fail due to concrete crushing in the compressive zone as shown in Figure 5, whereas this failure mode is unlikely when the beam is lightly reinforced. In addition, heavily reinforced beams will show a decrease in the utilization of the tensile capacity of FRP [19]. Similarly, over-strengthening with FRP will also lead to concrete crushing. This kind of failure should be avoided to prevent brittle behaviour of the beam.

Figure 5: Failure due to concrete crushing redrawn from [19].

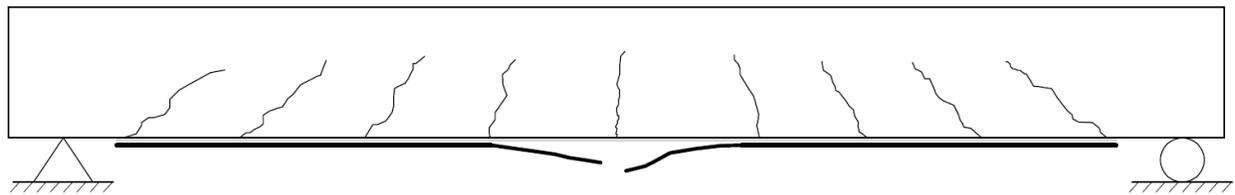
This type of failure occurs when the rupture strain of FRP is exceeded, see Figure 6. The thickness of FRP is an important parameter to be considered as increasing the thickness may switch the failure mode from FRP rupture to any other failure modes [20].

Figure 6: Failure due to FRP rupture redrawn from [19].

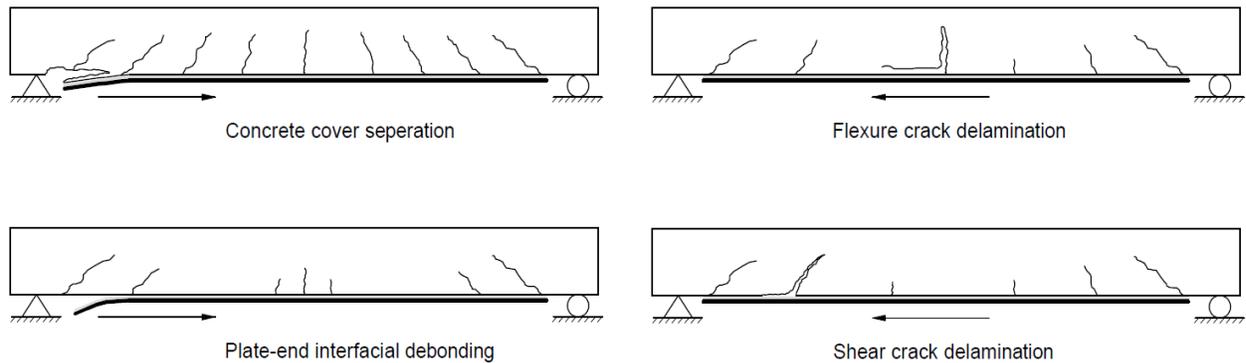
Failure that occurs when the FRP gets delaminated from the beam is known as failure due to debonding of FRP. This failure mode can be further classified into two types based on the location along the beam: 1) End debonding 2) Mid-span debonding. The end debonding originates closer to the end of the laminate and then progresses along the tensile reinforcement or near the bond line between FRP and concrete. As a result, two failure modes can take place, plate-end interfacial debonding or concrete cover separation at the end of FRP plate, respectively [19], see Figure 7. The mid-span debonding failure can occur because of flexural cracking (flexure crack delamination) or inclined flexural-shear cracking (shear crack delamination) which progresses towards the ends parallel to the concrete/adhesive interface. Flexural crack delamination is likely to occur when the beam is lightly reinforced in the presence of large flexural cracks. It is also likely to occur when the beam is notched, or when corrosion pits are observed on the tensile reinforcement. Although, shear crack delamination is more critical as the failure is very brittle [18].

Figure 7: FRP debonding failures redrawn from [19].

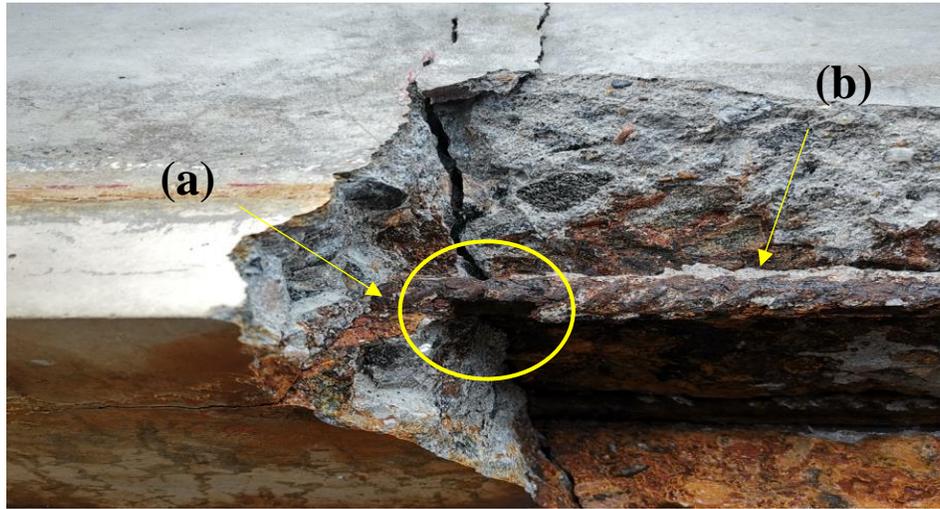
Figure 8: (a) Pitting corrosion. (b) General corrosion.

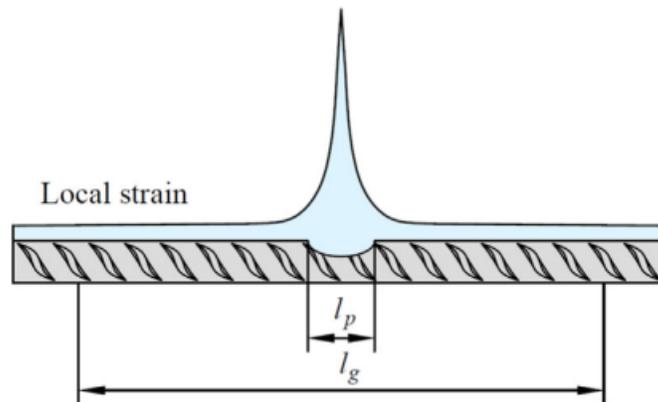
Figure 9: Local strain concentration in the position of the pits. Figure from [5], with permission.

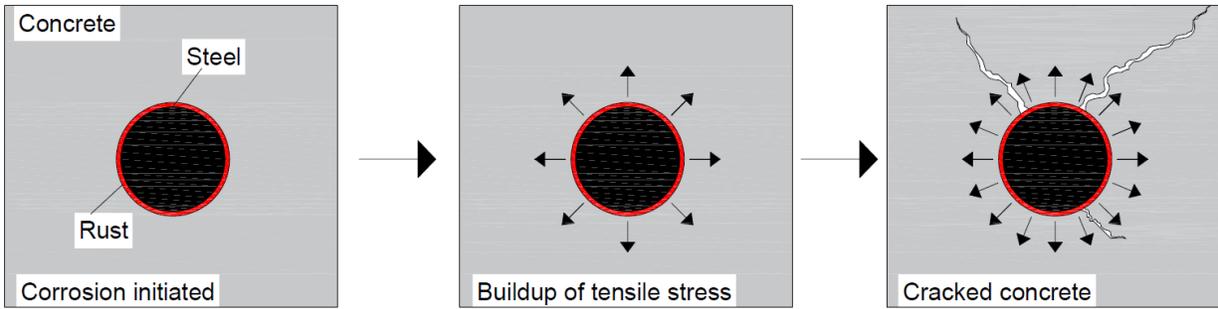
Figure 10: Stages of corrosion-induced cracking redrawn from [25].

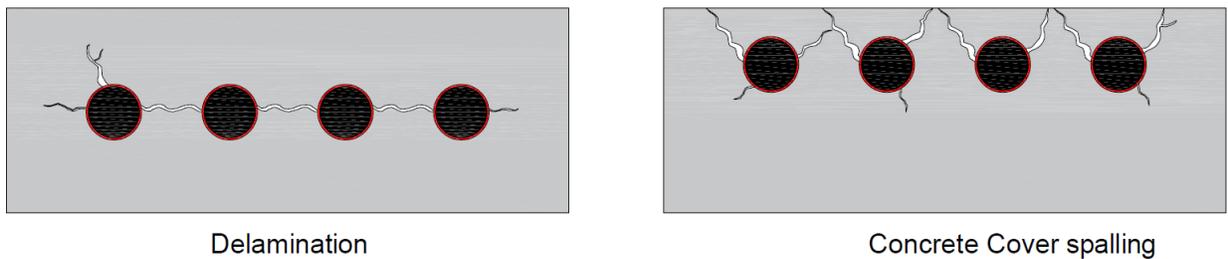
Figure 11: Cracking pattern based on concrete cover depth and rebar spacing redrawn from [25].

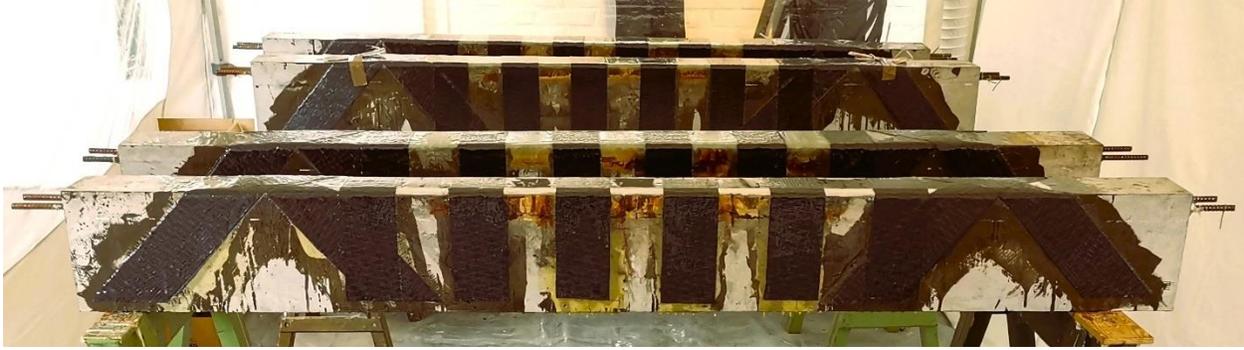
Different FRP components have been implemented or used to repair concrete structures, such as FRP plate laminate, vertical and inclined U-jackets, or a combination of them, see Figure 12. From the results of an experimental study [37], beams strengthened with single continuous FRP sheet along the length between supports showed lowering of ultimate load and deformation capacity compared to the beam strengthened with two smaller segments of FRP sheets nearer to the supports. Thus, an extra addition of FRP sheets in some cases can result in worsening of the flexural performance of the beam. Change of the dimension, amount, and arrangement of FRP could possibly influence the flexural response of RC beams. Several research have investigated the influence of different FRP components on deteriorated RC structures [8], [36], [38], [39], and their results are summarized.

Figure 12: Combination of different FRP components from [8], with permission.

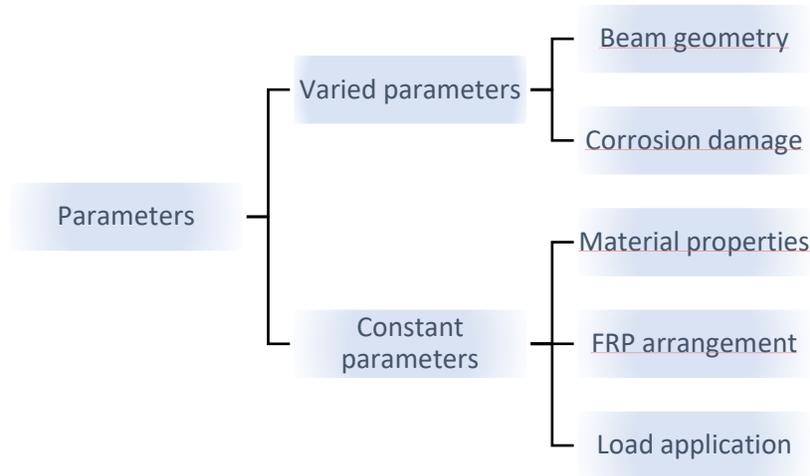
Two different beam geometries were chosen to be analyzed based on the qualitative assessment of the influencing parameters presented in section 3.1. Some of the parameters were assigned constant values whereas some of them were chosen to be varied for the two different beam geometries, see Figure 13.

Figure 13: Flowchart showing the choice of parameters.

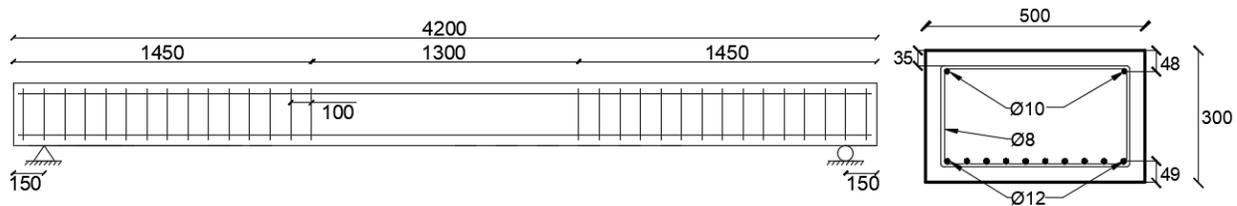
Figure 15: Beam geometry for Case B.

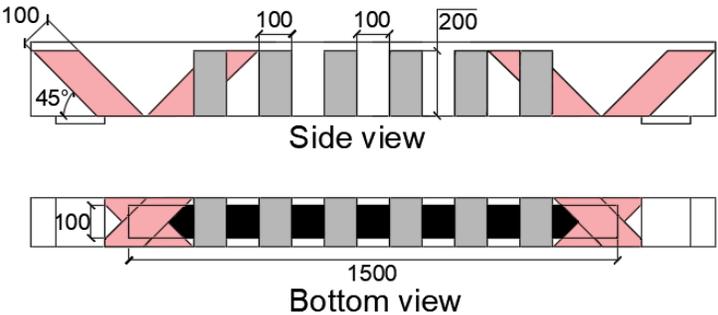
Three FRP components were attached externally to the RC beams in the following order: i) FRP plate laminate, ii) Inclined U-jackets, iii) Vertical U-jackets. The FRP plate with different dimensions depending on the beam geometry was connected to the beam soffit. Vertical U-jackets were made up of a single layer, whereas the inclined U-jackets consist of a triple layer of FRP. The inclined U-jackets have an inclination of  $45^{\circ}$  and have two sheets crossing each other near the supports. The arrangement of all FRP components for the cases A and B are illustrated in Figure 16 and 17.

Figure 16: FRP arrangement for Case A.

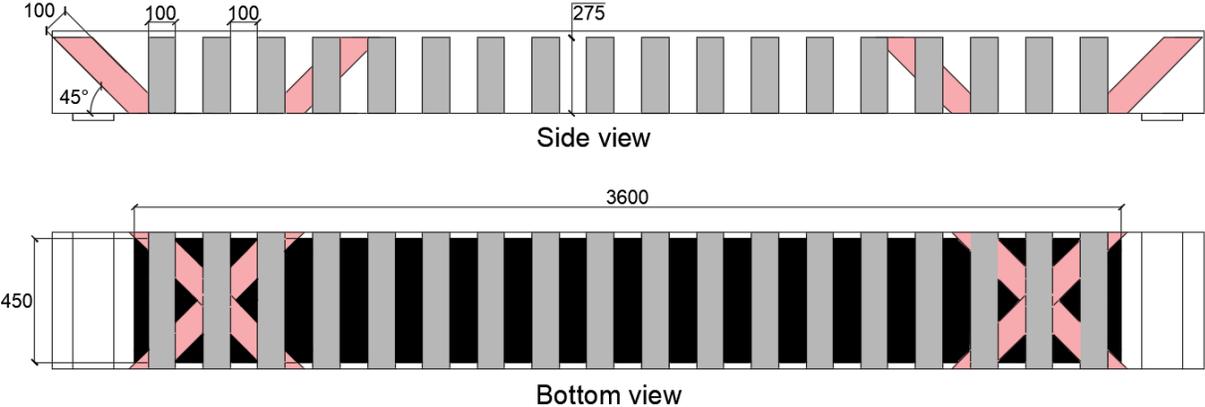
Figure 17: FRP arrangement for Case B.

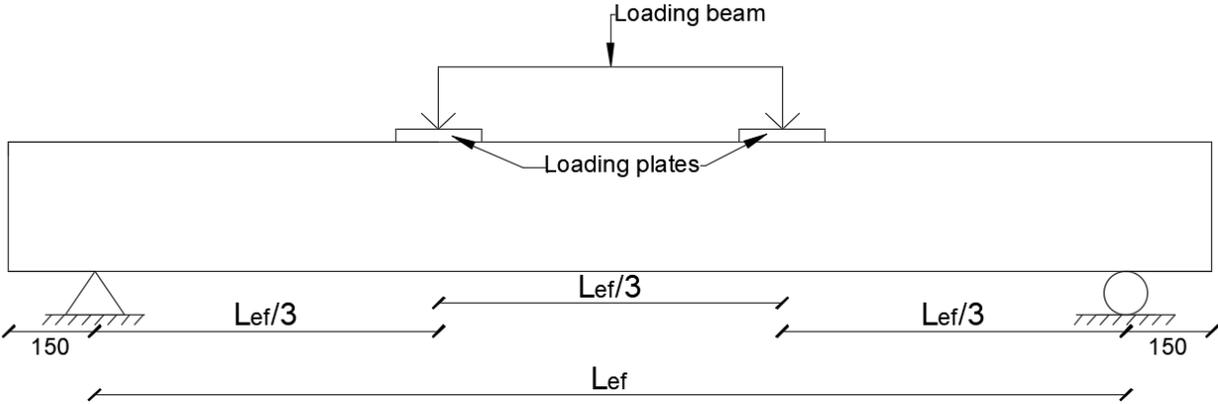
The beams in the analyses were subjected to four-point bending, increasing the load until failure. The load was applied in terms of deformation-controlled loading at the centre of a loading beam which transfers the load to the beam via loading plates. Loading plates are used to avoid stress concentration on the concrete beams [12]. An illustration of loading is presented in Figure 22.

Figure 22: Four-point bending of the corroded RC beam.

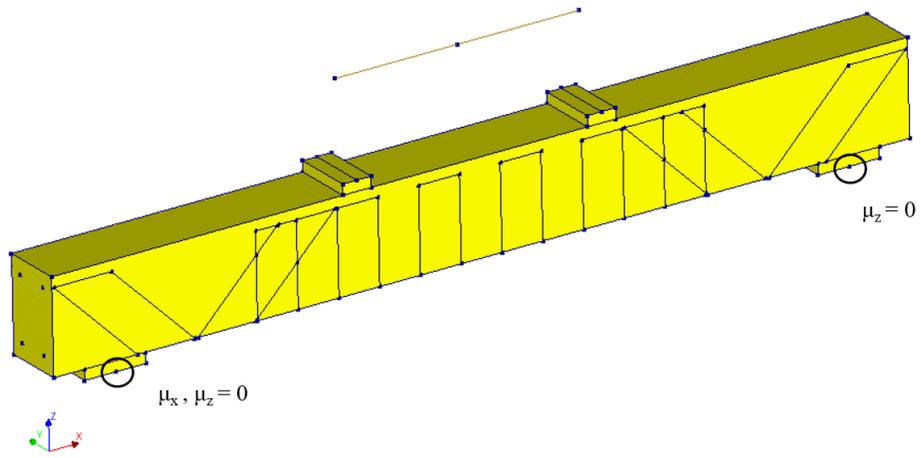
The complete beam geometry was modelled for Case A and the centre nodes of the support plates were restrained in Y direction as shown in Figure 23. As the beam geometry for Case B was considerably larger, a symmetry line along the beam running through the centre of the cross section was used in order to save computational time. This was carried out by restraining the faces and nodes passing through the symmetry line in Y direction as shown in Figure 24.

Figure 23: Beam geometry with support conditions modelled for Case A.

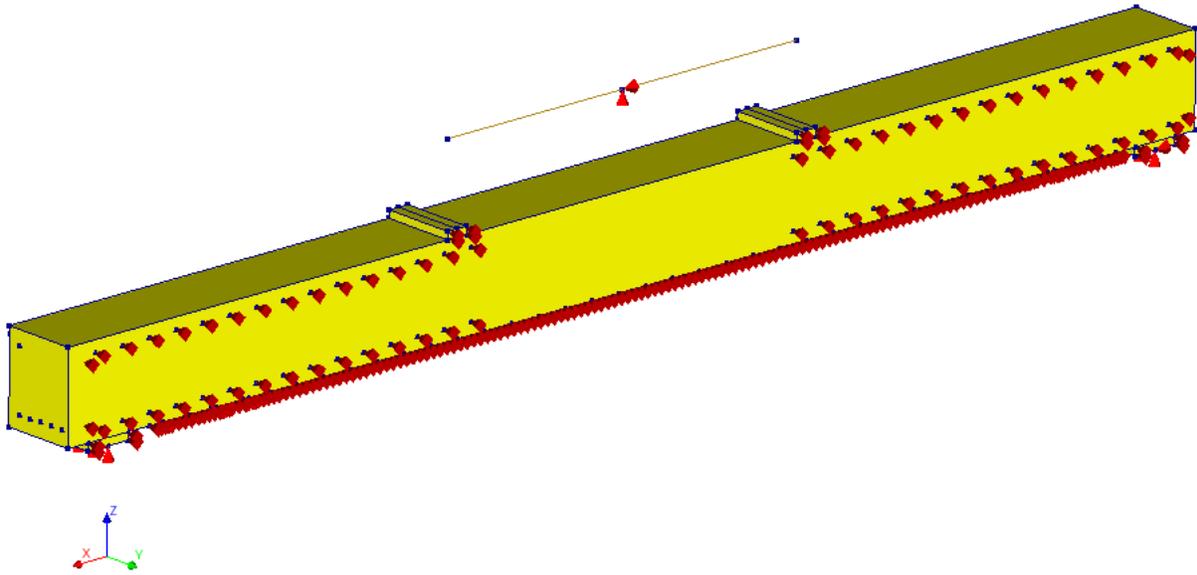
Figure 24: Beam geometry with support conditions and symmetry modelled for Case B.

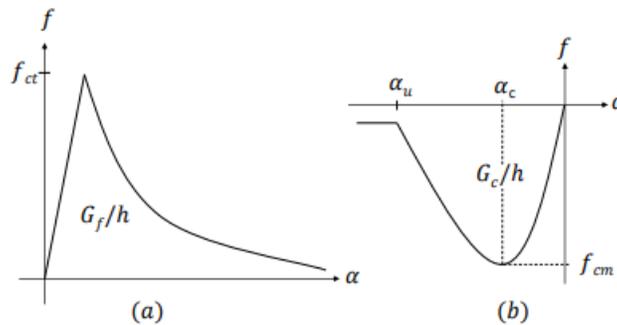
Both tensile and compressive curves for the concrete were estimated based on the respective fracture energy. The tensile curve for concrete given by Hordijk [46] is shown in Figure 25(a). The compressive curve was presented by Feenstra [47] as illustrated in Figure 25(b).

Figure 25: (a) The tensile curve by Hordijk (b) The parabolic compression curve by Feenstra. [12] with permission.

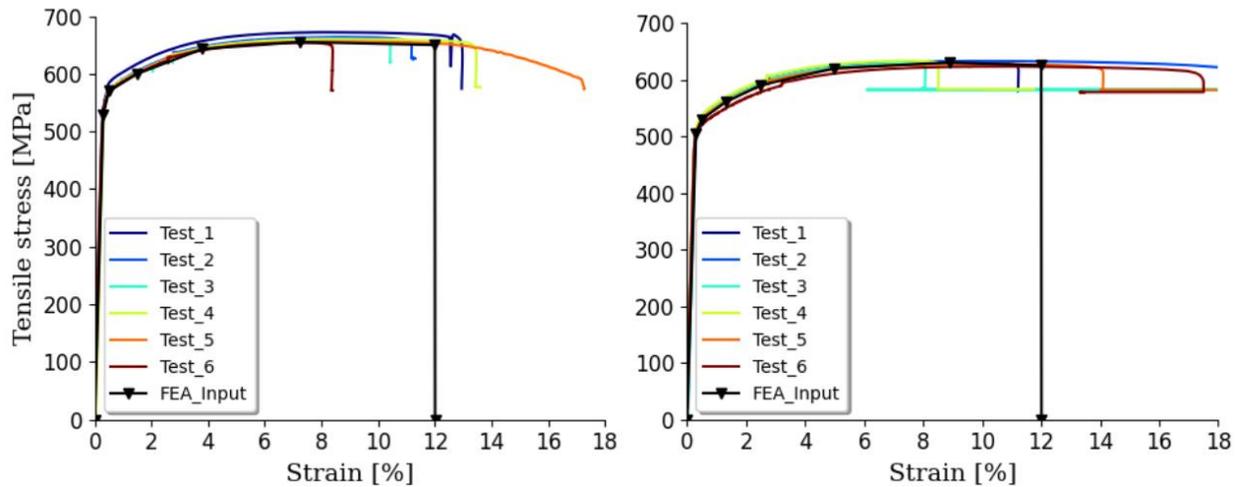
To assign material properties for the reinforcement bars, the tensile stress-strain relationship as shown in Figure 26 was used as input for the FE analysis. Standard tensile tests were carried out by Yang [8] and the test results have been used to obtain the stress-strain properties for steel reinforcement. Six tensile tests were conducted for both the top and bottom rebars and a suitable fitting curve corresponding to the average results from the tests by Franklin and Gotame [12] was chosen as the input for the NLFEA. The reinforcement properties for the tensile and compressive bars along with the stirrups are presented in Appendix A.

Figure 26: Tensile stress-strain relationship for tensile bars (left) and compressive bars (right) [12], with permission.

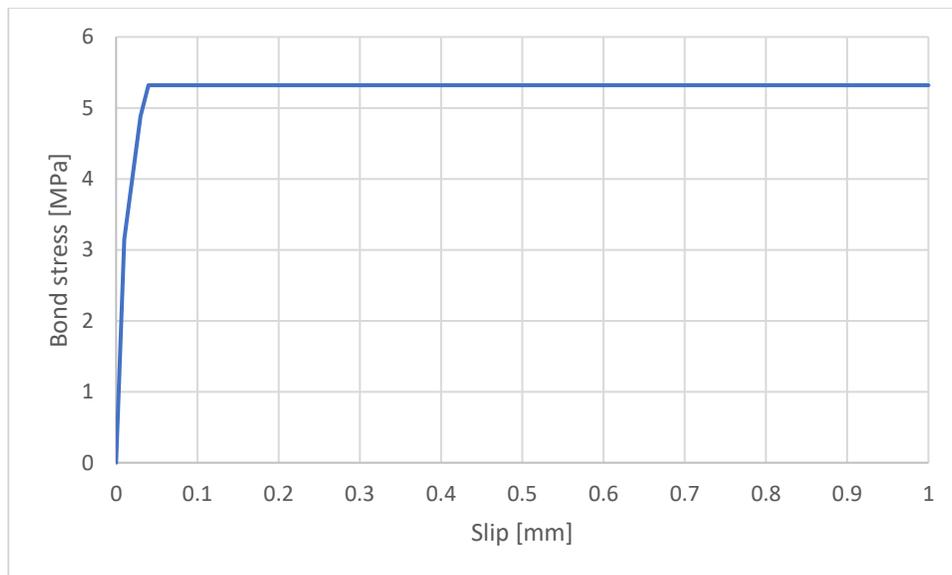
The interaction between concrete and corroded reinforcement was modelled according to the ARC- model [42]. The effect of corrosion level was considered, and corresponding bond stress-slip relationship was obtained from the ARC-model and applied into modelling. Material data for rebars and concrete, rebar geometry and corrosion level were input to the ARC model. Furthermore, a good bond condition was assumed. The inputs for Case A and Case B were different which led to different bond stress-slip relationships, as shown in Figure 27 and 28. It can be noted that the corrosion level was large enough such that only the residual branch in the bond stress-slip relationship remained.

Figure 27: Bond stress-slip relationship for Case A.

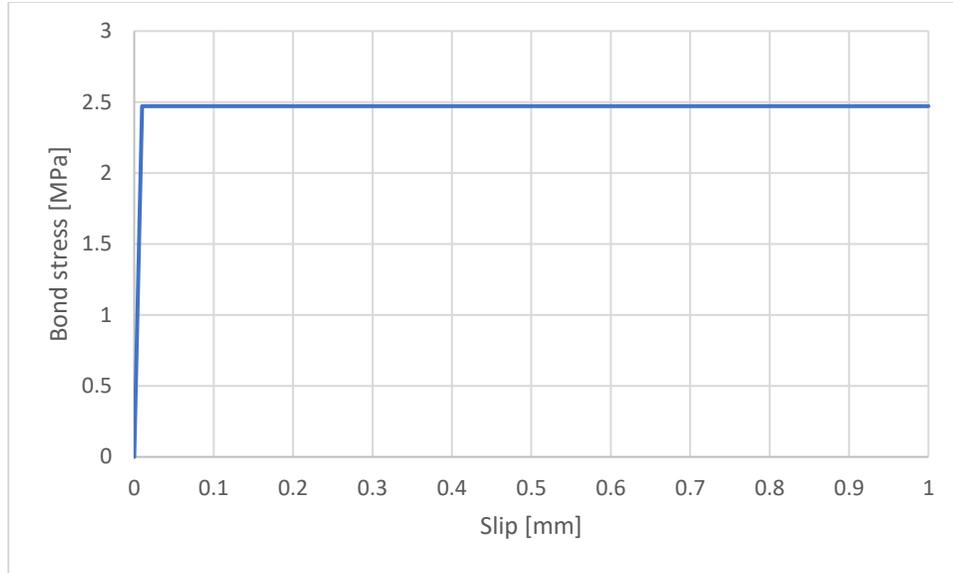
Figure 28: Bond stress-slip relationship for Case B.

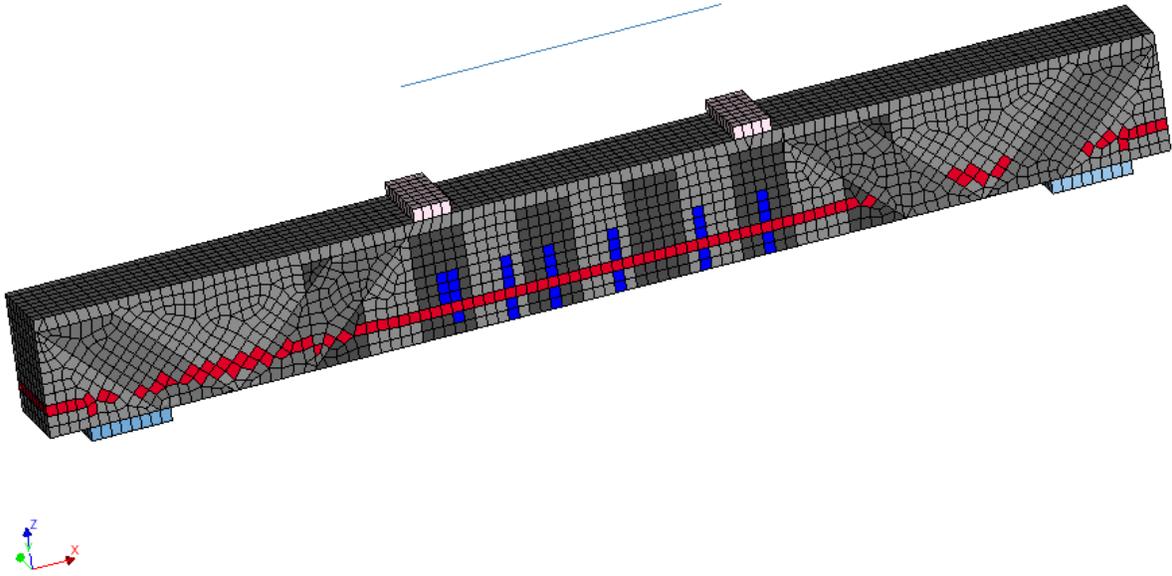
The concrete was modelled in the NLFEA as 3D solid continuum elements: Pyramid (PY15L), tetrahedrons (TE12L), bricks (HX24L), and wedges (TP18L). Linear interpolation and gauss integration was implemented into all element types. The size of the mesh was chosen to be 20 mm by taking lower value of  $(\frac{l}{50}, \frac{h}{6}, \frac{b}{6})$ , according to Hendriks [49]. The mesh size for the FRP plate was chosen to be 5 mm, as per the recommendation by Kalfat [50]. The interface elements between all components were modelled using element type Q24IF. The element type for the loading beam was chosen as three-dimensional beam elements with two nodes (L12BEA). Beam elements was chosen to model reinforcement bars. The 3D model from NLFEA of the meshed beam in Case B is illustrated in Figure 29

Figure 29: The meshed beam from Case A.

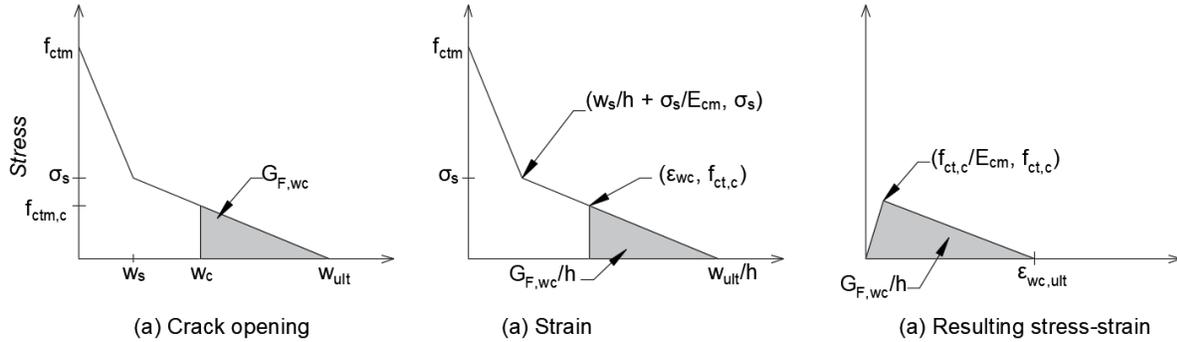
Figure 30: Deriving stress-strain properties for weakened concrete elements, redrawn from Blomfors et. al. [51].

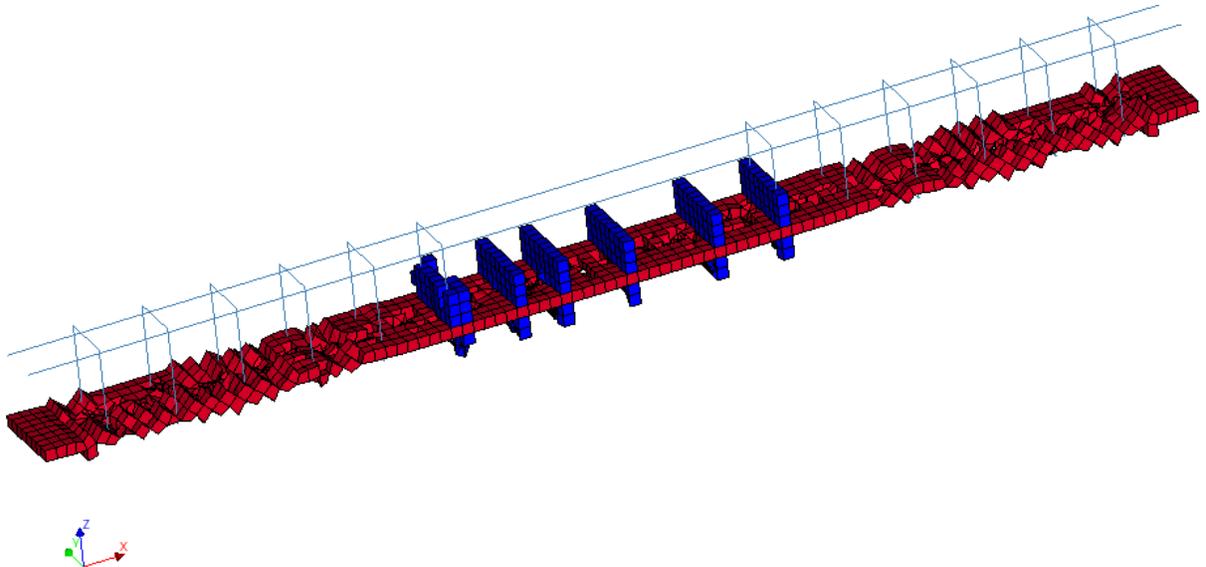
Figures 31 and 32 show 3D representations of how the cracks were modelled in Case A and B respectively. The horizontal corrosion-induced crack was assumed to extend along entire length of the beam. The pre-loading cracks for Case A were modelled based on the experiment by Yang [8]. For Case B, the pre-loading cracks were assumed to extend until the level of the neutral axis.

Figure 31: Modelling of cracks for Case A.

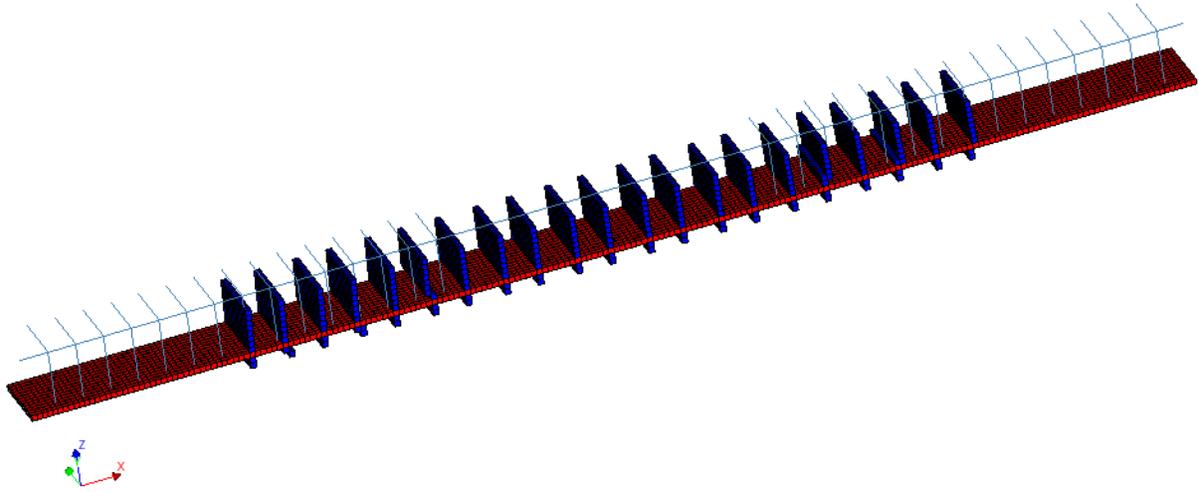
Figure 32: Modelling of cracks for Case B

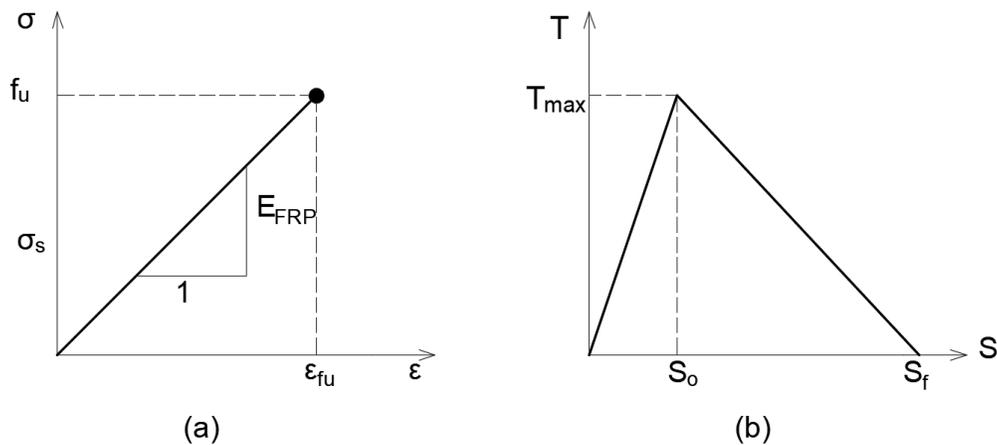
Where,  $s_f = 0.182$  mm,  $s_0 = 0.07$  mm,  $\tau_{max} = 5.74$  MPa, according to Lu et al. [54], see Figure 33(b). The bond stress-slip relationship between FRP/concrete and FRP/FRP were assumed to be the same, see Appendix D. This assumption was made as there was no information found regarding interface properties between FRP/FRP in the existing literature.

Figure 33: (a) Stress-strain relationship for FRP components, (b) Bond stress-slip for the interface between concrete and FRP. From [12], with permission.

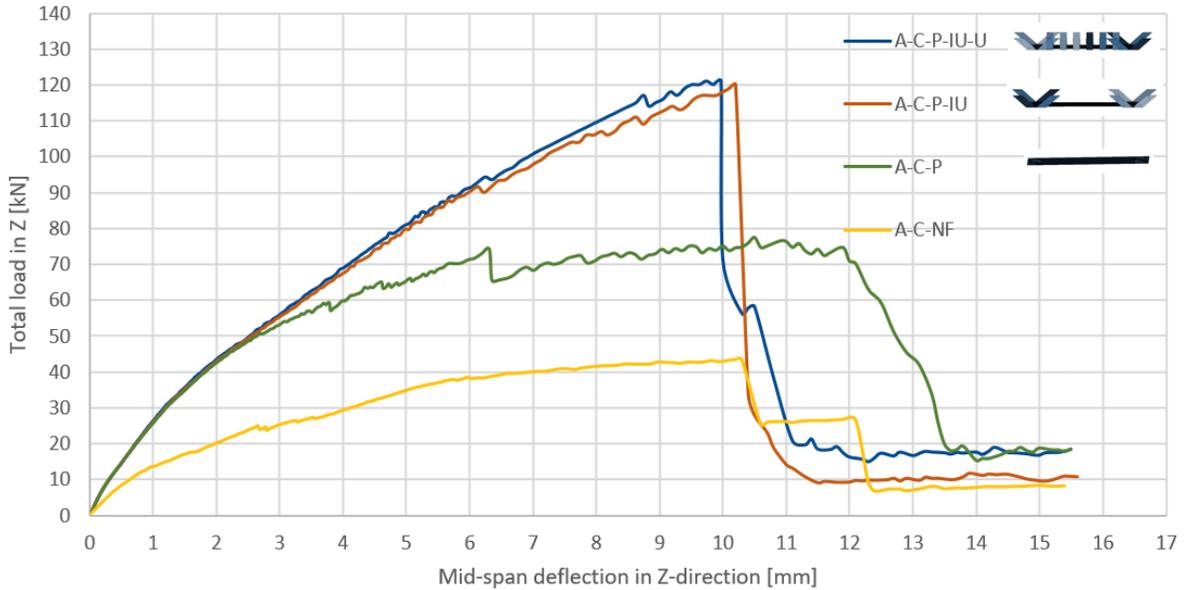
Figure 34: Overview of load versus mid-span deflection graphs for Subcase A-C.

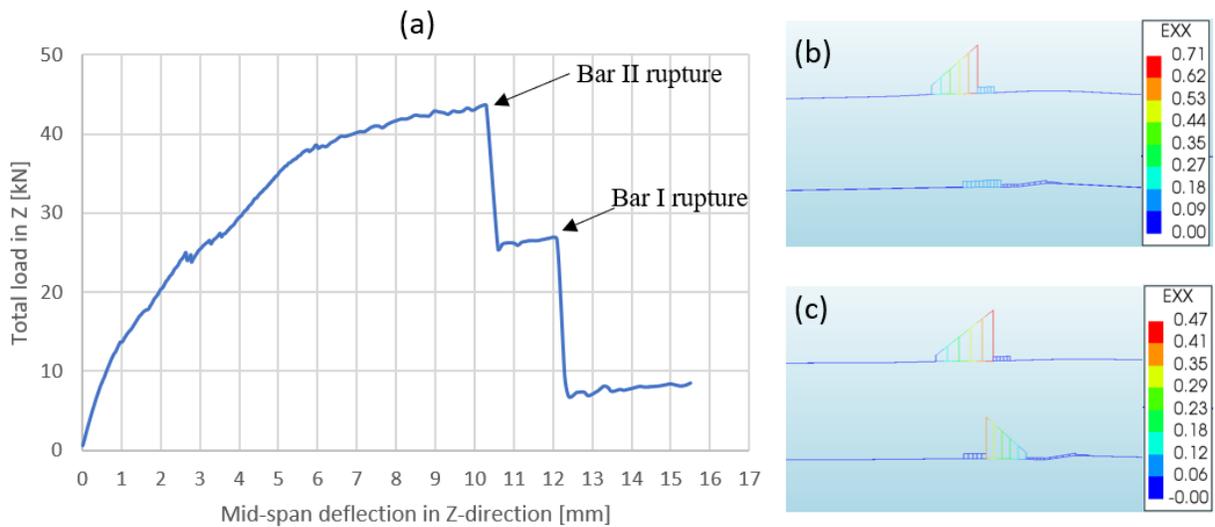
The failure mode from the analysis of A-C-NF was rebar rupture; the rebars failed at the pits. The failure occurred when the strain in the rebars exceeded the ultimate strain value of 0.12. Rupture of tensile bar II at pit IIa was observed as shown in Figure 35(b) followed by the rupture of tensile bar I at pit Ia, see Figure 35(c).

Figure 35: (a) Load versus mid-span deflection graph for FEA model A-C-NF, (b) Strain diagram showing bar II rupture at mid-span deflection of 10.5 mm, (c) Strain diagram showing bar I rupture at failure at mid-span deflection of 12.5 mm.

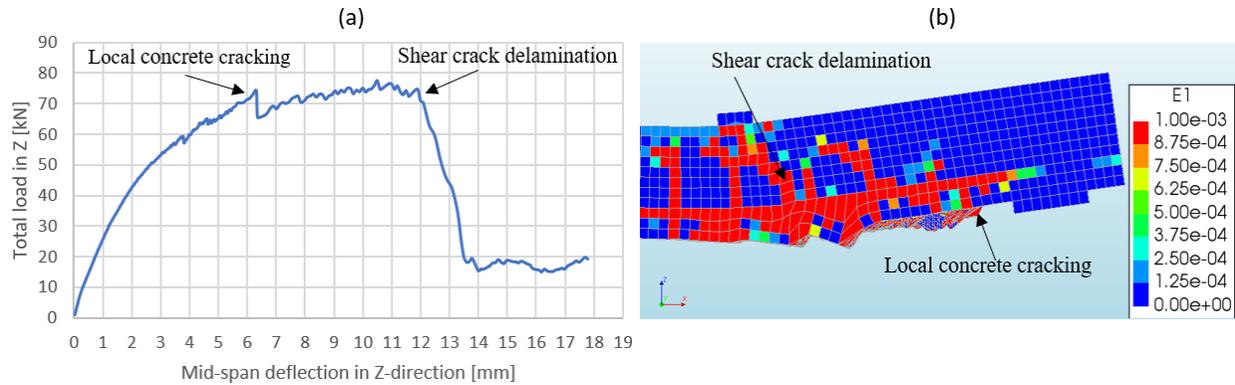
The failure mode from the analysis of A-C-P began with local concrete cracking at the edge of the FRP plate, followed by shear crack delamination as shown in Figure 36. In order to investigate the failure mode, the relative displacement between a set of two points at the centre and at the edge was plotted. One point was selected at the beam soffit and the other point was selected at a distance (twice the element size) above the horizontal corrosion crack, see Figure 37.

Figure 36: (a) Load versus mid-span deflection graph for FEA model A-C-P. (b) Principal strain showing the resulting failure modes at mid-span deflection of 12.5 mm.

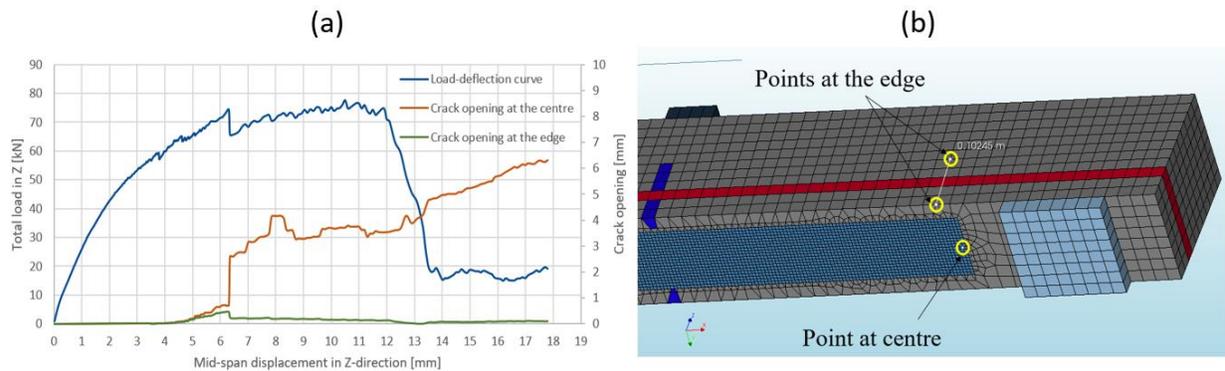
To investigate the first drop in the load-deflection graph, two sets of points were selected, with one set at the edge of the beam and the other at the centre of the beam, see Figure 37 (b). In Figure 37 (a) the crack opening at the edge and the centre points is plotted with the load versus mid-span deflection. This graph shows that the crack opened more at the centre of the beam, indicating that there was local concrete cracking near the FRP plate edge.

Figure 37: (a) Load and crack opening versus relative displacement graph for FEA model A-C-P. (b) Sets of point selected for failure mode investigation.

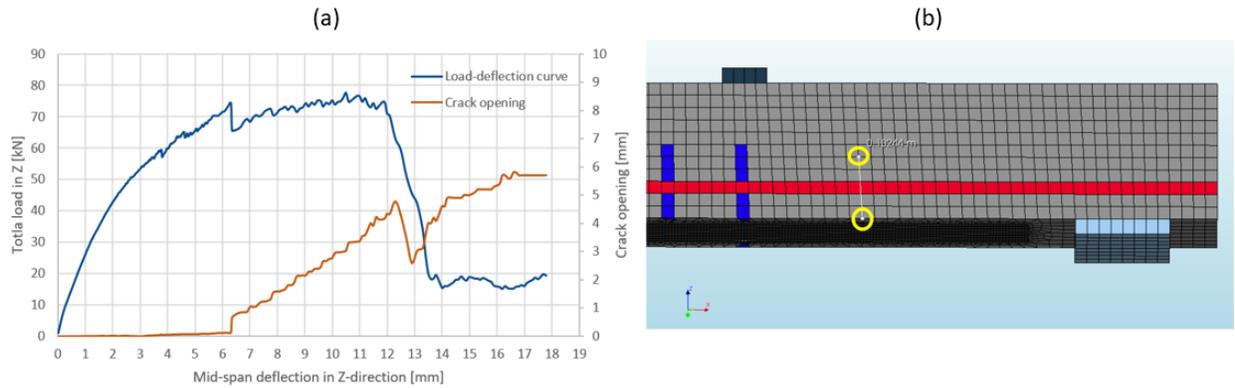
To investigate the second drop in the load-deflection curve, a single set of points was selected as highlighted in Figure 38 (b), and the load and crack opening vs mid-span deflection was plotted as shown in Figure 38 (a). An increase in the crack opening was observed from the first failure until the final failure. This indicates that the beam failed due to shear crack delamination as there was delamination of concrete at the position of the chosen set of points.

Figure 38: (a) Load and crack opening versus mid-span deflection graph for the set of points. (b) The set of points selected for failure mode investigation.

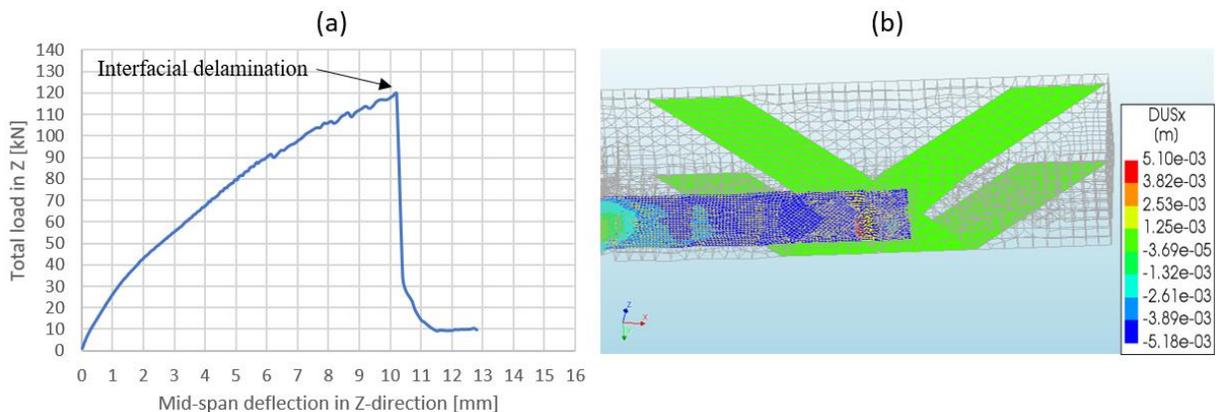
The failure mode from analysis of A-C-P-IU was observed to be interfacial delamination of FRP plate near the plate end. The load-deflection curve for this case is shown in Figure 39 (a). The investigation of failure mode was done by looking at the relative interface displacement (DUSx), see Figure 39 (b). A sudden increase in the (DUSx) was observed at the load step where there was a sudden drop in the load-deflection curve.

Figure 39: (a) Load versus mid-span deflection graph for FEA model A-C-IU. (b) Relative interface displacement between FRP and concrete at mid-span deflection of 10.5 mm.

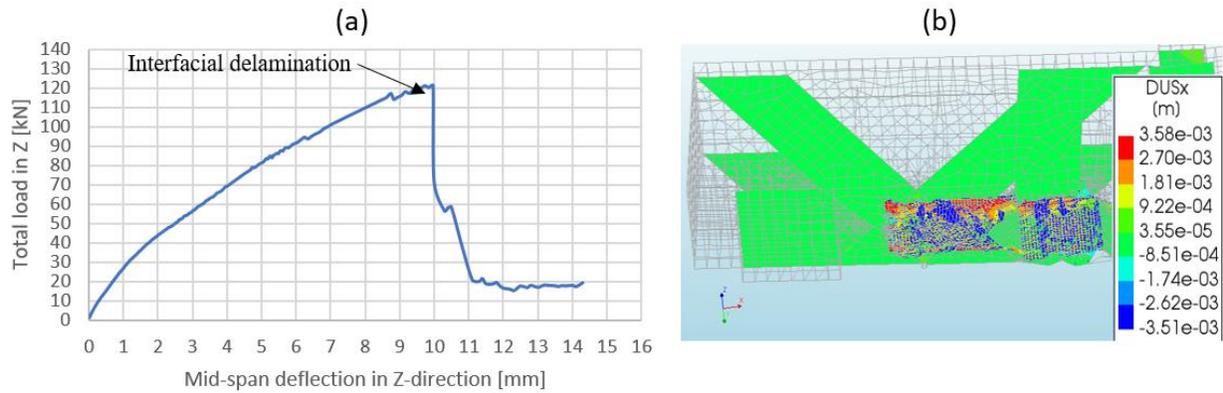
The failure mode from the analysis of A-C-IU-U was interfacial delamination of the FRP plate near the plate end similar to the results of the analysis of A-C-P-IU. The investigation was carried out by checking the relative interface displacement as shown in Figure 40 (b). The resulting load-deflection curve is shown in Figure 40 (a).

Figure 40: (a) Load versus mid-span deflection graph for FEA model A-C-P-IU-U. (b) Relative interface displacement between FRP and concrete at the mid-span deflection of 10.2 mm.

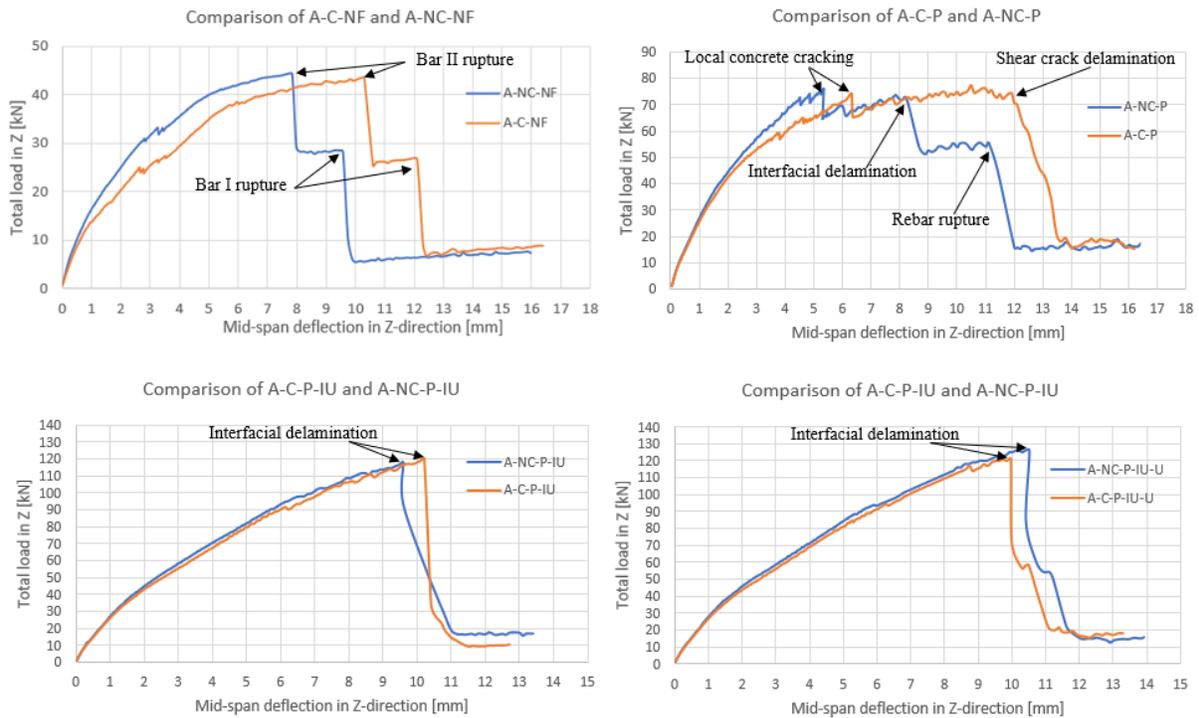
Figure 41: Comparison of Load versus mid-span deflection curves with failure modes for Case A with and without corrosion cracks.

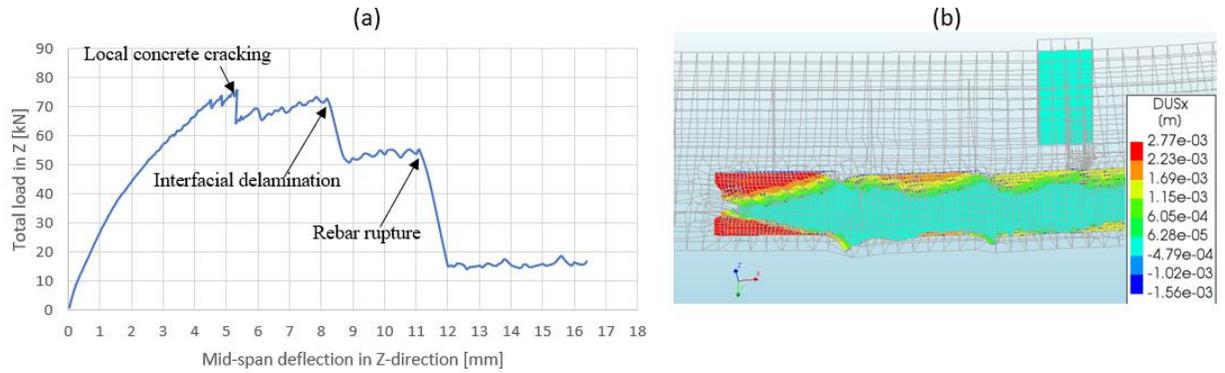
Figure 42: (a) Load versus mid-span deflection graph for FEA model A-NC-P. (b) Relative interface displacement between FRP and concrete at the mid-span deflection of 8.5 mm.

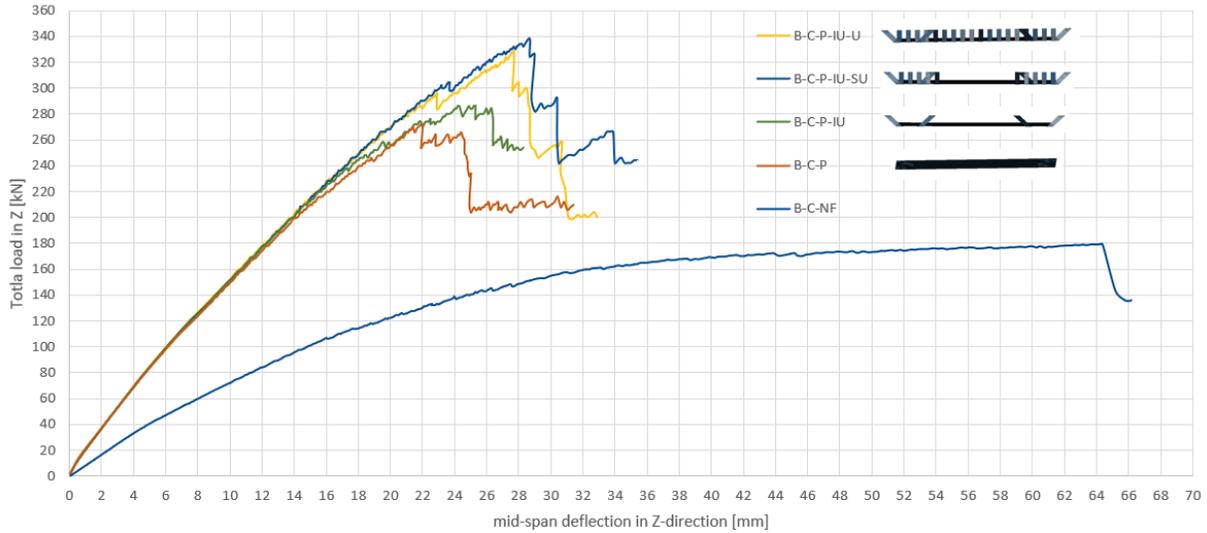
Figure 43: Load versus mid-span deflection graphs for Case B.

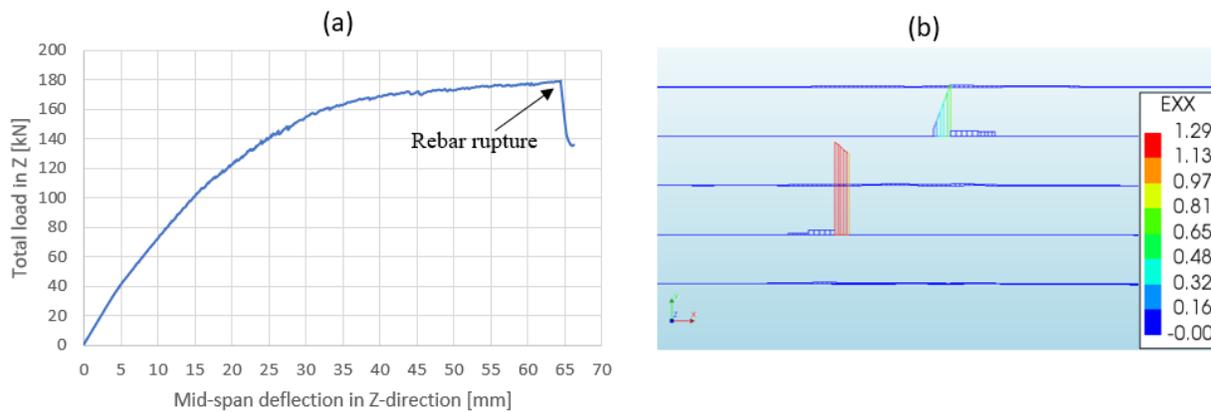
Figure 44: (a) Load versus mid-span deflection graph for FEA model B-C-NF, (b) Strain diagram showing bar II rupture at the mid-span deflection of 65 mm.
