# FE Analyses of Corrosion-Damaged RC Beams Strengthened with FRP Components

Master's Thesis in Structural Engineering

Omar Darwish and Akash Roshan

Department of Architecture and Civil Engineering  
CHALMERS UNIVERSITY OF TECHNOLOGY  
Master's Thesis ACEx30  
Gothenburg, Sweden 2022

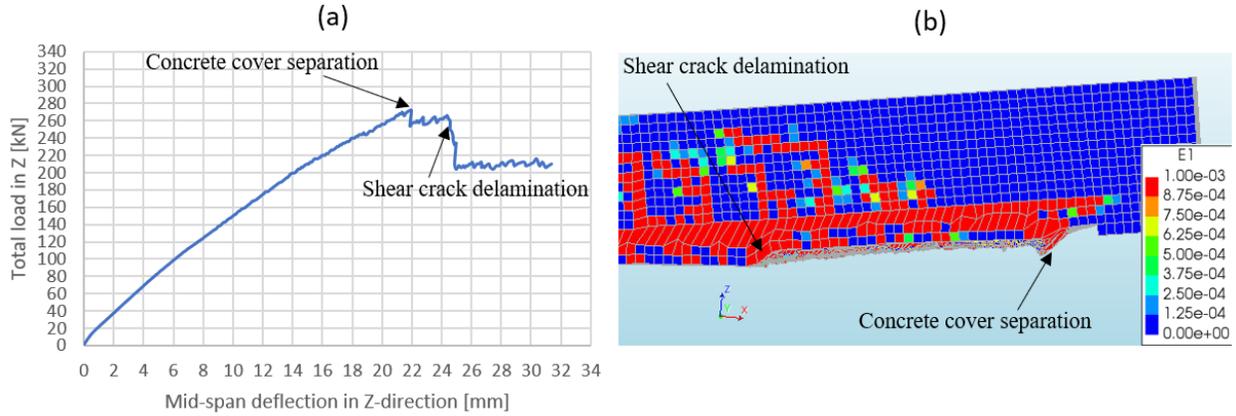
Figure 45: (a) Load versus mid-span deflection for FEA model B-C-P. (b) Principal strain showing the resulting failure modes at the deflection of 25 mm.

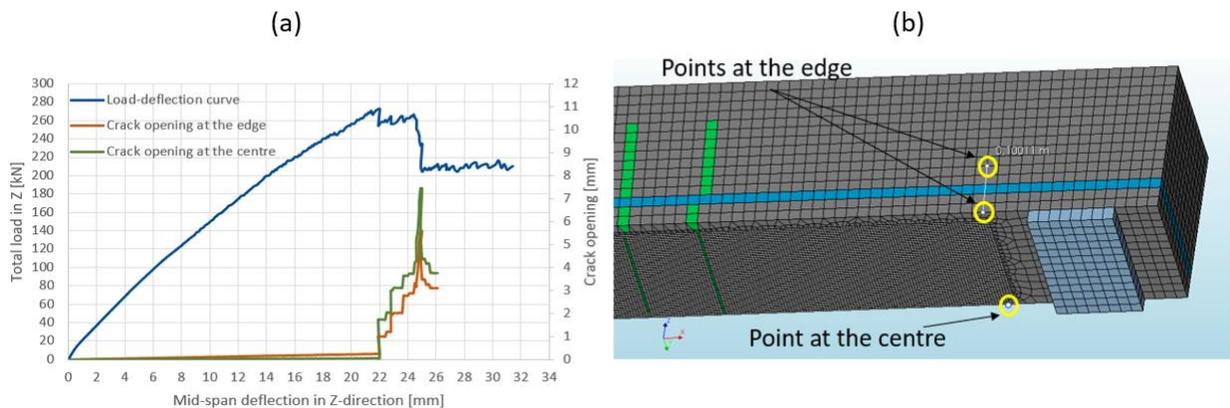
Figure 46: (a) Load and crack opening versus mid-span deflection graph for FEA model B-C-P-IU. (b) Sets of point selected for failure mode investigation.

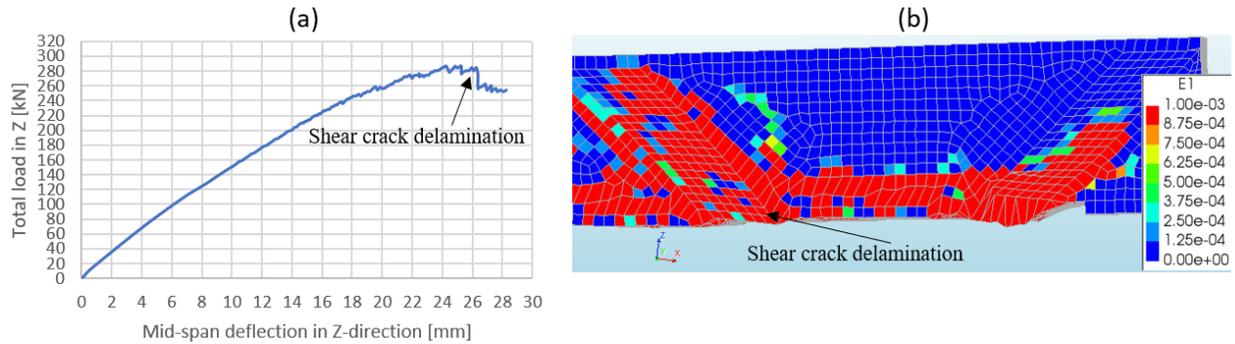
Figure 47: (a) Load versus mid-span deflection for FEA model B-C-P-IU. (b) Principal strain showing the resulting failure at the mid-span deflection of 26.5 mm.

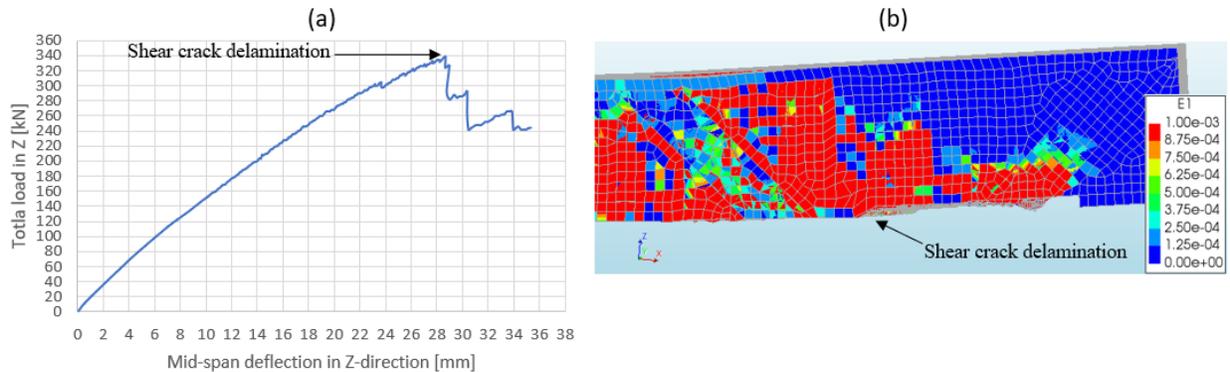
Figure 48: (a) Load versus mid-span deflection for FEA model B-C-P-IU-SU. (b) Principal strain showing the resulting failure at the mid-span deflection of 29 mm.

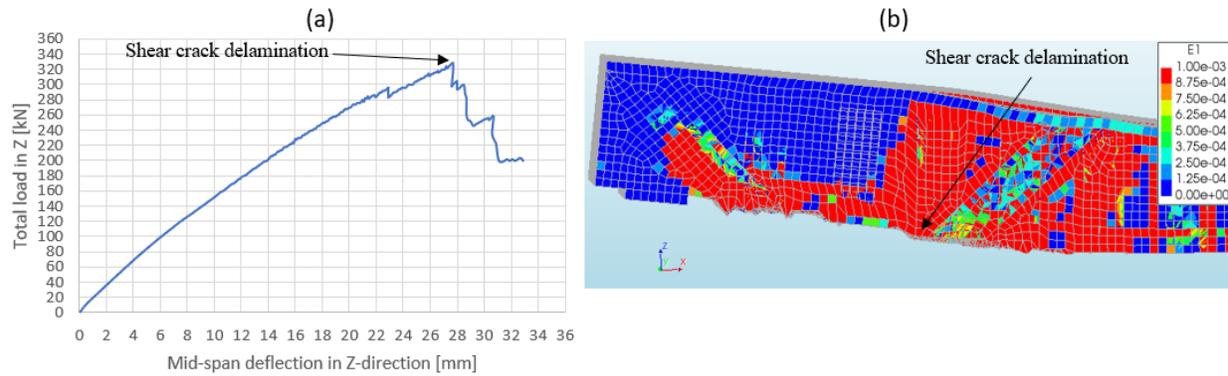
Figure 49: (a) Load versus mid-span deflection for FEA model B-C-P-IU-U. (b) Principal strain showing the resulting failure at mid-span deflection of 28 mm.
