Measurements and Analysis of Electromagnetic Interferences in the Swedish Railway Systems

Luleå University of Technology
Division of Operation and Maintenance
Luleå Railway Research Center

Doctoral Thesis

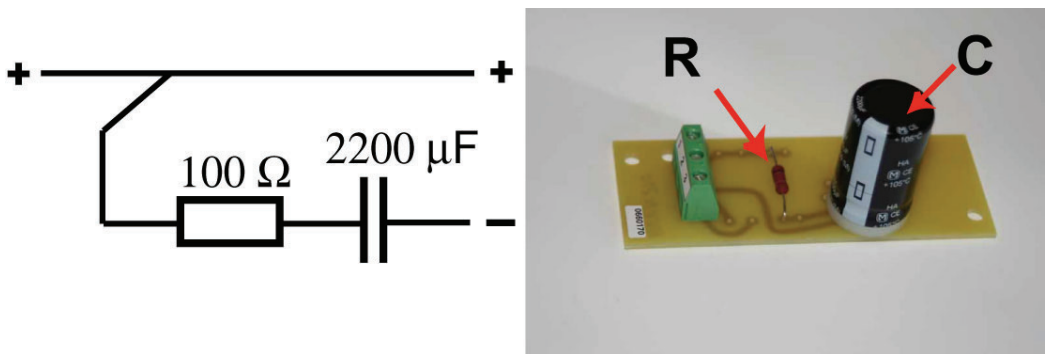
Figure 12 The circuit is an RC circuit, has a resistance, marked R in the figure and photo, of $100\ \Omega$ and is connected in series with a capacitor, marked C in the figure and photo, of $2200\ \mu\text{F}$.

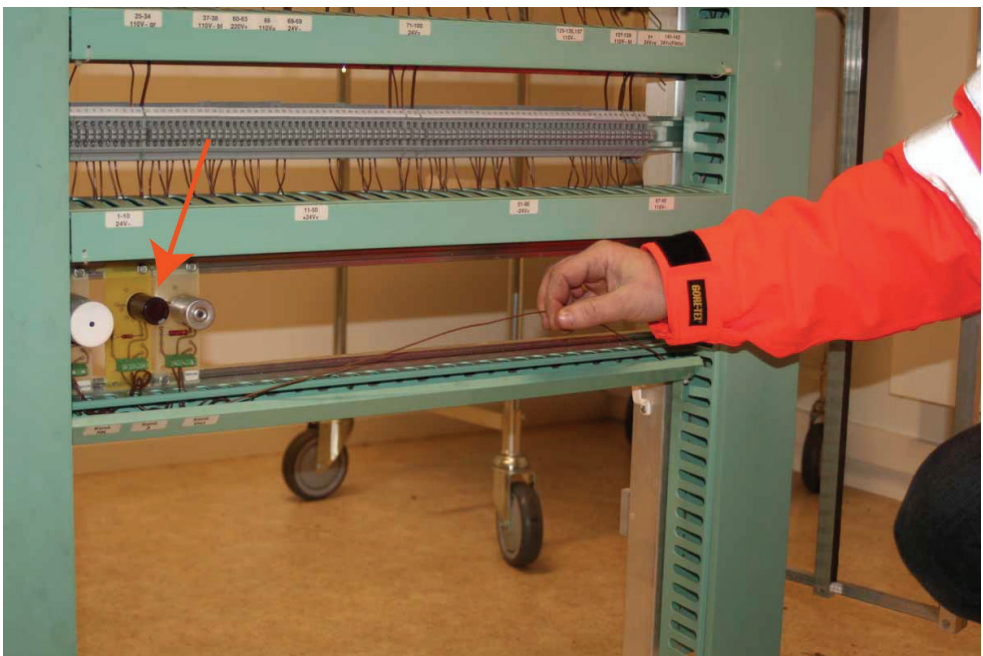
There is a fuse between the rectifier and the printed circuit card. The printed circuit card is connected on both sides with a $0.75\ \text{mm}^2$ solid wire. This wire goes to a negative wire loop joining other printed circuit cards that have the same function (but in different systems) and is grounded, see Figure 13.

Figure 13 The placement of the RC circuit in the rack (the middle RC circuit in the square indicated by the arrow) and the wire from RC circuits that have the same size both on the negative bound and on the voltage side. The area of the solid wire is $0.75\ \text{mm}^2$.

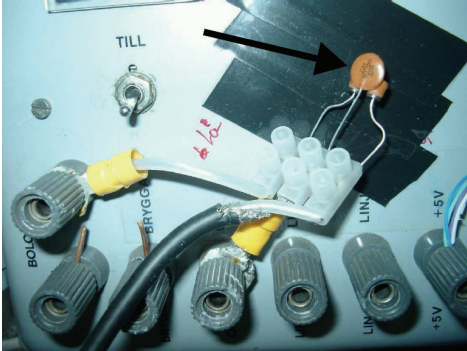
As mentioned in [42], many installations in the railway system are not performed according to the regulations. These deviations affect the EM environment for railway systems, and post-installation fixing has to be carried out to save the installed system, see for example Figure 25.

Figure 25 A filter, indicated with an arrow, is mounted on an incoming signal. This filter has been mounted after the system started to be used.

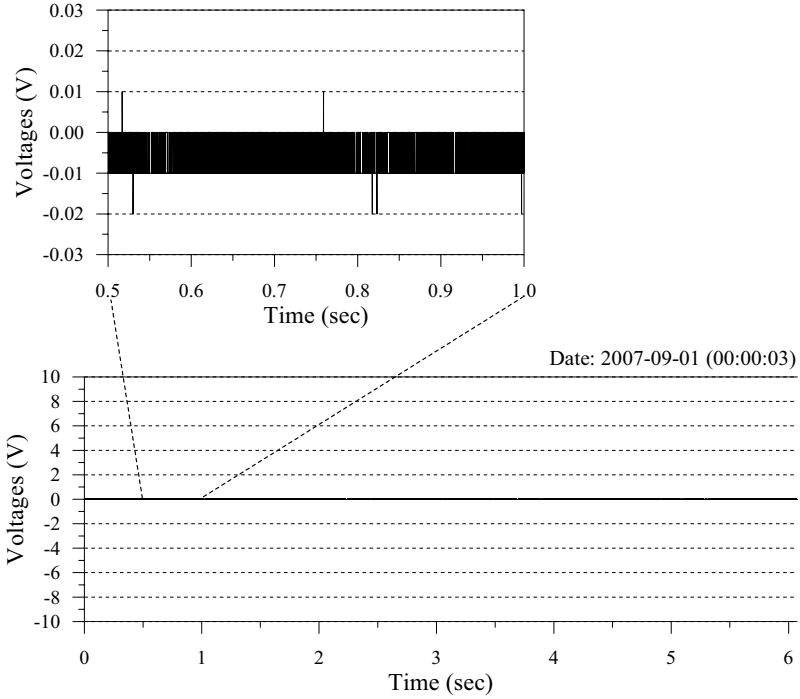
During the measurements at Öre Älv and Oxmyran the sampling rate was set to 10 kHz at first and then 1 MHz. The measurement at Öre Älv showed no recorded activity, which made further measurements uninteresting. The only recorded measurement at Öre Älv was the forced measure in the middle of the night when no train was passing the station. A comparison between the forced measurements at Öre Älv and at Oxmyran is shown in Figure 30 and Figure 31.

Figure 30 The forced trigger at Öre Älv at the date 2007-09-01 at the time 00.00.03.

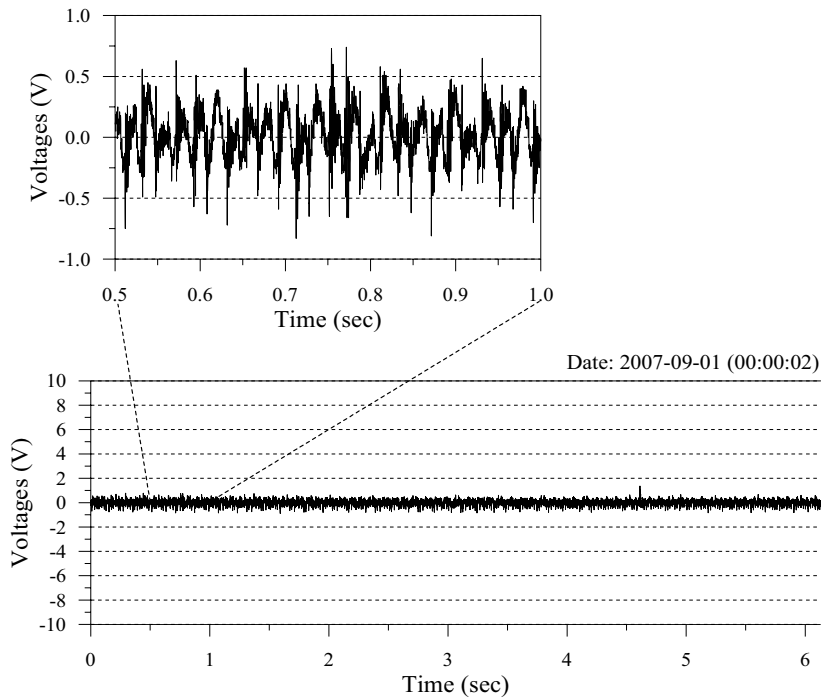
Figure 31 The forced trigger at Oxmyran at the date 2007-09-01 at the time 00.00.02.

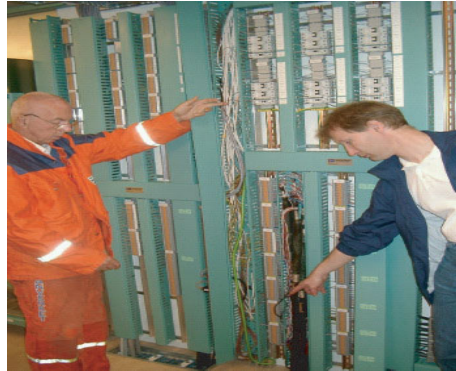
The overvoltage protection was placed more than one metre in on the rack, as measured from the wall that is the barrier. The incoming cable was placed together with all the other cables in a cable channel for both the incoming and the internal cables, see Fig 3. If a transient enters this way through the cables, it interferes with all the closest cables before it enters the overvoltage protection after more than 1 metre.

Figure 3: Incoming cables in a technical building where the overvoltage protection filter is placed over 1 metre from the wall that is the barrier. The unfiltered cable is mixed with filtered cables before it reaches the overvoltage filter.

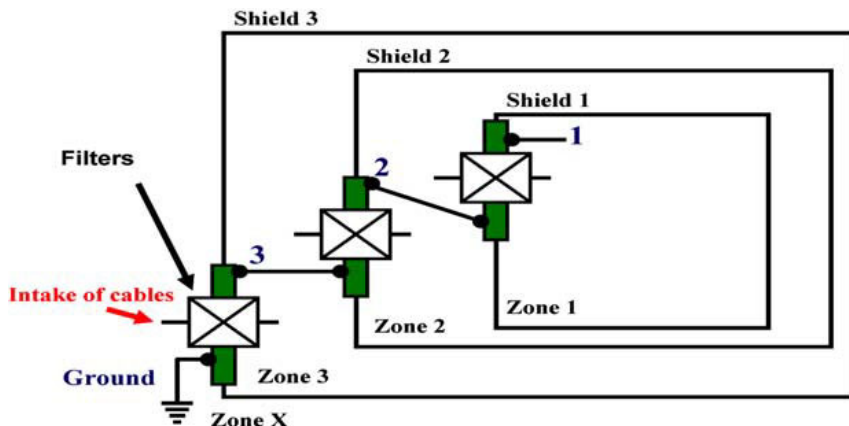
question (telecommunications, signals and electric power supply). Instead it should be the sensitivity of the equipment that defines the zones, as in Fig 5.

Figure 5: Design of the buildings, huts or cabins involving different zones, each of which has a specific level of allowed EM fields and the cables that enter every zone through a filter.

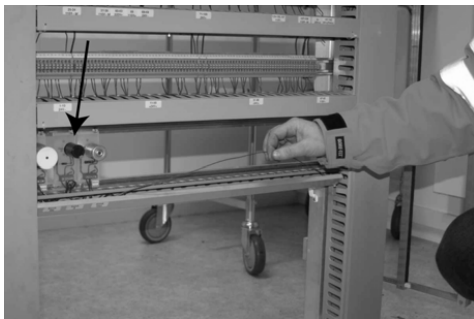
Figure 11. The placement of the RC circuit in the rack (the middle RC circuit in the square indicated by the arrow) and the wire from RC circuits that have the same size both on the negative bound and on the voltage side. The area of the solid wire is $0.75\ \text{mm}^2$.

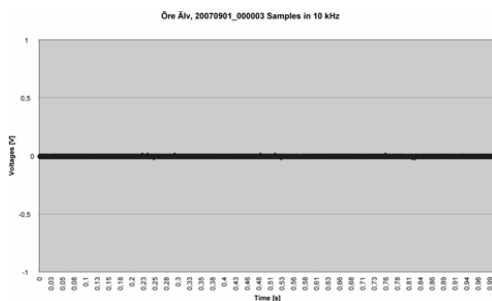
The measurements clearly show that there are differences between the station at Öre Älv and the station at Oxmyran. The diagram from a measurement of the RC circuit from Öre Älv, Figure 13, is very stable with a low voltage and indicates the zero level. The diagram from a measurement at the same point at Oxmyran has a ripple signature and a different voltage level, 80 times higher than that at Öre Älv, see Figure 14. Both measurements were produced during the night and no trains were passing. The voltage level should be zero, but this clearly shows that there are differences between the systems. The presented difference may cause the problems in the subsystem that contains the RC circuit at Oxmyran.

Figure 13. Measurement during the night when there were no trains at Öre Älv Station.

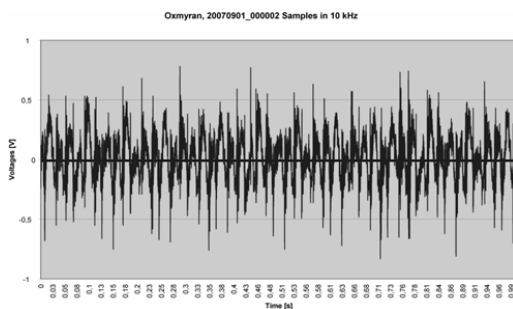
Three measurement runs were triggered at Oxmyran and none triggered at Öre Älv. The trigger level is set over the normal level and differs from the specification in the system and

the specific RC circuit. The levels of the transients are 50 V or more.

Figure 14. Measurement during the night when there were no trains at Oxmyran Station.

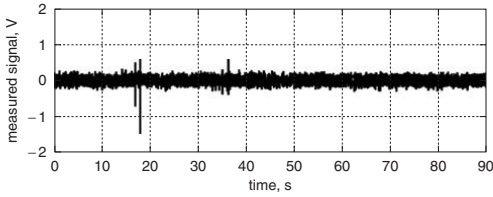
(a) *Flat wheel detector system and parallel cable setup:* First, a 90 s measurement on one flat wheel detector in Notviken is shown in Fig. 3, together with measurements on a parallel passive cable in Fig. 4. At least one recorded transient, seen around 18 s, at the flat wheel detector is also seen at the passive cable indicating radiated electromagnetic disturbances.

Fig. 3 Measured signal on flat wheel detector for 90 s

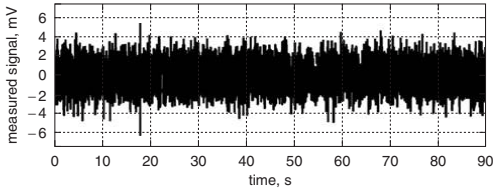
Fig. 4 Measured signal on parallel passive cable 3 m from track for 90 s

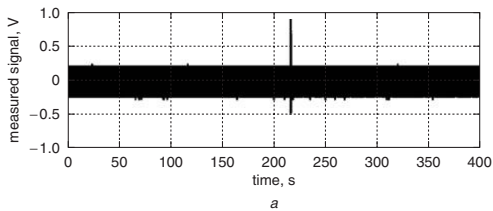
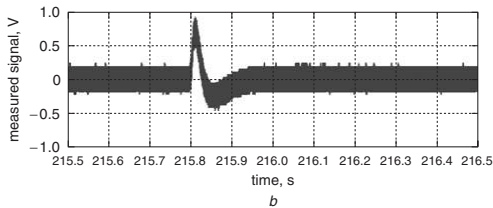
- (b) *Hot brakes detector system:* Secondly, measurements on the hot brakes detector system in Sunderbyn is presented in Fig. 5a with a closeup of one large transient in Fig. 5b. Large transients of this type (Fig. 5) are often recorded by the measurement equipment when trains are absent.
- (c) *Hot bearings detector system:* Finally, measurements on the hot bearing detector system are shown in Fig. 6a with a closeup of one large transient in Fig. 6b. Although these measurements are performed in parallel to the hot brakes measurements shown in Fig. 5, the transients is not occur at the same time, indicating conducting electromagnetic disturbances.

Fig. 5 Measured signal
a Hot brakes detector for 400 s
b Closeup for one transient

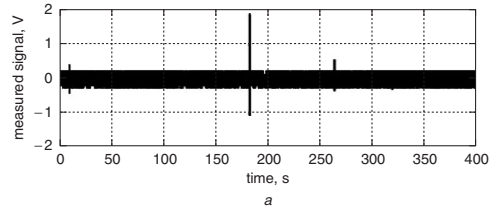
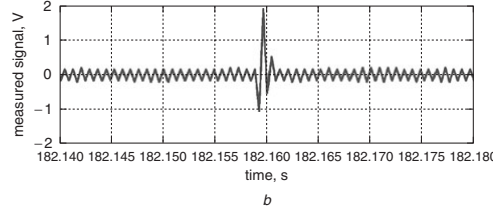
Fig. 6 Measured signal
a Hot bearing detector for 400 s
b Closeup for one transient

Fig. 10b. These measurements are performed in parallel to the hot brake measurements shown in Fig. 9 and some transients are recorded in both systems at the same time (15.23 s) indicating radiated electromagnetic disturbances. However, there are several large transients recorded in the hot bearing detector system that are not present in the hot brake detector system indicating both radiated and conducted electromagnetic disturbances. Further, the transient shown in Fig. 10b is very similar (with regard to period) to transients resulting from the braking/closing of the line-pantograph system, as reported in [12].

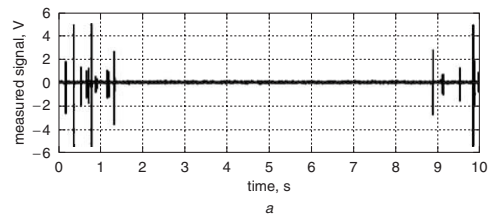
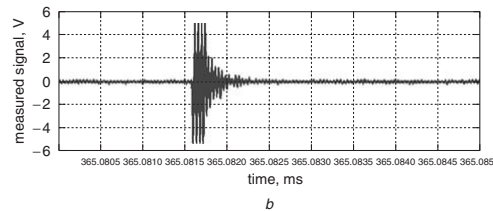
Fig. 7 Measured signal
a Flat wheel detector for 10 s
b Closeup for one transient

Notviken is presented (Fig. 7) together with measurements on a parallel passive cable (Fig. 8). As for the background measurements in the previous Section, transients observed at the flat wheel detector are also found at the parallel cable (0.365, 0.721, and 9.762 s) indicating radiated disturbances. Further, the closeup in Fig. 7b shows that the recorded transients, at the flat wheel detector system, are saturated at ± 5 V, indicating the presence of larger transients.

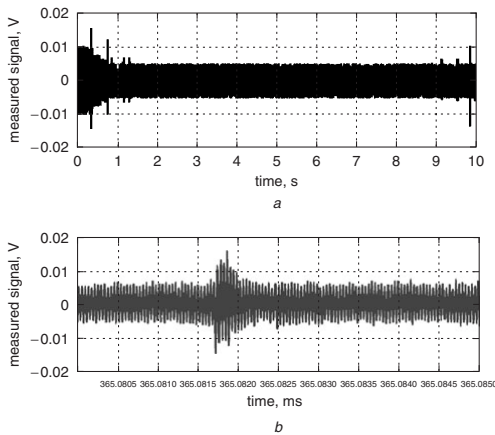
Fig. 8 *Measured signal*
a Parallel passive cable for 10s
b Closeup for one transient
 Four peaks can be identified at same time in both cable and flat wheel detector (shown in Fig. 7a)
 Transient at cable as shown in *b* arrives 150 ns after same transient is seen at flat wheel detector in Fig. 7b

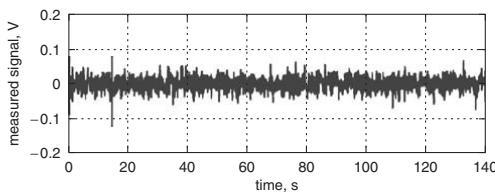
Fig. 9 *Measured signal on hot brake detector for 140s*

- (b) *Hot brakes detector system:* Secondly, measurements on the hot brake detector system are presented (Fig. 9). One transient at a fairly low magnitude (85 mV) is visible at 15.23 s. These results, indicating a relatively low disturbance on the hot brakes detector, are typical for the studied detector system.
- (c) *Hot bearings detector system:* Finally, measurements during train passage on the hot bearing detector system are shown in Fig. 10a with a closeup of one transient in

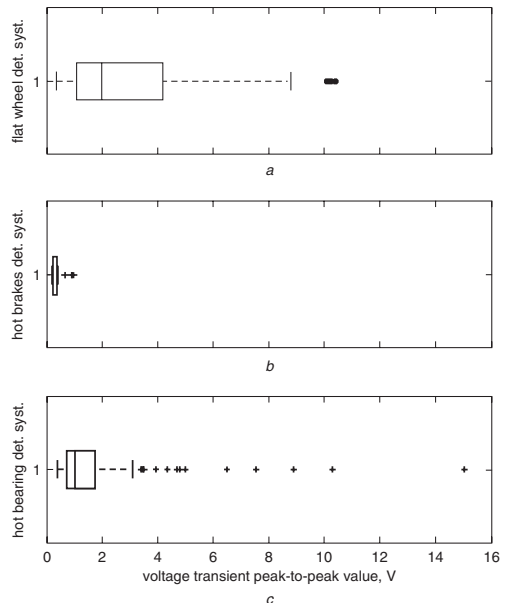
Fig. 11 *Boxplot for measured signals for a two-day period*
a Flat wheel detector system
b Hot brake detector system
c Hot bearing detector system

- From the plots the following observations can be made:
- (a) 25% of the measured transients are above 4.20 V for the wheel flat detector system (Fig. 11a)
 - (b) 25% of the measured transients are above 0.35 V for the hot bearing detector system (Fig. 11b)
 - (c) 25% of the measured transients are above 1.85 V for the hot bearing detector system (Fig. 11c).

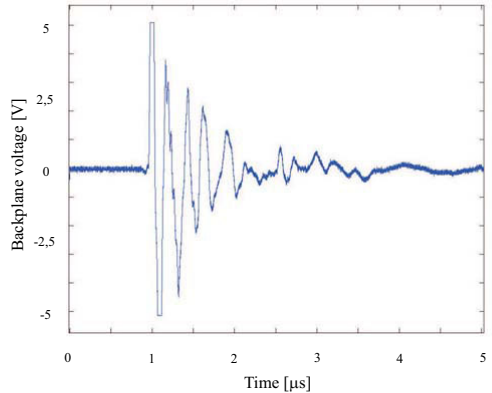
An important observation, from the performed measurements over a period of one and a half year (May 2002 - November 2003) in about 20 occasions, is that when the train is present at the measurement location it generates very low noise levels. However, measurements could show very high amplitude randomly occurring transients, see for example fig. 4, that had no correlation with the presence of trains at the measurement location. The train's exact position on the stretch and the distance to the measurement location could not be verified due to various communication problem. Possible sources of the observed large transients could be lightning strikes, switching operations, arching etc.

Fig. 4. Measured transient on the backplane inside the shed of the analyzing unit in Sunderbyn. The extremely high amplitude could not be registered by the measurement equipment.

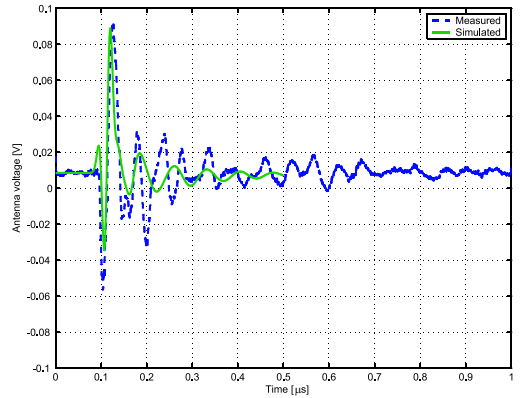
Fig. 7. Comparison between measured and modelled loop antenna voltage.

difference in frequency content of the modelled and measured pulse. However, this model gives a good indication on the magnitude of the randomly occurring transients in the rail system. The loop antenna modeling results indicate that there are transients, on the I-rail, on the order of 2 A. that was recorded by the loop antenna measurements.

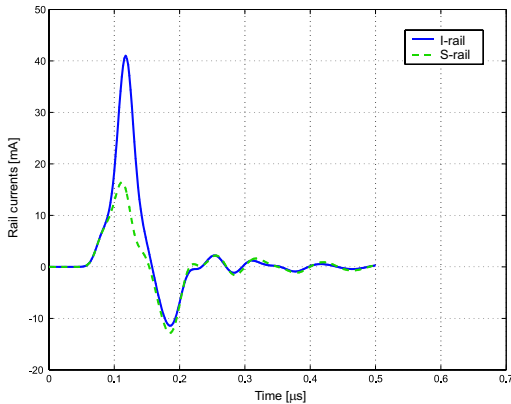
Fig. 8. Crosstalk between the I- and S- rail.

To model the coupling to the hot-box detector cover from the S-rail, the PEEC model is not necessary since the two systems have a direct connection through the grounding. However, the transient coupling from the I-rail to the S-rail is shown in fig. 8. The use of the PEEC method to model transient coupling in a local railway stretch is straightforward and, for this model situation, computationally efficient. However, electromagnetic modeling of the investigated railway stretch is not required to substantially improve the performance of the detector system (including the shed). Modeling can give important results after improving the overall electrical environment in the detector system.

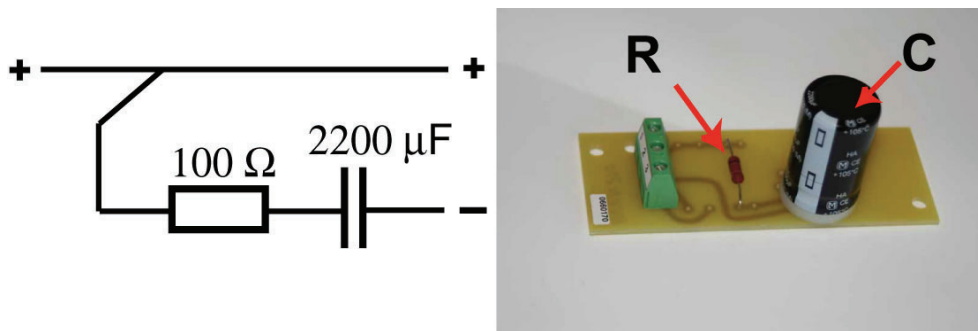
According to Banverket's failure database, "Ofelia", an RC-circuit in the signal box at Oxmyran has, compared to other similar circuits, failed remarkably often (32 times) during the past 6 years. This circuit failure has created large unnecessary costs for replacement of the circuit and a number of train delays. The cause of the failures is suspected to be electromagnetic interference.

Figure 3. The investigated circuit is an RC circuit, consisting of a resistor of 100 Ω , marked R in the figure and photo, and connected in series with a capacitor of 2200 μF , marked C in the figure and photo.

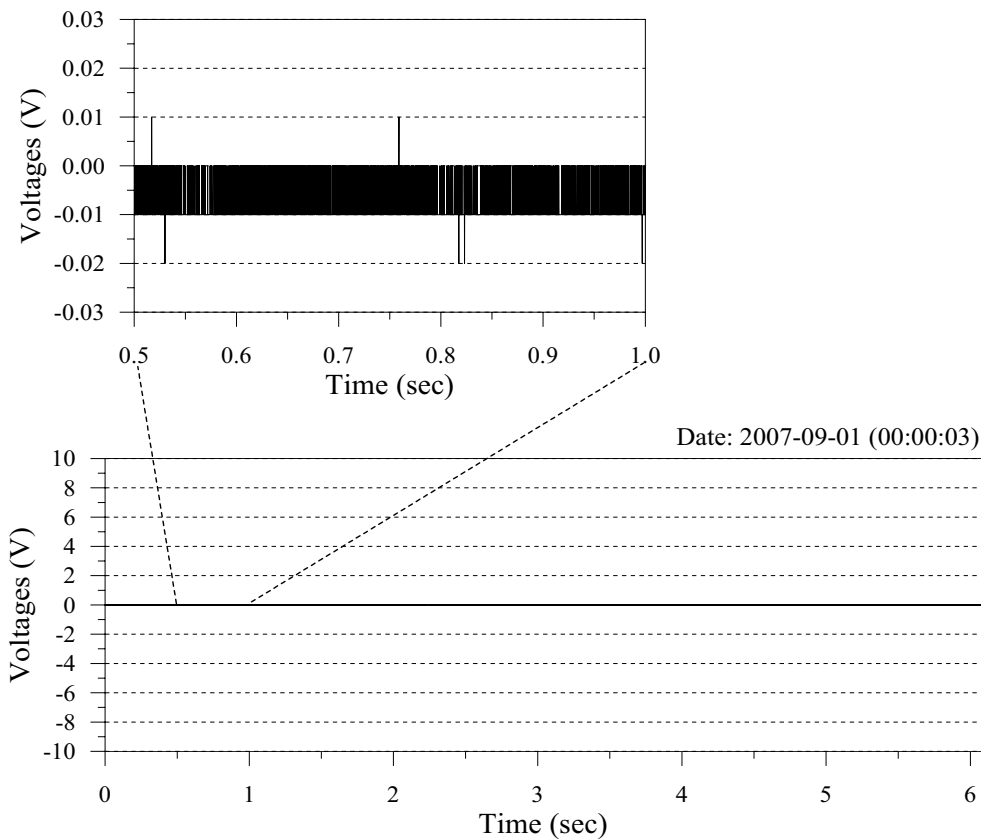
The measurements of 1/9/2007 from Öre Älv, Figure 5, show very low voltages. Furthermore, after two weeks of measurements at Öre Älv, the trigger level of 30 V had never been reached and only the curves from the forced midnight action had been registered.

Figure 5. The voltage curve from Öre Älv.

The results from Figure 5 and 6 clearly show a significant difference between Öre Älv and Oxmyran. The background levels are much higher at Oxmyran, even when no train is passing the station.

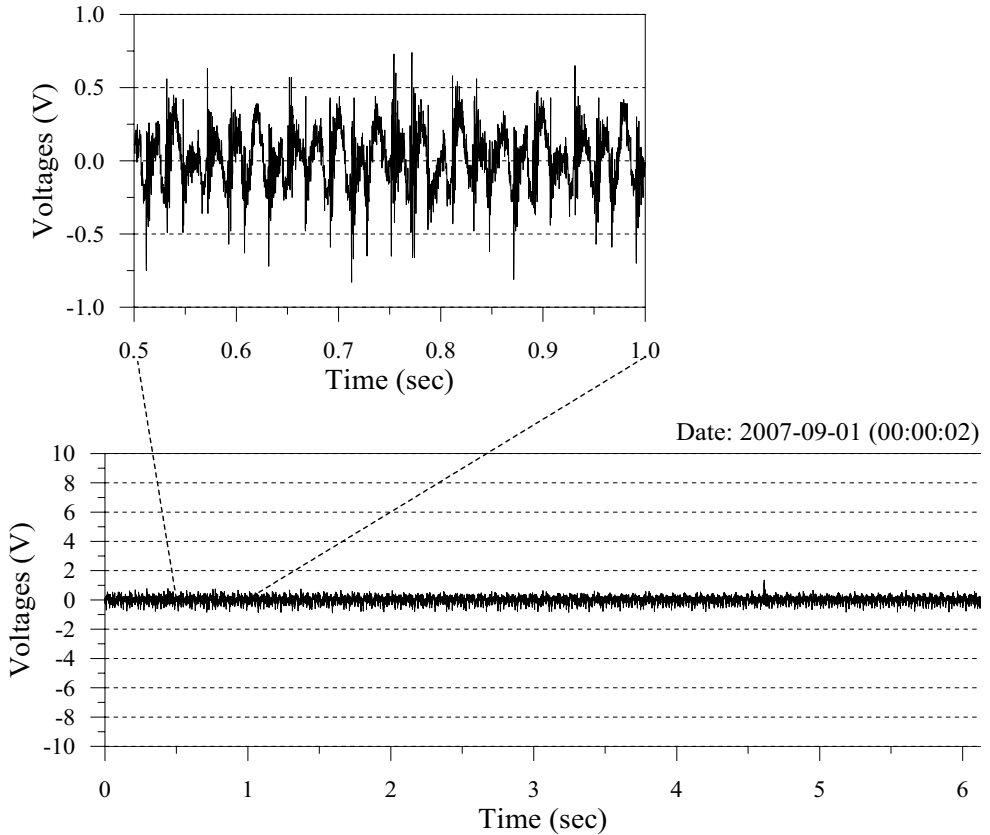
In Figure 6, a similar curve is shown for Oxmyran. The curve from Oxmyran shows a much wider spectrum of noise, up to 80 times higher than that for Öre Älv. The levels are not high enough to cause any problem for train indication, but the figure clearly shows that Oxmyran is not as stable as Öre Älv. During the first 12 hours of measurements at Oxmyran, there were 18 triggering events of the system, indicating voltage levels above 30 V.

Figure 6. A voltage curve from Oxmyran.

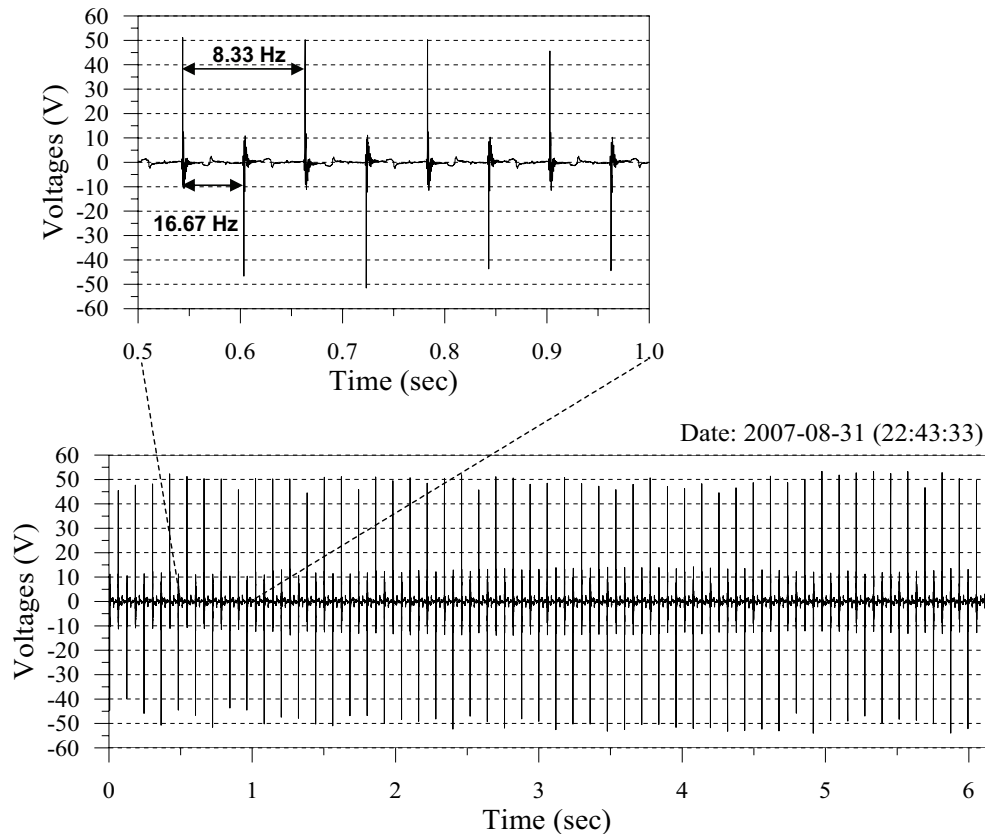
During the first period of measurements, the reference measurements, analysis shows that 8 1/3 Hz is the dominant frequency in the system. This is half of the frequency that Banverket employs in their power system, 16 2/3 Hz. See Figure 7.

Figure 7. Voltage measured with a sample rate of 10 kHz at Oxmyran.

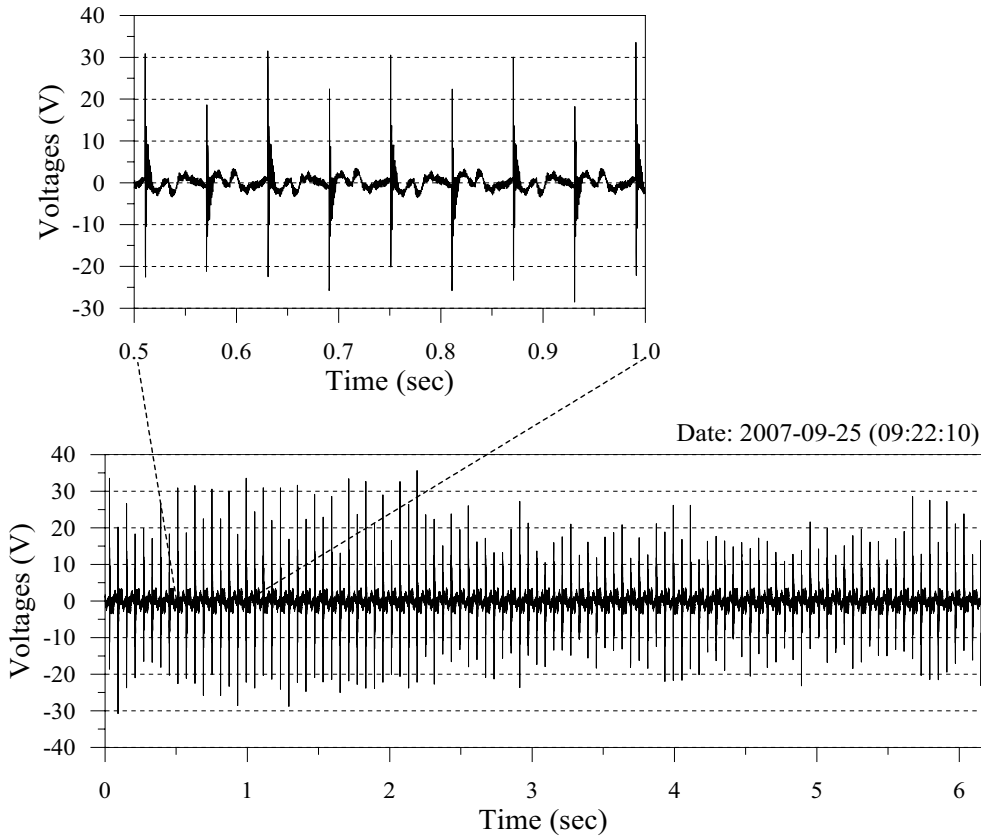
Many measured curves during this period are similar. On 25/9/2007 there were 12 triggers and no alarm showing that the RC circuit went out of order, In Figure 8 the transients are barely above the trigger value of 30 V. Here is a noise of several volts, but the figure shows clearly that the power is centred on zero, which means that the rectifier is not supplying power and no train is present at the station. The curve in Figure 8 can be compared to the curve in Figure 7, where the noise between the high transients is higher, but the tail dies out quicker. The transients on both these days, 31/8/2007 and 25/9/2007, have less power than what is required to break the RC circuit.

Figure 8. Voltage measured on 20070925; there were 12 triggers that day and night.

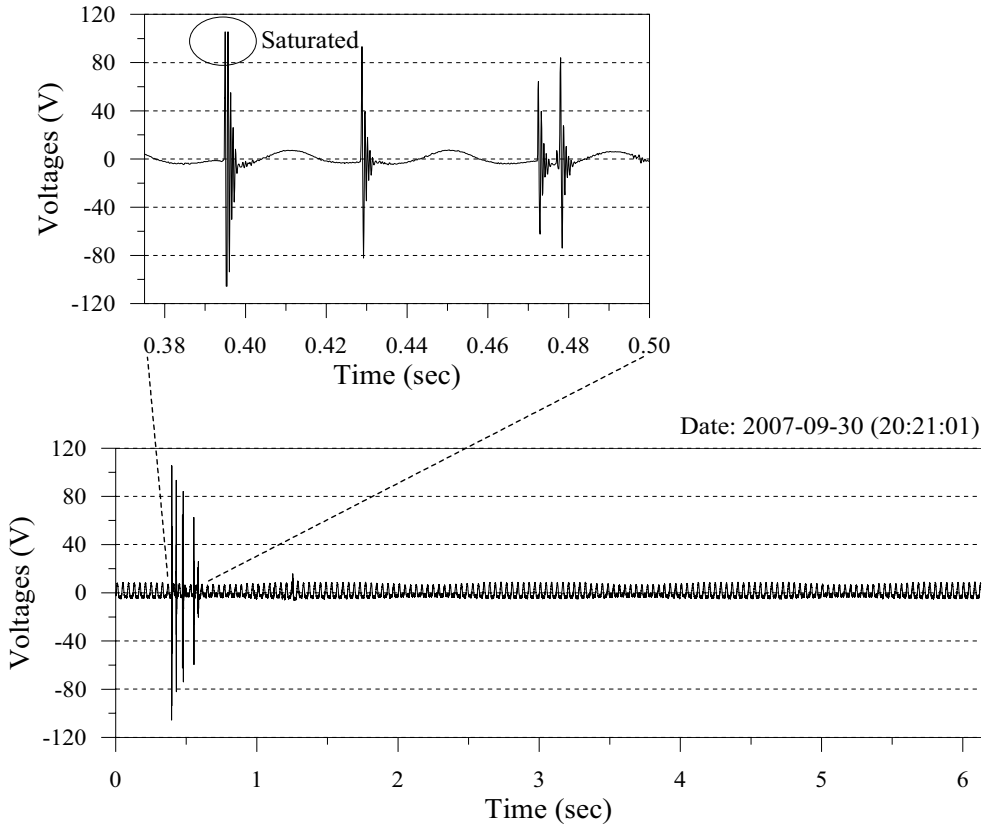
One of the times when the RC circuit was out of order was in the evening of 30/9/2007. The alarm was registered at the CTC office at 23.13. According to the maintenance support personnel, there was a thunderstorm this evening. There were 58 triggers during that twenty-four-hour period, see Table 1, and 56 of these triggers occurred between 19.43 and 20.46 (7.43 and 8.46 pm). There were no triggers at all when the fault occurred and the last trigger was recorded at 20.46 (8.46 pm). Analysis of the last recorded curves before the alarm shows some interesting features. The curve, Figure 9, is saturated at the beginning and has a short tail.

Figure 9. Measured voltages where the first transients are saturated.

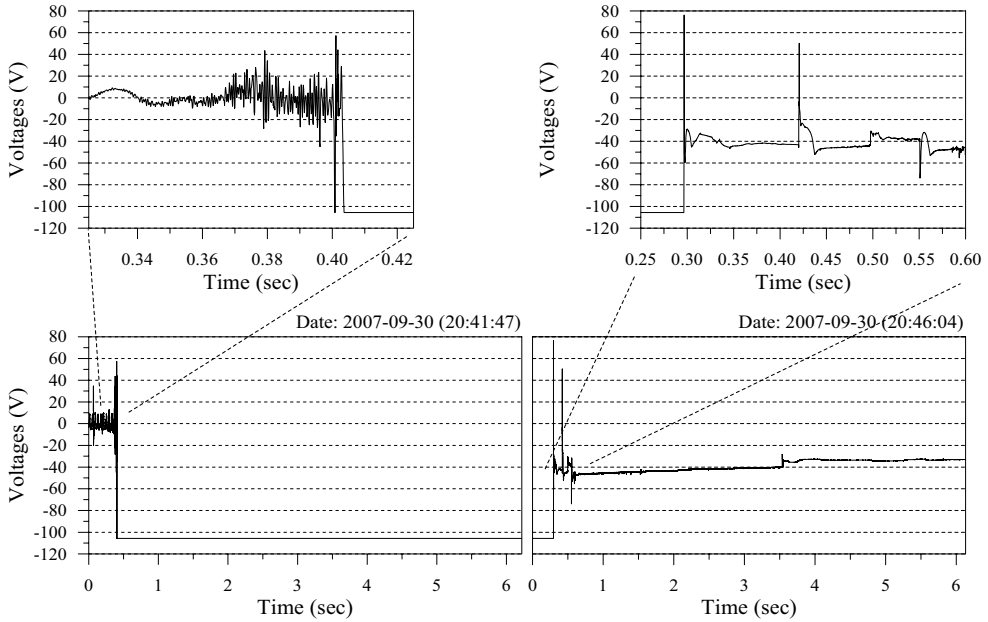
The last two curves that day, 30/9/2007, were recorded at 20.41.47 (8.41 and 47 seconds pm) and at 20.46.04 (8.46 and 4 seconds pm). The voltages dropped, or the whole system's potential was raised, see Figure 10. There is no evidence that the potential between these two measurements was saturated, but it is likely that it was saturated the whole time, approximately 5 minutes.

Figure 10. Measured voltages where the potential has dropped and the measurement system has been saturated. There are approximately 5 minutes between the two measurements.

During the measurement period the trigger level was set to 30 V and not -30 V. In Figure 10 both curves dropped below -30 V and were also saturated. The reason why these two curves were monitored was a short positive transient over 30 V before and after they were saturated. In this case it can be argued that the specific voltage levels and time would contain enough power to make the RC circuit go out of order. However, again the RC circuit was not out of order until much later that day, and no specific curve was recorded that could be the primary reason for the failure of the RC circuit.

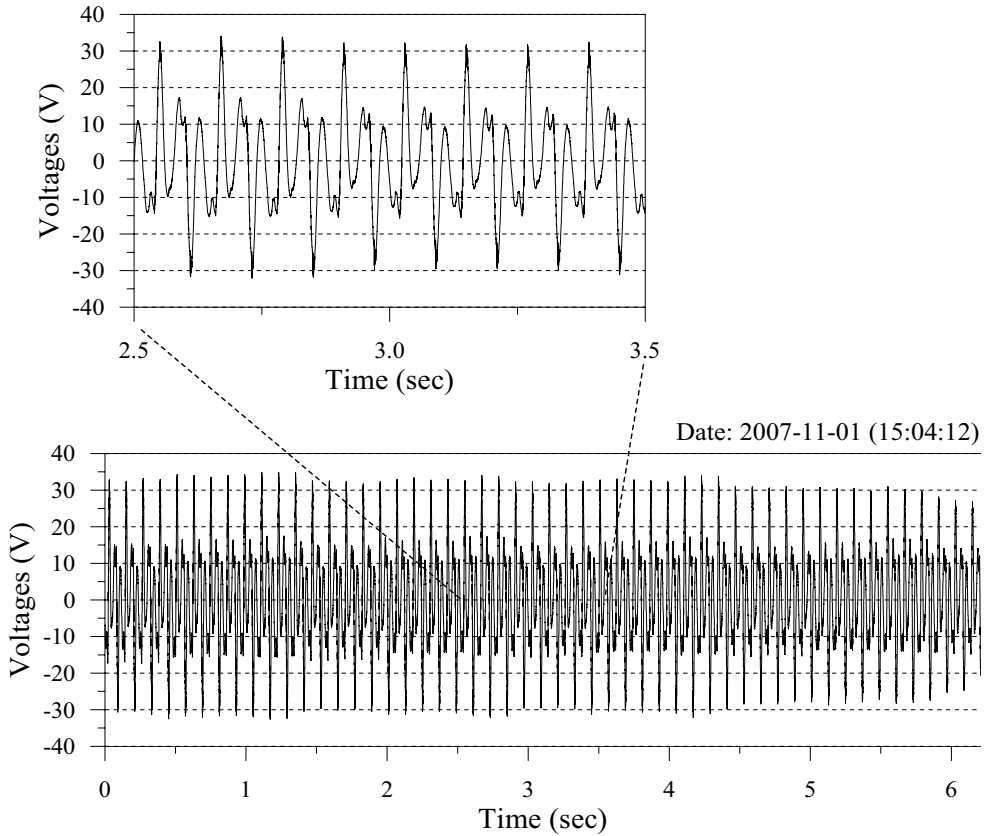
The other two days when a fault was registered for the RC circuit were 1/11/2007, with 225 triggers, and 8/11/2007, with 690 triggers, see Table 1. The curves for these two days when the RC circuit went out of order are slightly different compared to the curves for other days, and contain more energy in the transients, see Figure 11.

The curve in Figure 11 was triggered at 15.04. The next curve was triggered at 15.13 and looks similar to the curve triggered at 15.04. The alarm was detected at 15.10.

Figure 11. Voltage curve 20071101 1504.

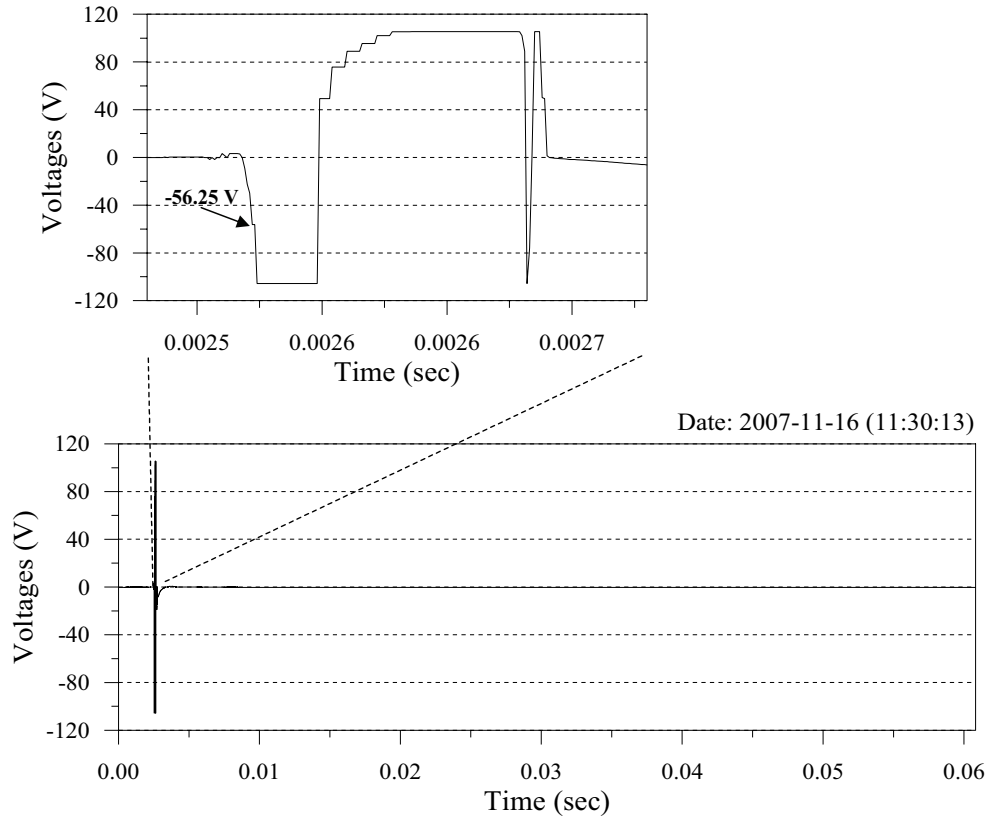
In comparison with Figure 7 and 8, Figure 12 shows, due to the faster sampling rate, only a single transient. All the curves during this measurement period show a similar behaviour. The first transient in all the curves has the same value, - 56.25 V, as seen in Figure 12. The figure shows that the transient is very fast on the flanks in the middle. The tail seen in Figure 7 and 8 is not seen in Figure 12. The transient is very fast and the voltage drops immediately after the last high transient.

Figure 12. Voltage curve where the first transients are saturated. The sampling rate was 1 MHz.

Regarding the detailed analysis of the transients, see Figure 12, the supplier of the rectifiers controls and checks every delivered rectifier according to specific instructions. The supplier also states that there is not any internal or external source that could generate the voltage -56.25 V that is seen in Figure 12. It is not a normal behaviour that a high transient should drop that fast. A more normal behaviour is seen in Figure 7 and Figure 8, and resembles more what has been seen in measurements and simulations of pantographs [17, 18, 19]. To exclude faults or mistakes during the measurement, the measurement system was checked afterwards, and it was working correctly, even if there is no guarantee that the measurement is correct.

If the rectifier had been active and delivered the power, the level should have been around 26 to 27 V, which is what the rectifier delivers to its subsystem when it is active. This gives a clear indication that it was not a train or locomotive that was the primary cause of the interference. All the measurement curves are also centred on zero, which indicates that there were no trains located at the station.

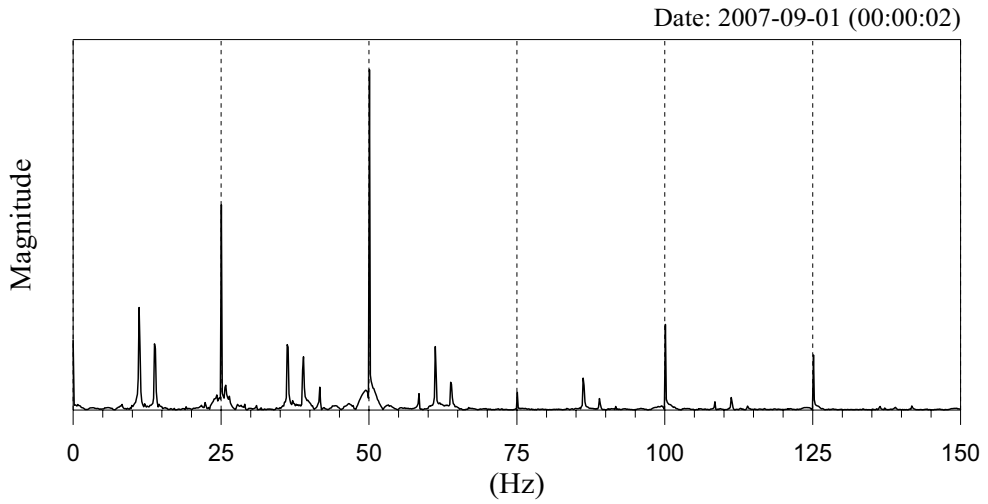
Figure 13. The frequencies from Oxmyran during the forced night trigger.

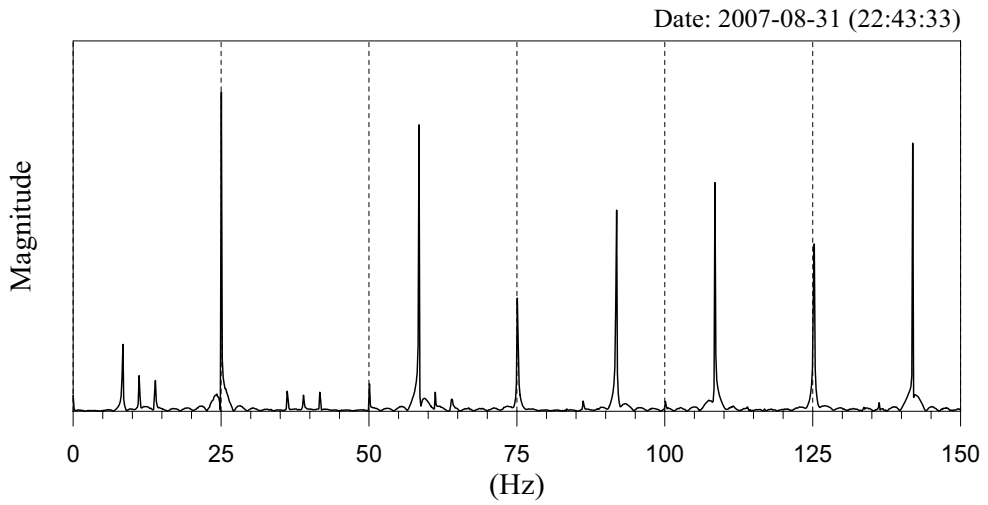
Figure 14. An FFT on the curve from the date 2007-08-31, the time 22:43:13.

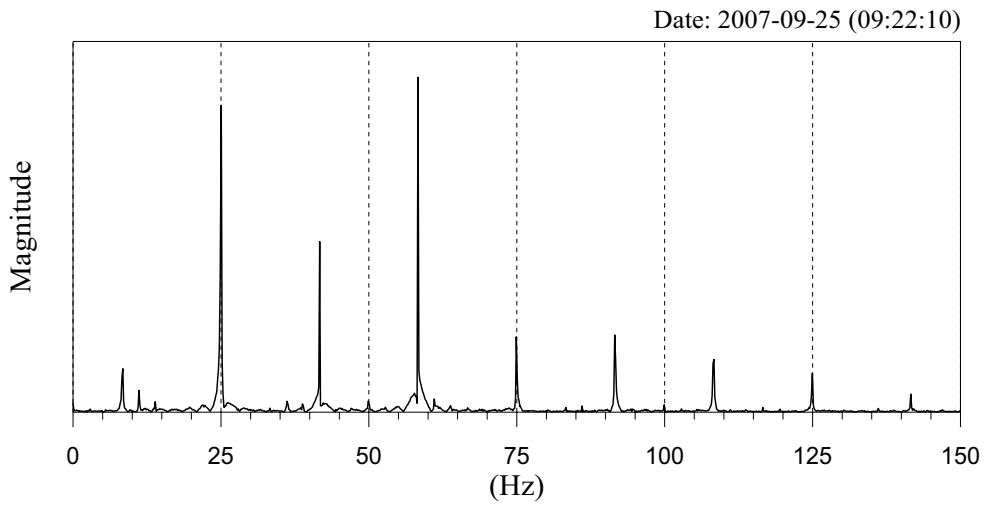
Figure 15. The FFT from the date of 2007-09-25, the time 09:22:10.

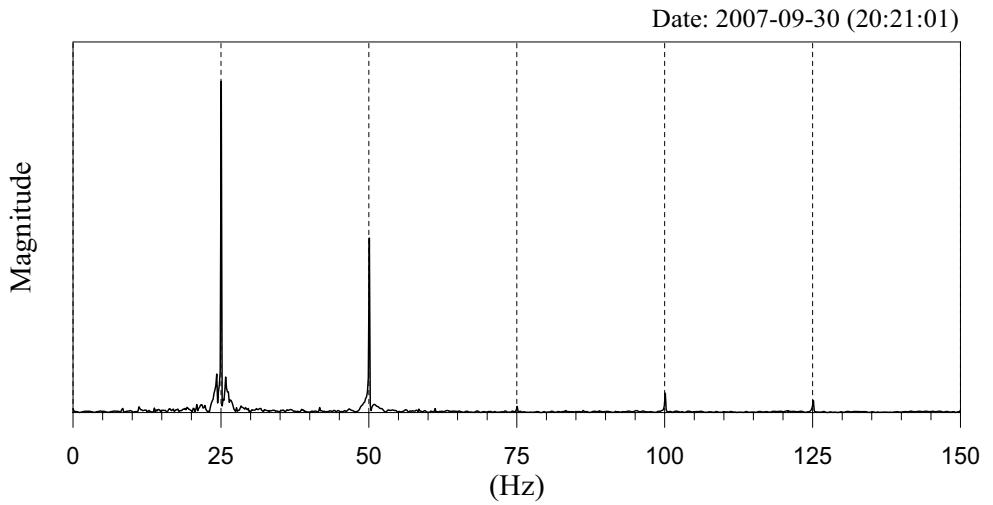
Figure 16. The FFT from the date of 2007-09-30, the time 20:21:01.

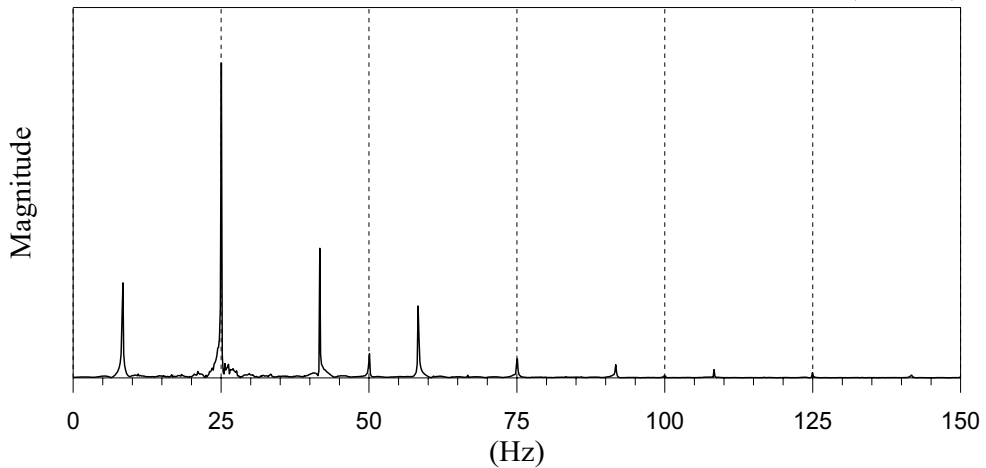
Figure 17. The FFT from the date of 2007-11-01, the time 15:04:12.
