Impact of climate on railway operation - a Swedish case study

U. Juntti¹,

Luleå Railway Research Center, Luleå University of Technology, Luleå, Sweden

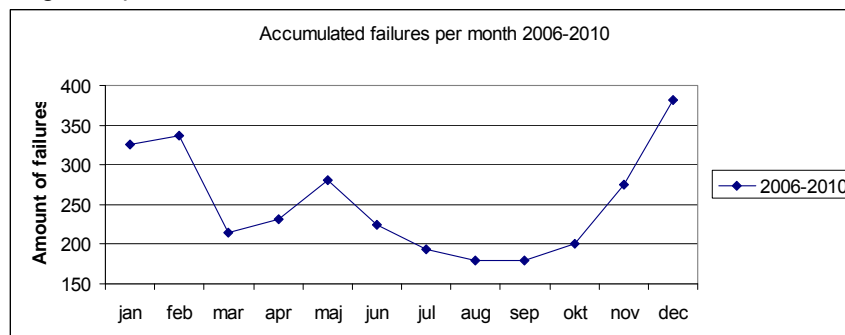
How the failures are distributed per month is shown in Figure 2, which shows the accumulated failures per month for the period 2006 to 2010. There are fewer failures during August to October when the average temperature is 4 °C.

Figure 2: Accumulated failures per month 2006-2010.

By predicting the probability for a failure to occur (see Figure 2) it also would be possible to allocate the emergency organisation at right place in right time. An Improvement area is to investigate and find the root causes to the increases in failure in November and May and suggest solutions.

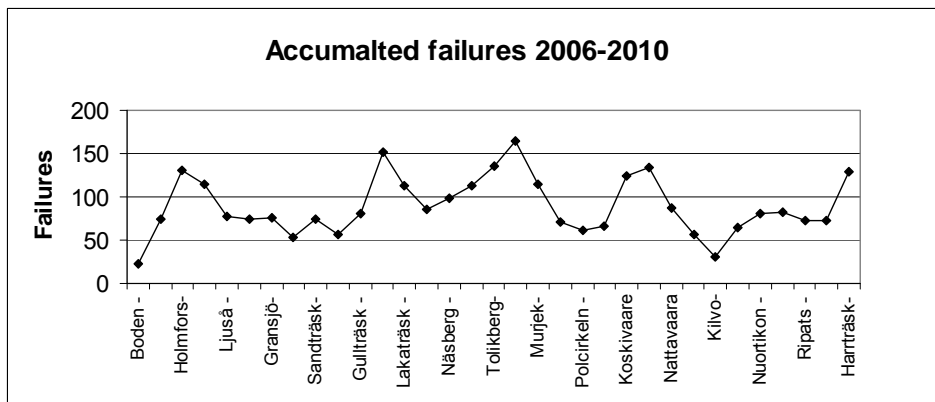
Step 4: Geographical conditions; most failures occurs at Holmfors-Ljuså, Lakaträsk, Näsberg-Tolikberg, Murjek and Nattavaara. See Figure 4.

Figure 4. Accumulated failures

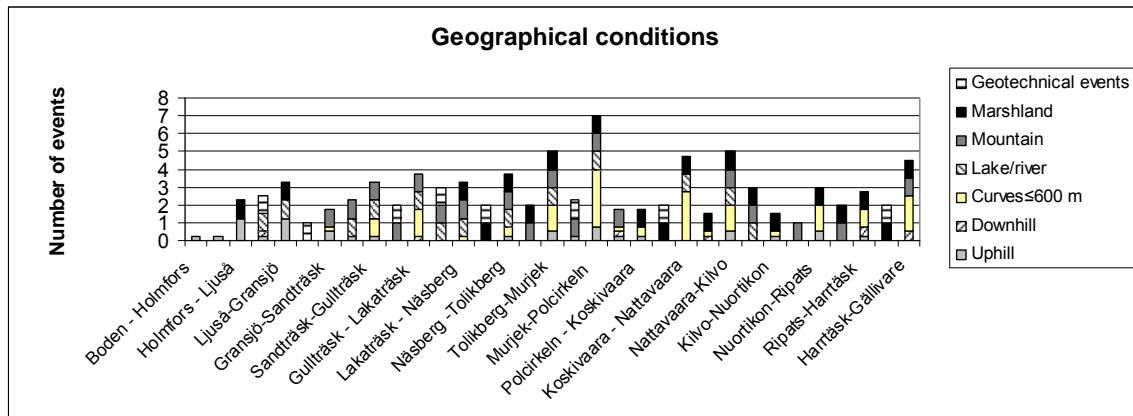
Figure 5 shows in what kind of geographical condition most failures occurs. Geographical conditions have been group in “up hill”, “down hill”, near “lake/river”, near “mountain”, “marshland” and “geotechnical events”. There are a total of 56 geotechnical locations with an average length of 100 m that have had problems with frost extension, erosion and subsidence [1]. If a geographical condition has occurred on a section/yard, it has been given the value = 1. In order to show the density of curves, the number of curves with a radius less than 600 m have been summarized per section and multiplied with 0,25 in order to scale the geographical event “curves” in parity with other geographical conditions. A similar procedure as has been conducted to compare

Figure 5. Geographical conditions

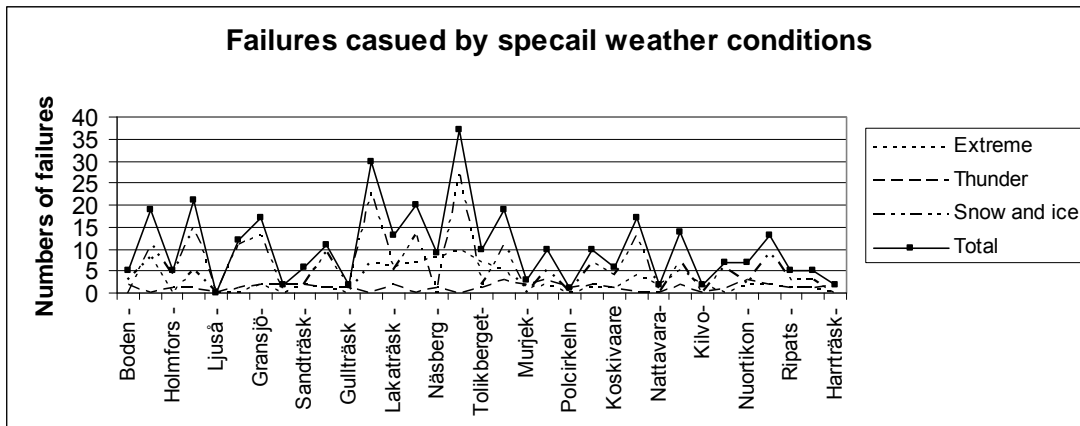
In Figure 6 the numbers of failures caused by extreme weather conditions (according to step 2) has been related with weather related failures reported into Ofelia.(see step 3). Figure 6 shows that there is a correlation between “extreme weather conditions” and snow and ice. It also shows that most affected section/yard is Lakaträsk, Ljuså, Murjek, Tolikberg –Murjek.

Figure 6. Failures cause by special weather conditions

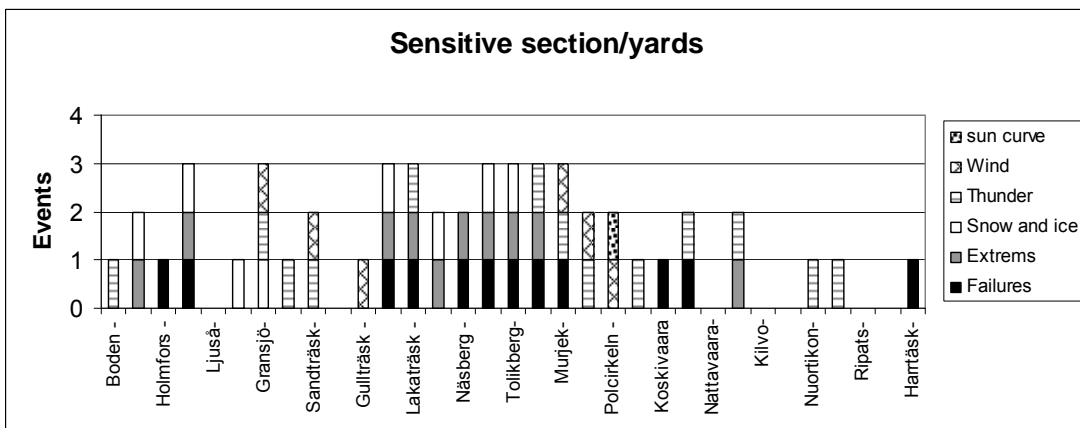
Figure 7 shows sections/yard sensitivity for weather related failures on an aggregated level, so to say that sections and yards causing less than 5 % of their failure in their own category has been excluded.

Sections with increased vulnerable towards failures (not just weather related) are Näsberg to Murjek, see black bar in Figure 7. Particularly vulnerable sections of extreme weather conditions are e.g. Gullträsk to Murjek.

Figure 7. Sensitive sections/yards
